LASER-ULTRASONIC INSPECTION OF THE COMPOSITE STRUCTURE OF AN AIRCRAFT IN A MAINTENANCE HANGAR

Marc Choquet, René Héon, Christian Padioleau and Paul Bouchard
UltraOptec Inc.
Boucherville, Canada

Christian Néron and Jean-Pierre Monchalin
Industrial Materials Institute
National Research Council of Canada
Boucherville, Canada

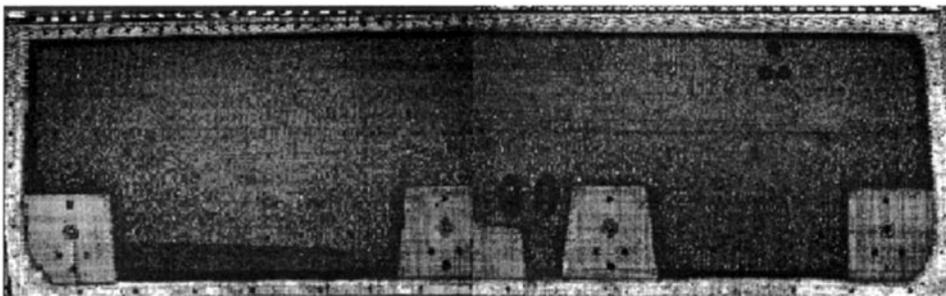
The first component inspected during these tests was a side panel of the aircraft fuselage, identified as panel 10L. This panel is one of the left forward fuselage doors of the aircraft. It is composed of an aluminum honeycomb core with a graphite epoxy skin with one ply of fiberglass overlay on the inner surface of the skin. The component is slightly curved. Given the maximum horizontal angle of a scan with the prototype system, two separate laser-ultrasonic scans were performed to cover the complete surface of the component. A first section of 674 mm x 390 mm was inspected, followed by a second inspection of 672 mm x 366 mm. Between the two acquisitions, the generation unit was moved and centered on the targeted area. By combining the two amplitude C-scans, a complete image of the panel is obtained and presented in figure 2. The underlying structure of the panel is clearly visible in the image. Notice that one can see the composite back reinforcement structure used for affixing the panel to the fuselage.

Figure 2: Laser-ultrasonic amplitude C-scan of panel 10L.

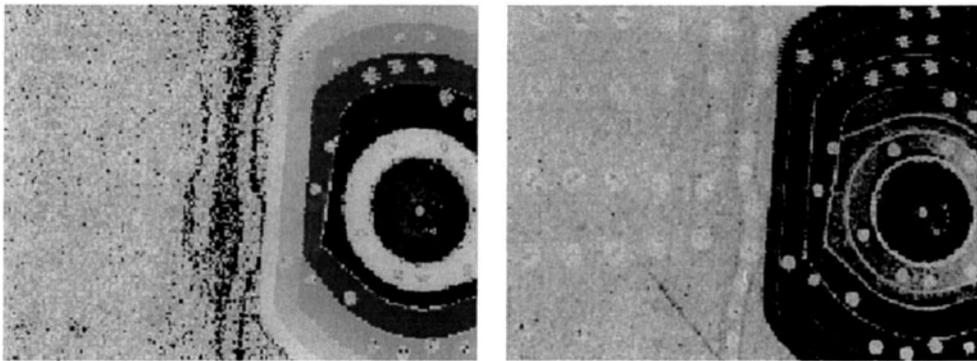
Figure 3 shows a time-of-flight C-scan and an amplitude C-scan of the area near the fuel plug. The images reveal the structure around the fuel tank access plug. In the left section of the images, one can see a complex structure composed of multiple plies of composite material. The right section of the inspection area includes a thick composite structure of varying thickness, up to approximately 0.75 inch. In the midsection of the time-of-flight C-scan, one can see a darker region indicating the presence of a sealant which had spread outward during the fabrication of this section. The amplitude C-scan reveals several rows of fasteners (light white spots) present in this component.

Figure 3: Laser-ultrasonic images of a section near the fuel plug; left - time-of-flight C-scan, right - amplitude C-scan.

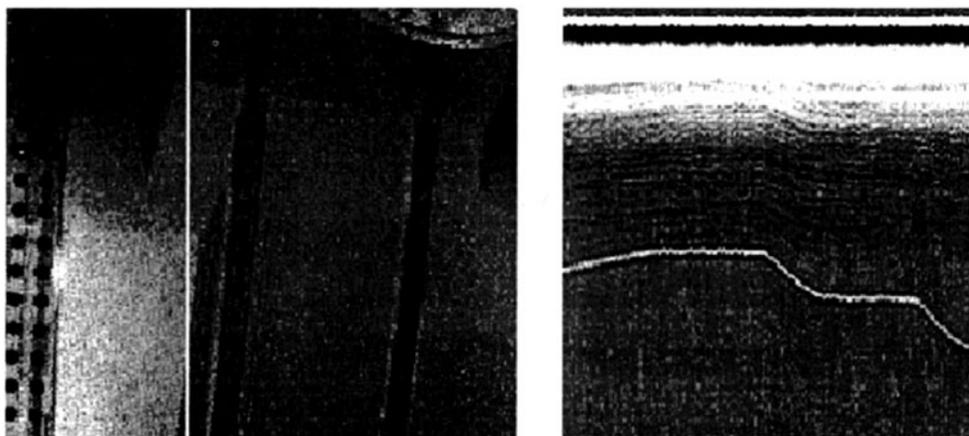
Figure 4: Laser-ultrasonic images of a section under the fuel tanks; left: amplitude C-scan, right: B-scan, cut along the white line shown on the left.

The second area inspected is a lower portion of the inner wing under the wing's fuel tanks. On the top right of the image shown in figure 4, one can see the lower edge of the section previously scanned. The image clearly shows the boxlike fuel tank inside the wing. One can also observe the stiffeners of the structure. To better see the thickness variations in the component, a B-scan along the white line shown in the C-scan is also displayed in figure 4. One can clearly see the thickness variation along this line.

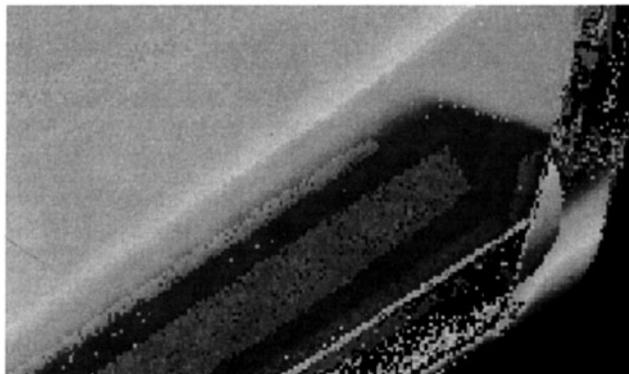
The first scan shown in figure 5 demonstrates the ability of our laser-ultrasonic system to completely inspect a given part, including its edges. The inspection area determined by the operator (which is always rectangular) can be larger than the inspected component. When the beams do not reach the component, no signal is returned. With proper setting of the C-scan image parameters (time and amplitude gates), these sections can appear dark. In the image shown in figure 5, one can clearly see the edge structure of the stabilizer. Thickness variations within the part can also be clearly observed.

Figure 5: Laser-ultrasonic image of the edge of the horizontal stabilizer.

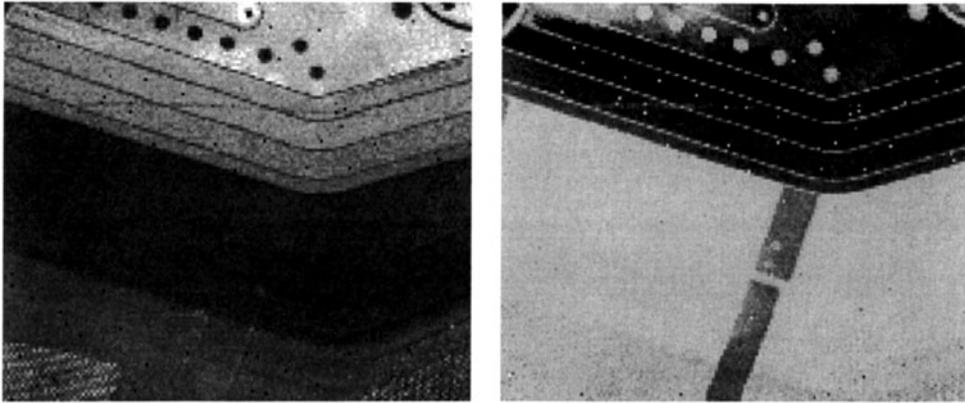
The second scan, shown in figure 6, depicts a section near the attachment point of the horizontal stabilizer to the aircraft's fuselage. The section is composed of a variety of structures. Two amplitude C-scans produced by different gate settings are presented in figure 6. The left image is obtained by gating the A-scan to conserve only the positive polarity echoes, whereas the right image uses echoes with negative polarity. This demonstrates the ability of laser-ultrasonics to focus on a particular structure by manipulating the C-scan gates. In the upper half of the images, one can observe a titanium composite joint of varying thickness. In the left image, one can clearly see the honeycomb structure in the lower left section, while in the right image, one can observe a structure that is barely visible in the left image.

Figure 6: Laser-ultrasonic C-scan images of the horizontal stabilizer.
