VIBROTHERMOGRAPHIC NDE OF FIBEROUS COMPOSITES

S. S. Russell

Mechanical Engineering Dept.
University of South Carolina
Columbia, SC

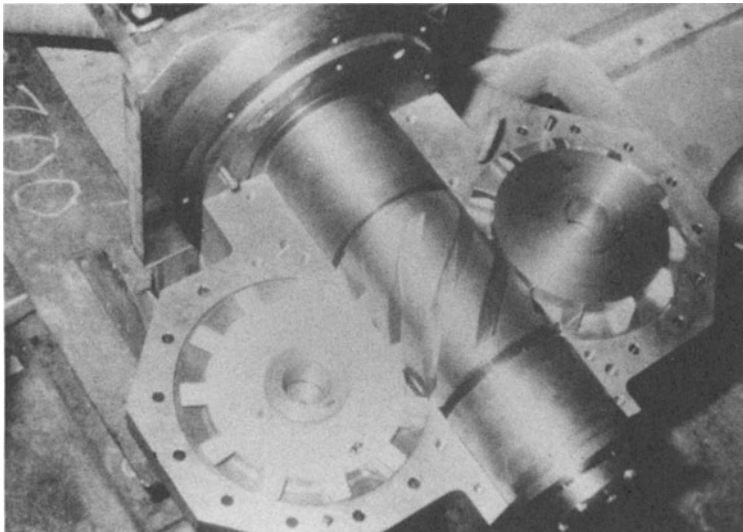
Figure 2. Gate Rotor Pump with Top Housing Removed

The gate rotor seal investigated had been a component in a hydraulic pump, as seen in Fig. 2, the part with an "R" written on it. The bronze screw, in the center of the pump and also in the center of Fig. 2, failed damaging the glass-epoxy gate rotor seal. The seal was running in hydraulic fluid, and the damaged zones were stained in the translucent seal. Hence the damaged areas were very apparent for each reference. The damage consisted primarily of delaminations with some surface chips and abrasions. The damage was mapped onto a drawing of the part for reference.

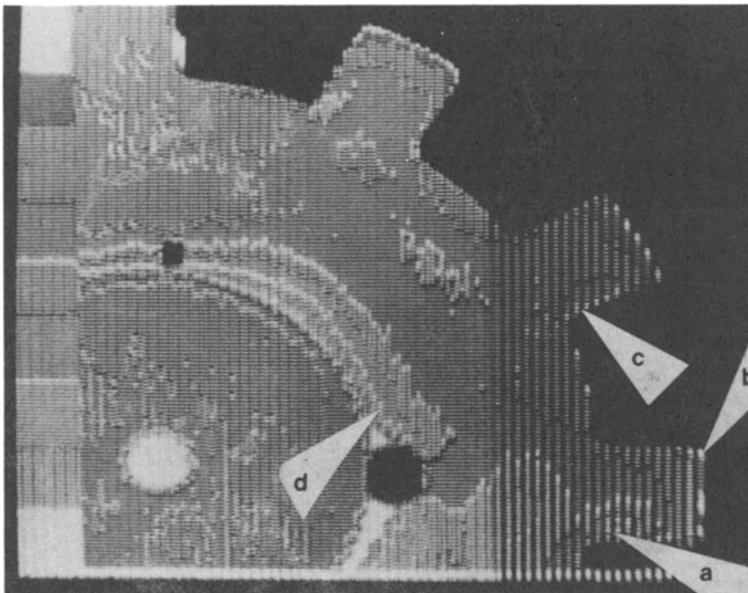
Figure 3. Vibrothermogram of Gate Rotor Seal

A Vibrothermogram of one quadrant of the seal with excitation frequency of 13.6 kHz is presented as Fig. 3. Because of the inadequacy of this black and white copy of a color photograph, lettered arrows are used to indicate zones of interest. Zones "a", "b" and "c" are two delaminations and some surface gouges, respectively. The area "d" is a semicircle of higher temperature where heat from the shaker is being conducted by the aluminum plates into the gate rotor seal. A change of the excitation frequency caused different flaws to heat, but the union of all the hot spots indicates 75% of the damage observed by the staining.

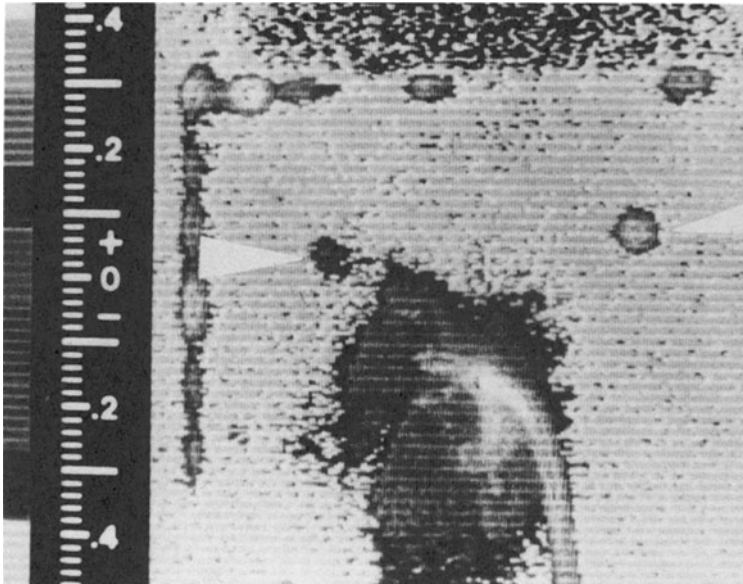
Figure 6. Vibrothermogram of Hybrid Composite Panel

A Vibrothermogram of this panel is presented as Fig. 6. The shaker and vacuum tube are located in the center of this photo, with the impact damage indicated by arrows. Notice that zones of damage along the panels edge caused by the cutting of this panel from a larger panel are actively heating. This experiment illustrates the feasibility of inspecting a part or panel where access is allowed only to one side of the specimen through a temporary connection.

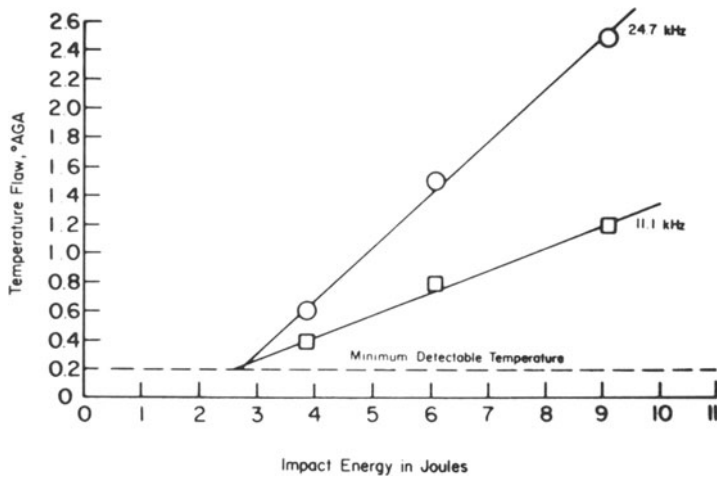
Fig. 7. Temperature of Center of Impact Damage versus the Energy of the Steel Sphere Impact

The beam resonance of these coupons occurred at 11.1 and 24.7 kHz, and at these frequencies the damage zones heated well. The steady-state temperature at the two resonant frequencies of the center of the impact zone was plotted as a function of the impact energy that caused the damage in Figure 7. The small damage zone was not detectable by Vibrothermography. However, an almost linear relationship existed between the impact energy and the temperature observed.
