TSM 416 Technology Capstone Project

Silicone Applicator Cleaning Improvement

Client: Cardinal Glass, 716 NE 6th Street, Greenfield, IA 50849

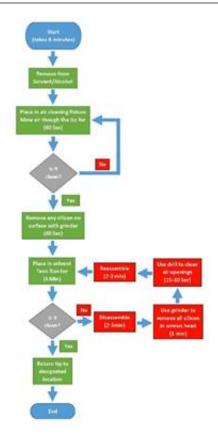
6 GRAPHICAL ABSTRACT

Clean Tip

Dirty Tip
