[Evaluating Roadway Subsurface Drainage Practices – Phase II](#)

Iowa Highway Research Board  
(IHRB Project TR-662)  
Iowa Department of Transportation  
(InTrans Project 13-473)

tech transfer summary

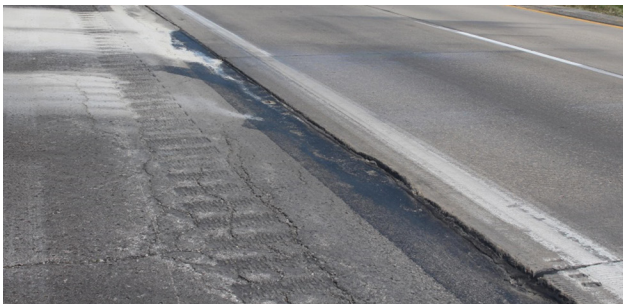
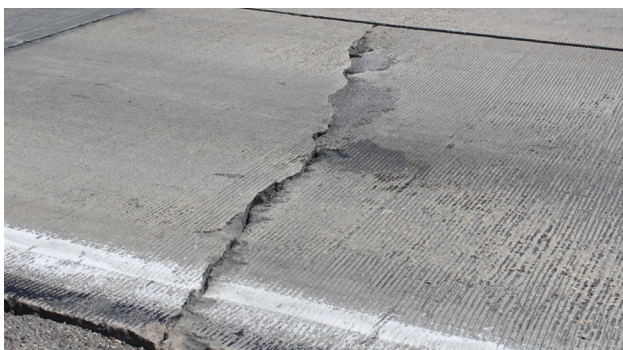
*Moisture-related distresses on JPCP where no drainage outlets located at site*

- Moisture-related pavement surface distresses were observed in sections where no drainage outlet could be located.
- At the JPCP sites, slightly more outlets were observed with blockage and associated surface distresses in summer 2013 than in fall 2012. However, these differences are not significant.

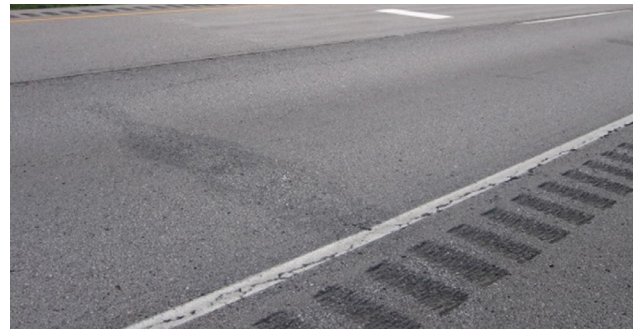
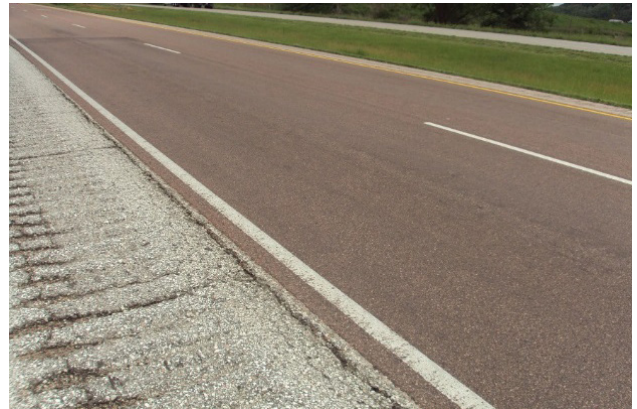
*Moisture-related distresses on HMA over JPCP-type composite pavement system where no drainage outlets located in the field*

- More than 50 percent of HMA over JPCP outlets were blocked by sediment and soil deposits.
- Surface distresses were observed near blocked drainage outlet locations at HMA over JPCP sites.

- At HMA over JPCP sites, moisture-related distresses were observed more frequently near blocked than clear drainage outlet locations. Compromised drainage outlet performance may therefore accelerate the development of moisture-related distresses in HMA over JPCP.

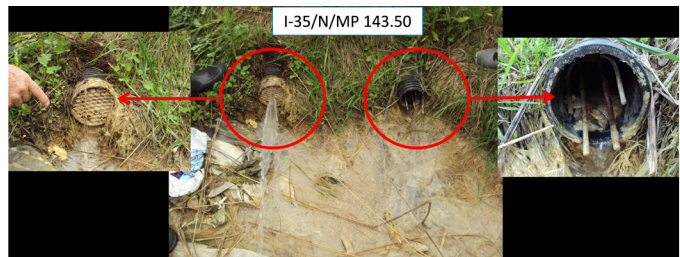
*Mesh screen type rodent guards (left) exacerbated outlet clogging by blocking free flow of draining water while fork-shaped rodent guards (right) did not*

- Use of a gate or mesh screen rodent guard may cause outlet blockage. Because very little rodent evidence was observed during field investigations, it is highly recommended that rodent guards not be used to cover drainage outlets.
