Access Audits

Julie E. N. Irish, PhD

The Access Audit

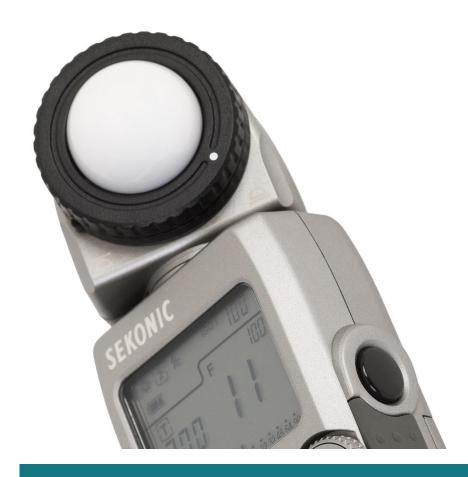
Light Meter

- Measured in lux/lumen
- Record time of readings and weather conditions as these can effect readings
- Follow recommendations

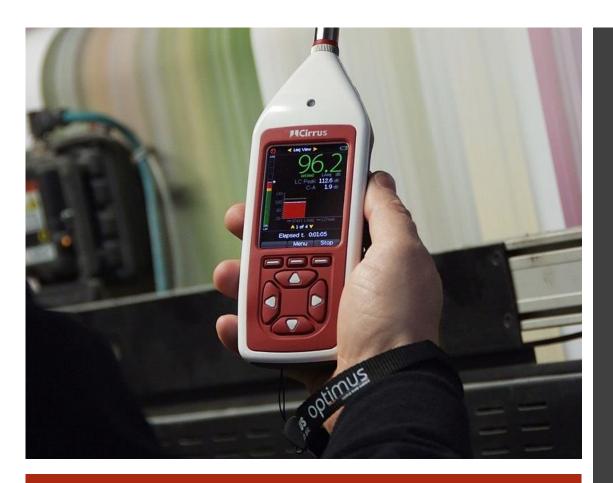
Sound Level Meter

- Measured in decibels
- Record time of day and conditions, e.g. transition time in a school corridor

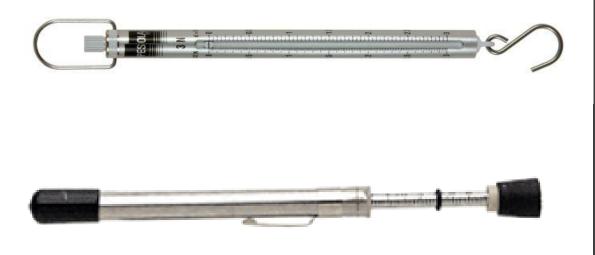
Door Pressure Gauge

- Measured in pounds or newtons
- Opening force 5lbs (22.2N) max.
- Does not apply to fire doors
- Door pressure gauge or spring balance
- Measured at leading edge of door

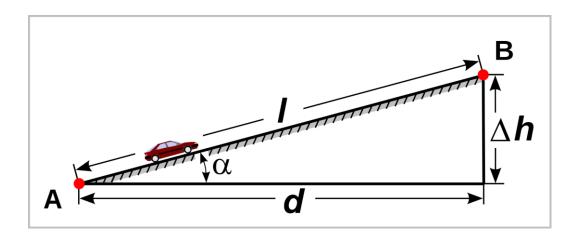
Gradient Level

d = run $\Delta h = rise$ l = slope length $\alpha = angle of inclination$

- Ramps 1:12
- Existing ramp 1:8 –
 1: 10, 3" max. rise
- Existing ramp 1:10 1:12, 6" max. rise
- Rise of ramp max. 30"
- Calculated with formula divide rise (Δh) by the run of ramp (d), ie the horizontal distance
- Use an online calculator https://www.ezaccess. com/tools/inclinecalculator

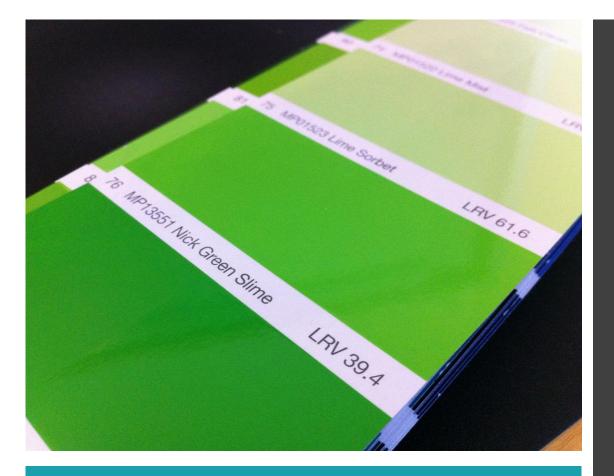
Light Reflectance Value

- Good color contrast between surfaces
- LRV code can be found on the back of paint swatches
- 70% LRV contrast recommended for signage
- LRV Formula for Contrast = [(B1-B2)/B1] x 100 percent
- Where B1 = light reflectance value (LRV) of the lighter surface, B2 = light reflectance value (LRV) of the darker surface.
- Try ASI calculator <u>https://asisignage.com</u> <u>/doc-resource/lrv-calculator/</u>

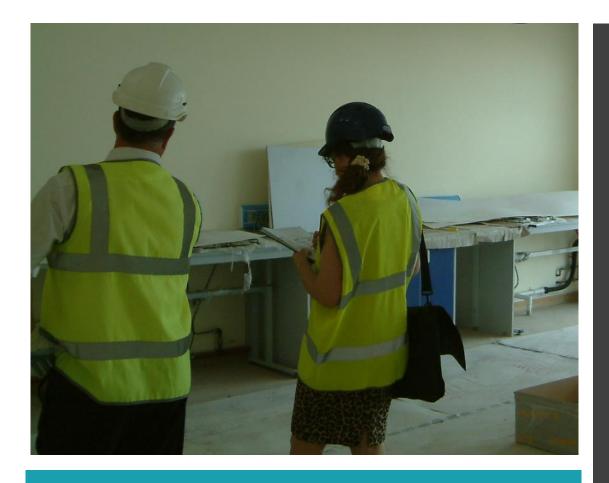
Photographic evidence

- Make a note of photo numbers!
- Cross reference with room numbers
- Cross reference with your report
