TSM 416 Technology Capstone Project

## Test Device and Process for Assessment of Smithfield Facility Aging

Predicting naturally ventilated Swine facility life expectancy in the NW ¼ of Iowa.

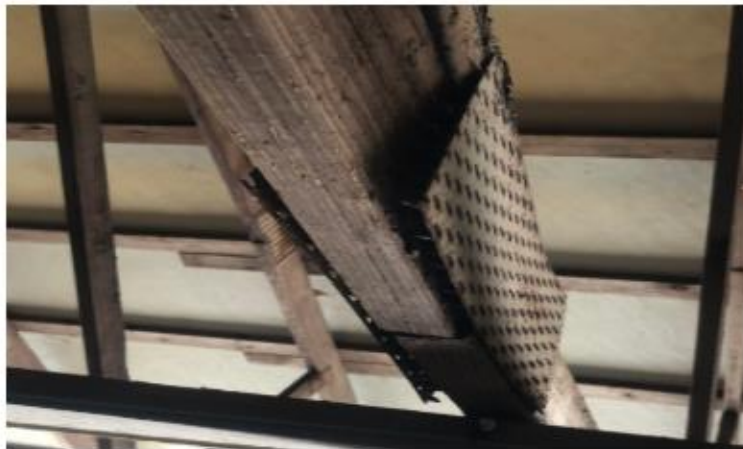
Complete separation of truss or butt joint plate teeth from wooden beams on any tested truss results in an automatic 25% rating for evaluation tests. Note the gap between wood and truss plate teeth in the image below.

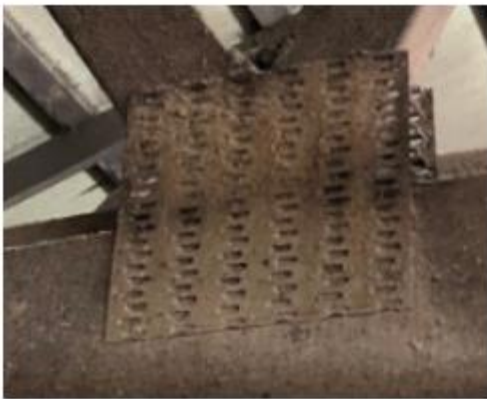
1. 25% - Requires Immediate Repair

**Component Description:** Steel plates connecting the webbing of a truss, evaluate all truss plates on for visual deterioration. Record rating for worst condition truss plate on truss.

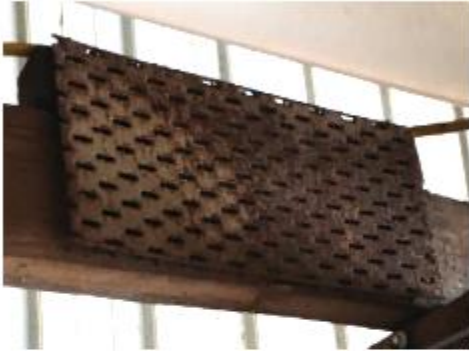
1. 25% - Requires Immediate Repair

**Component Description:** Steel plates connecting 2, 2x6 bottom truss chords. 2 to 3 connections per truss. Record rating for worst condition butt joint plate on truss.

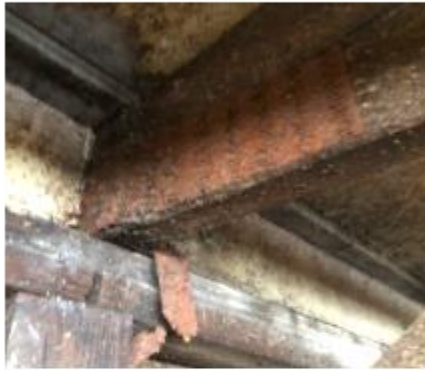
1. 25% - Requires Immediate Repair

**Component Description:** Eve plates(Gussets) and hurricane clips(strips). These components support the connections at the ends of the truss at the wall. Record rating for worst condition Eve Plate/Hurricane clip kit of the pair on each truss.

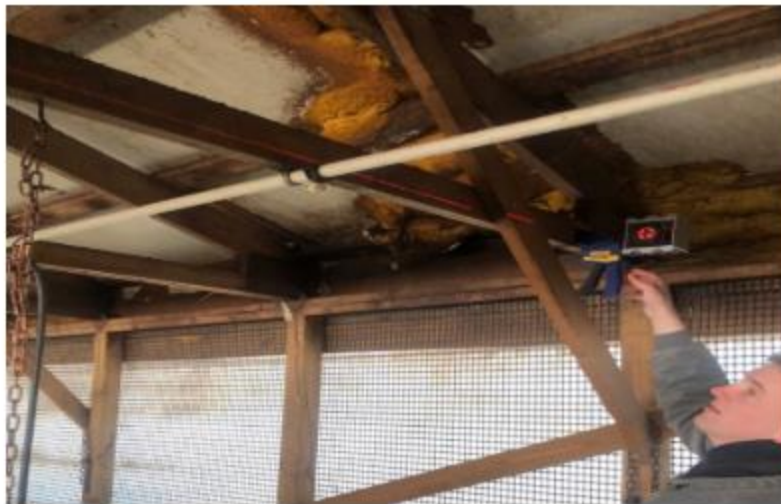
| 1. <b>2in or greater deflection</b><br>25% - Requires immediate Repair | 2. <b>1 in deflection</b><br>50% - Reinforcement Recommended |
| 3. <b>0.5 in deflection</b><br>75% - Components Show Minor Wear | 4. <b>Zero noticeable deflection</b><br>100% - No Need for any action |

8. Repeat the test reorienting the mount in the opposite direction on the same truss chord as shown in the demonstration images on the following page.

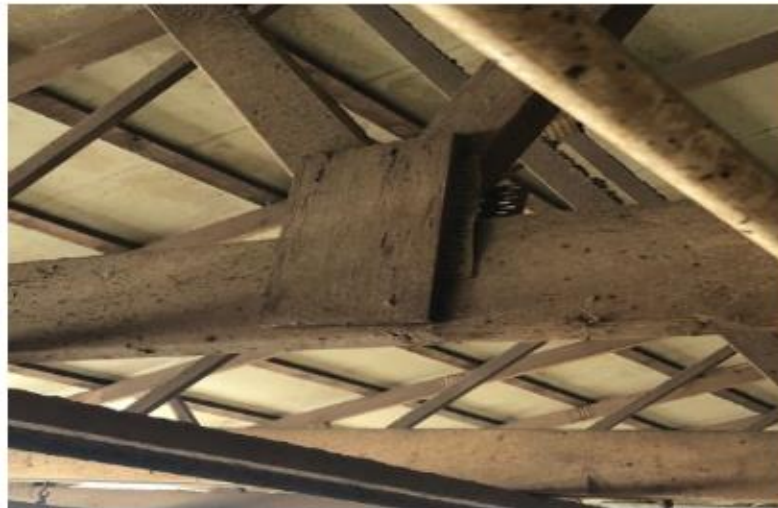
## Plywood on Truss Plates (At webbing)

- 3/4 inch plywood added overtop existing steel truss plates.
- Secured using screws
- Added to any observed truss plates at a rating of approximately 50% or lower.

**Material List:** A piece of plywood of equal or greater size than the original truss plate with 8-12 wood screws 1 3/4 - 2" in length

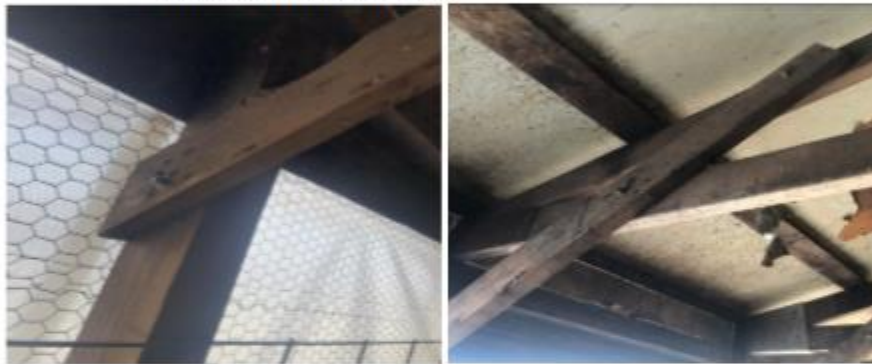
## Wind Braces

- Reinforces the connection between the chord, rafter, and 4x4.
- 1 kit every rafter at both ends of rafter
- Applied at wall 4x4's and rafters.
- Secured by SS bolts in 3 places - 4x4, rafter cord, and rafter.

**Material List:** 3, 5/16" SS bolts per kit, each with a set of washers and nylock nuts.  
2 kits per rafter(1 each end).

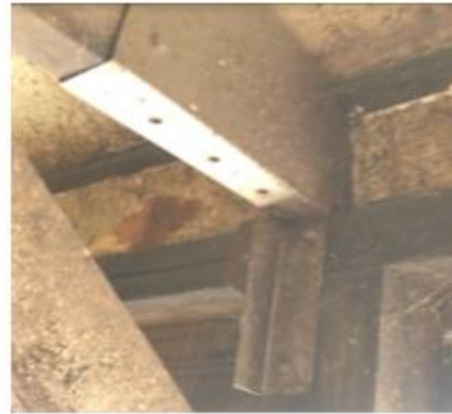
## Eve Brackets and Hurricane Clips

- Reinforce connections at the end of the truss and the wall.

**Material List:** 2 eve brackets and hurricane clip kits for every truss.  
Lag screws for each kit.

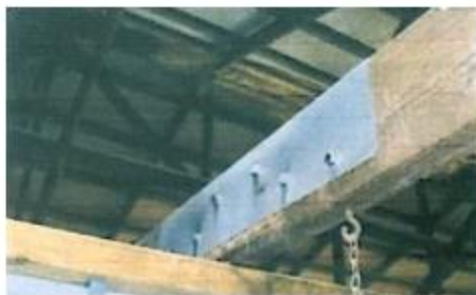
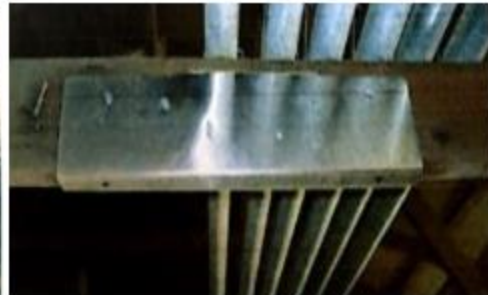
## Stainless Steel Butt Joint Brackets

- Stainless steel brackets connecting the butt joints along the bottom truss chord.
- Applied in top or bottom orientation.
- 2 or 3 connection points per truss.

**Material List:** 2-3 butt joint brackets per truss  
Lag screws for each location.

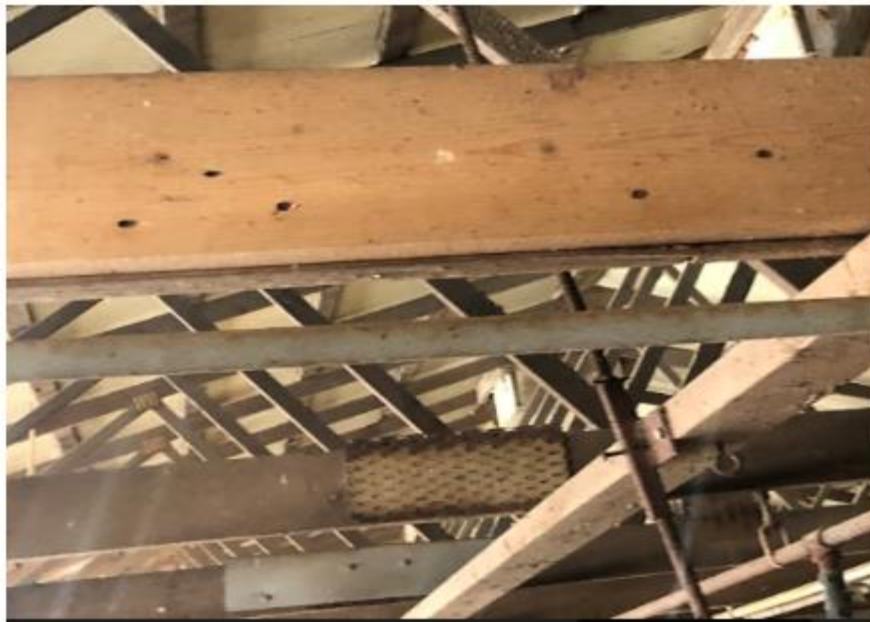
## 2 x 6 Added to Bottom Truss Chord

- Additional 2x6 beam added along the length of the bottom truss chord.
- Noted by the brighter colored wood in the visual below.
- Applied every third Truss in rotation with the Butt Joint Brackets.

### Material List: Non treated 2x6's

Approximately 60, 12ft long for 1 facility.
