## GLASS FIBER AIRPLANE INSPECTED WITH

## INFRARED LOCKIN THERMOGRAPHY

A. Salerno, D. Wu, G. Busse  
Institut für Kunststoffprüfung und Kunststoffkunde  
Universität Stuttgart  
Pfaffenwaldring 32  
D-70569 Stuttgart-Vaihingen, Germany

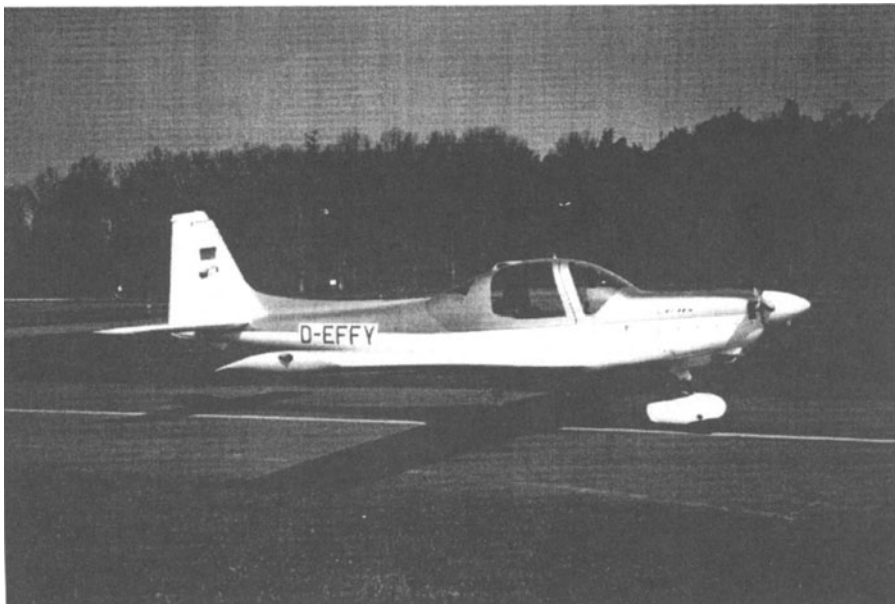
Figure 3. Picture of the airplane Grob G115

The airplane used for the inspection is a Grob G115 (fig. 3), mainly made of glass fiber reinforced polymer (GFRP). The lockin system has been brought to an airfield in order to

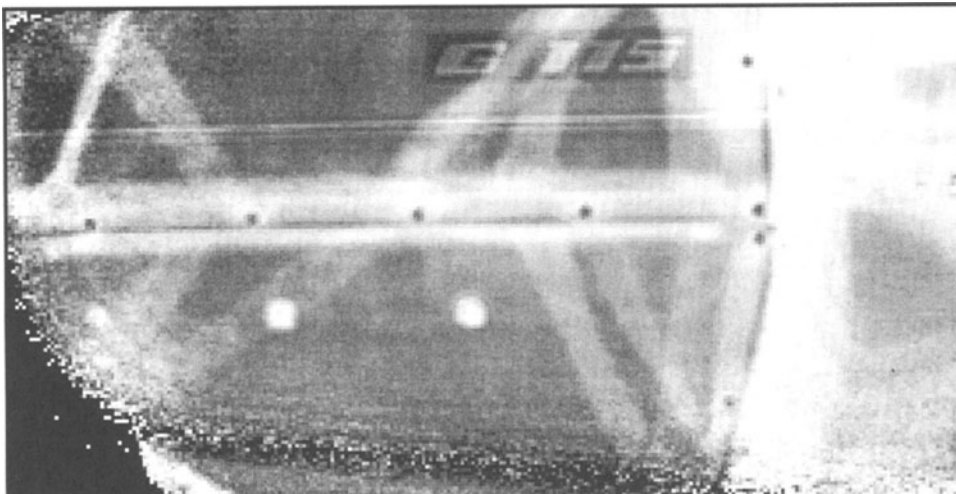
Fig. 5 shows the cowling of the plane: many stripes are visible due to the overlapping parts of the GFRP material used in the construction of the shell. The three round structures, not visible on the other side, indicate the points where the cables for the landing lights are attached underneath the cowling. The dark spots are fasteners. During a hard landing the front and the main gear were damaged. No damage was visible at the attachment of the two gears, but the structure had to be opened for an inspection and delaminations were found and subsequently repaired. Fig. 6 shows a repair at the attachment of the front gear.

Figure 5. Part of the upper and lower cowling of the plane (0.015 Hz).

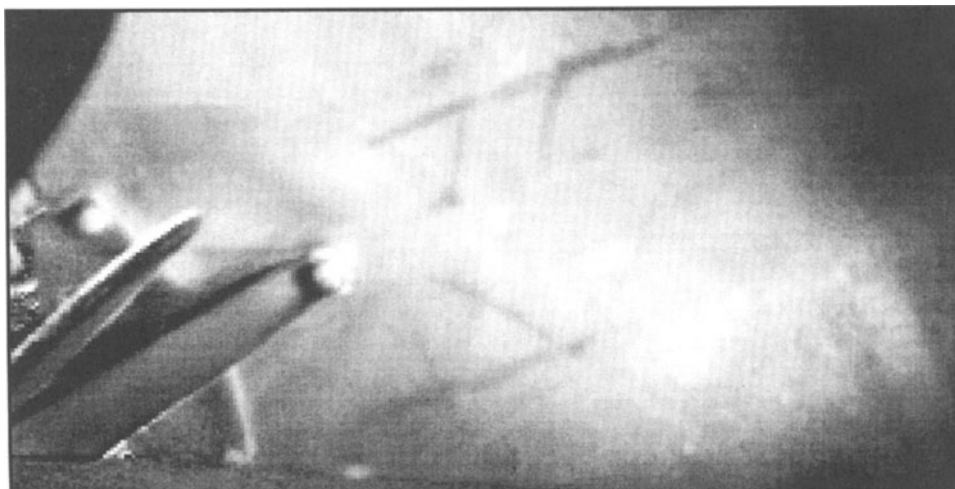
Figure 6. Repair of a delamination at the attachment of the front gear at the bottom of the fuselage (0.02 Hz)
