Field testing of railroad flatcar bridges on low-volume roads

A thesis submitted to the graduate faculty
in partial fulfillment of the requirements for the degree of
MASTER OF SCIENCE

Major: Civil Engineering (Structural Engineering)

Iowa State University

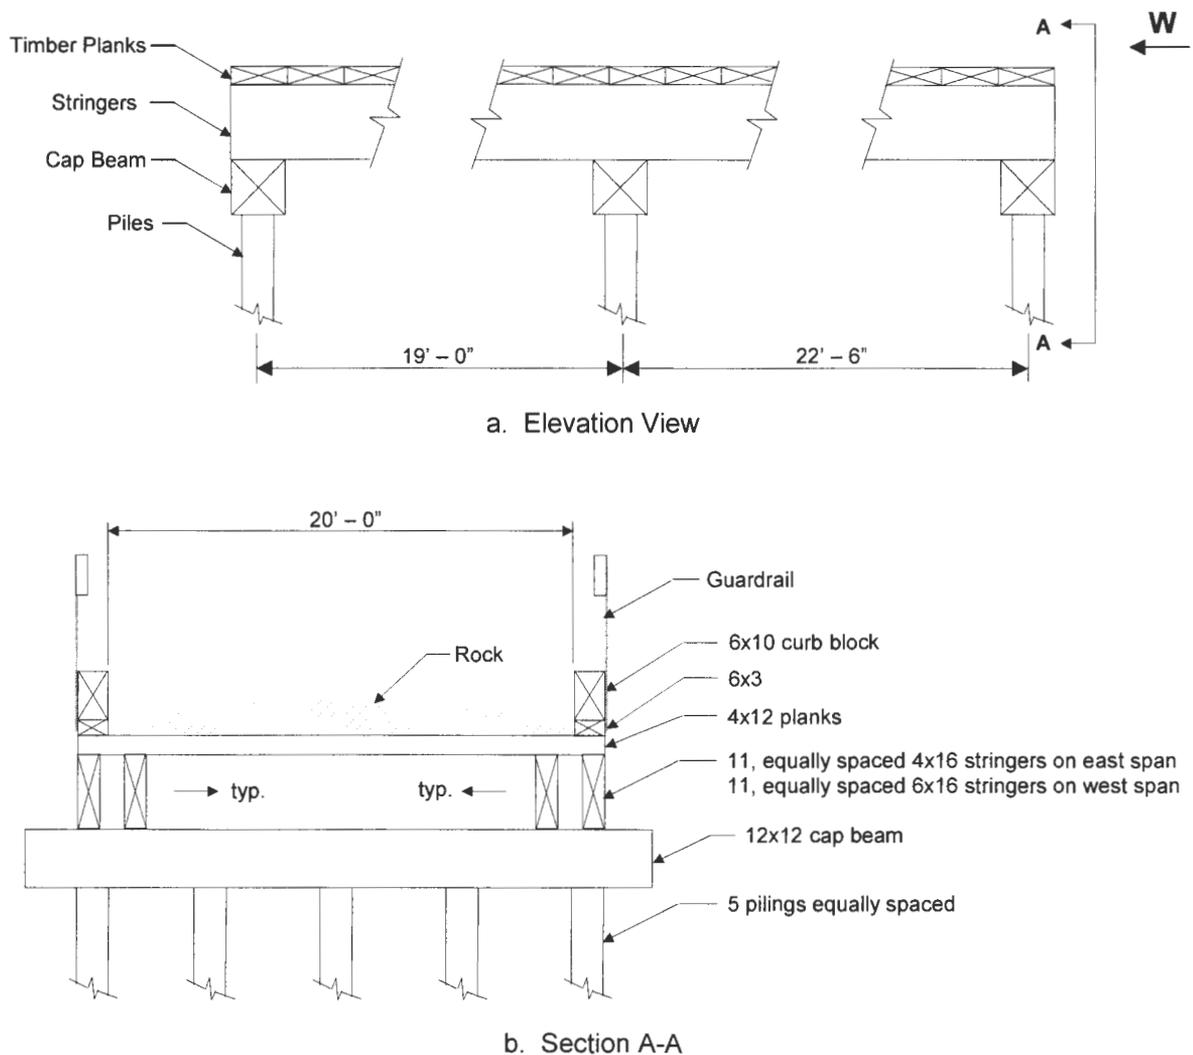
Figure 2.2. Original Buchanan County Bridge on 270th St.

The BCB3 replaced a two-span timber bridge (19 ft – 0 in. and 22 ft – 6 in. spans) with a 20 ft wide deck which was constructed in 1948 (FWHA No. 082160). A sketch of the previous structure can be seen in Figure 2.2. Five timber pilings at the abutments and pier were capped with a 12x12 timber section. Throughout the bridge length there were 11 equally spaced stringers; however, the west, smaller span was comprised of 6x16 timber stringers and the east, larger span had 4x16 timber stringers. Timber planks and gravel create the driving surface.

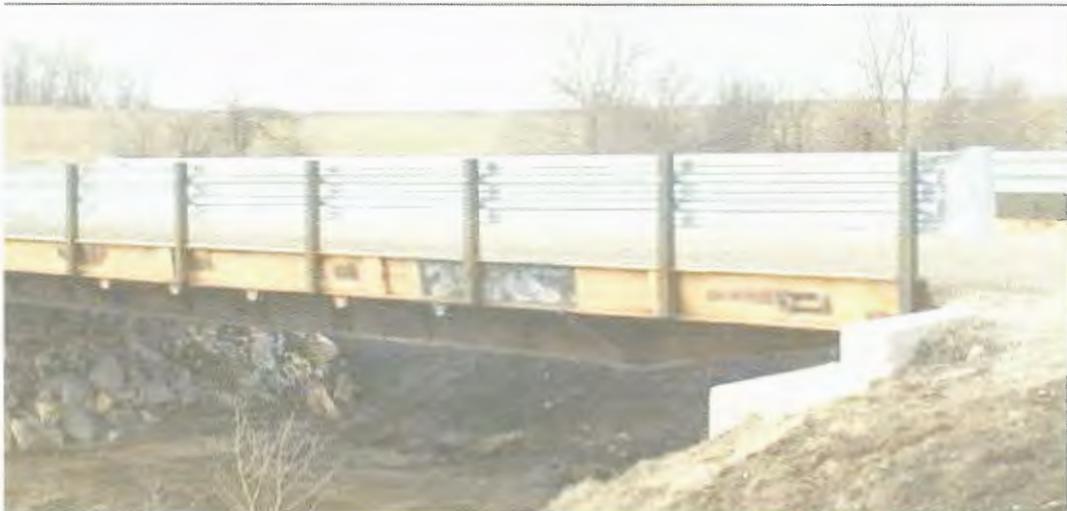
a. Photograph of the BCB3

Figure 2.3. Buchanan County RRFC Bridge 3.

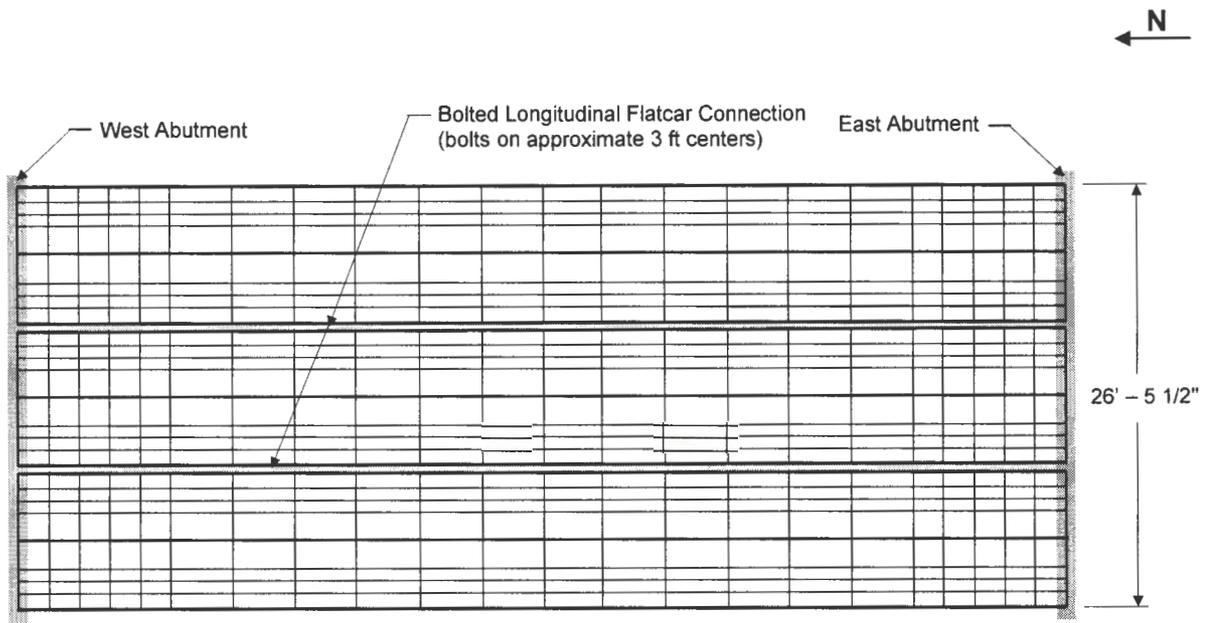
b. Plan View

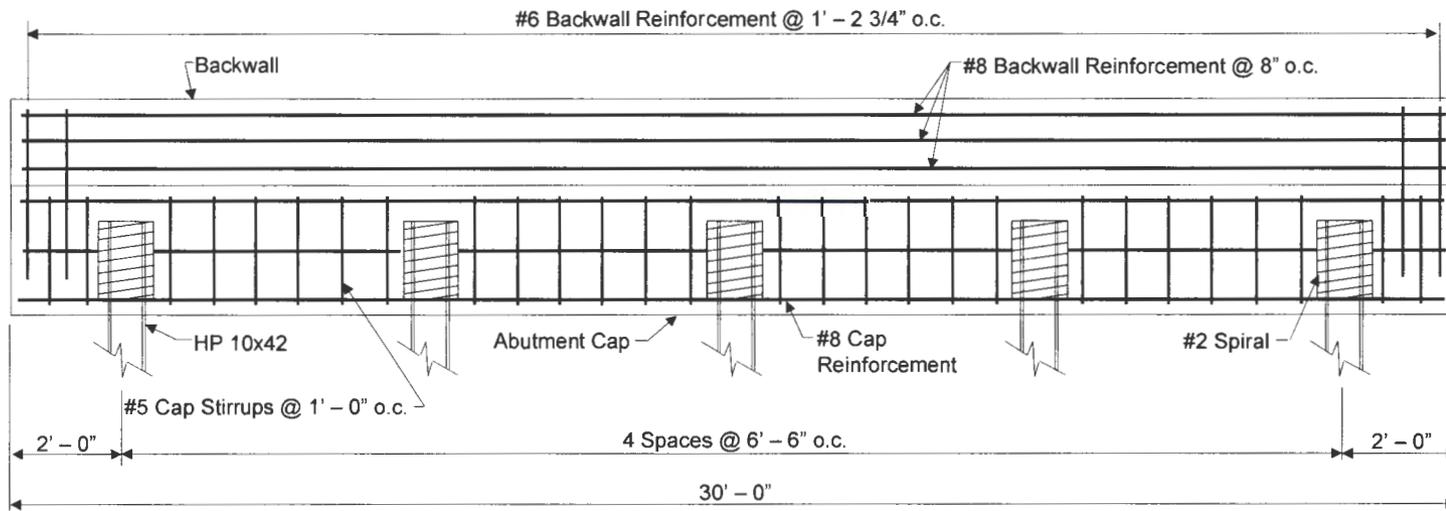
a. End view showing steel reinforcement

The abutment and backwall details for the BCB3 are presented in Figure 2.4. The abutment was a modification of the Iowa Department of Transportation (Iowa DOT) standard stub abutment with zero skew [4]. The constructed concrete abutment was 3 ft tall, 4 ft wide, and 30 ft long. Five HP 10x42 piles were extended 24 in. into the concrete cap and surrounded with spiral reinforcement within the cap. Cap beam reinforcement included #8 longitudinal bars for flexure and #5 stirrups for shear resistance. The backwall was connected to the cap using #6 reinforcement. A 1/4 in. thick, 12 in. wide, and 30 ft long plate (shown in Figure 2.4c) was welded to the top of the RRFCs to prevent foreign material from falling in the expansion joint between the backwall and the railcars.

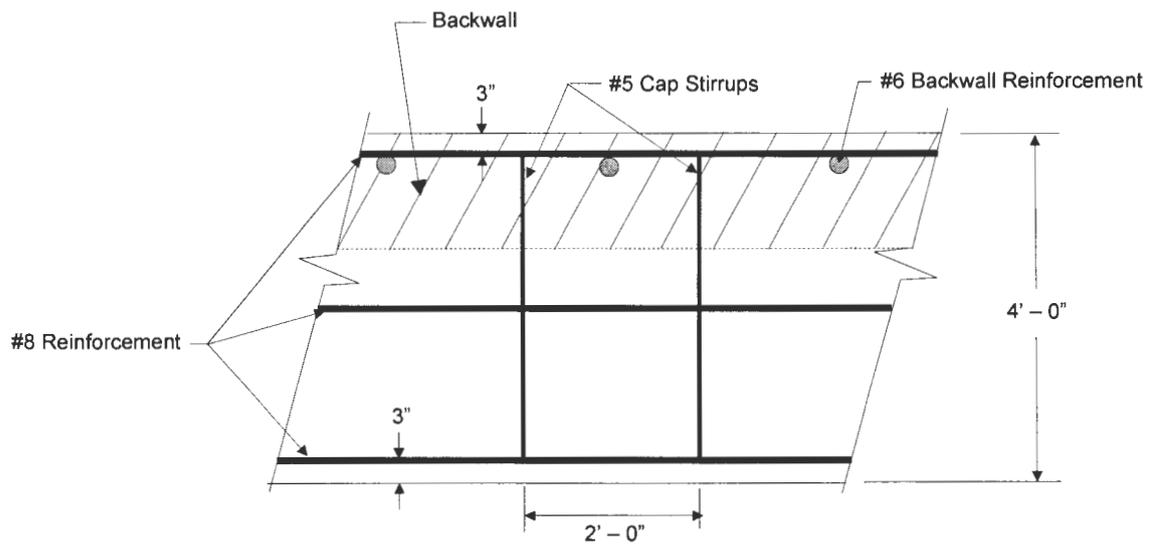
d. Top view showing abutment reinforcement

Figure 2.4. Continued.

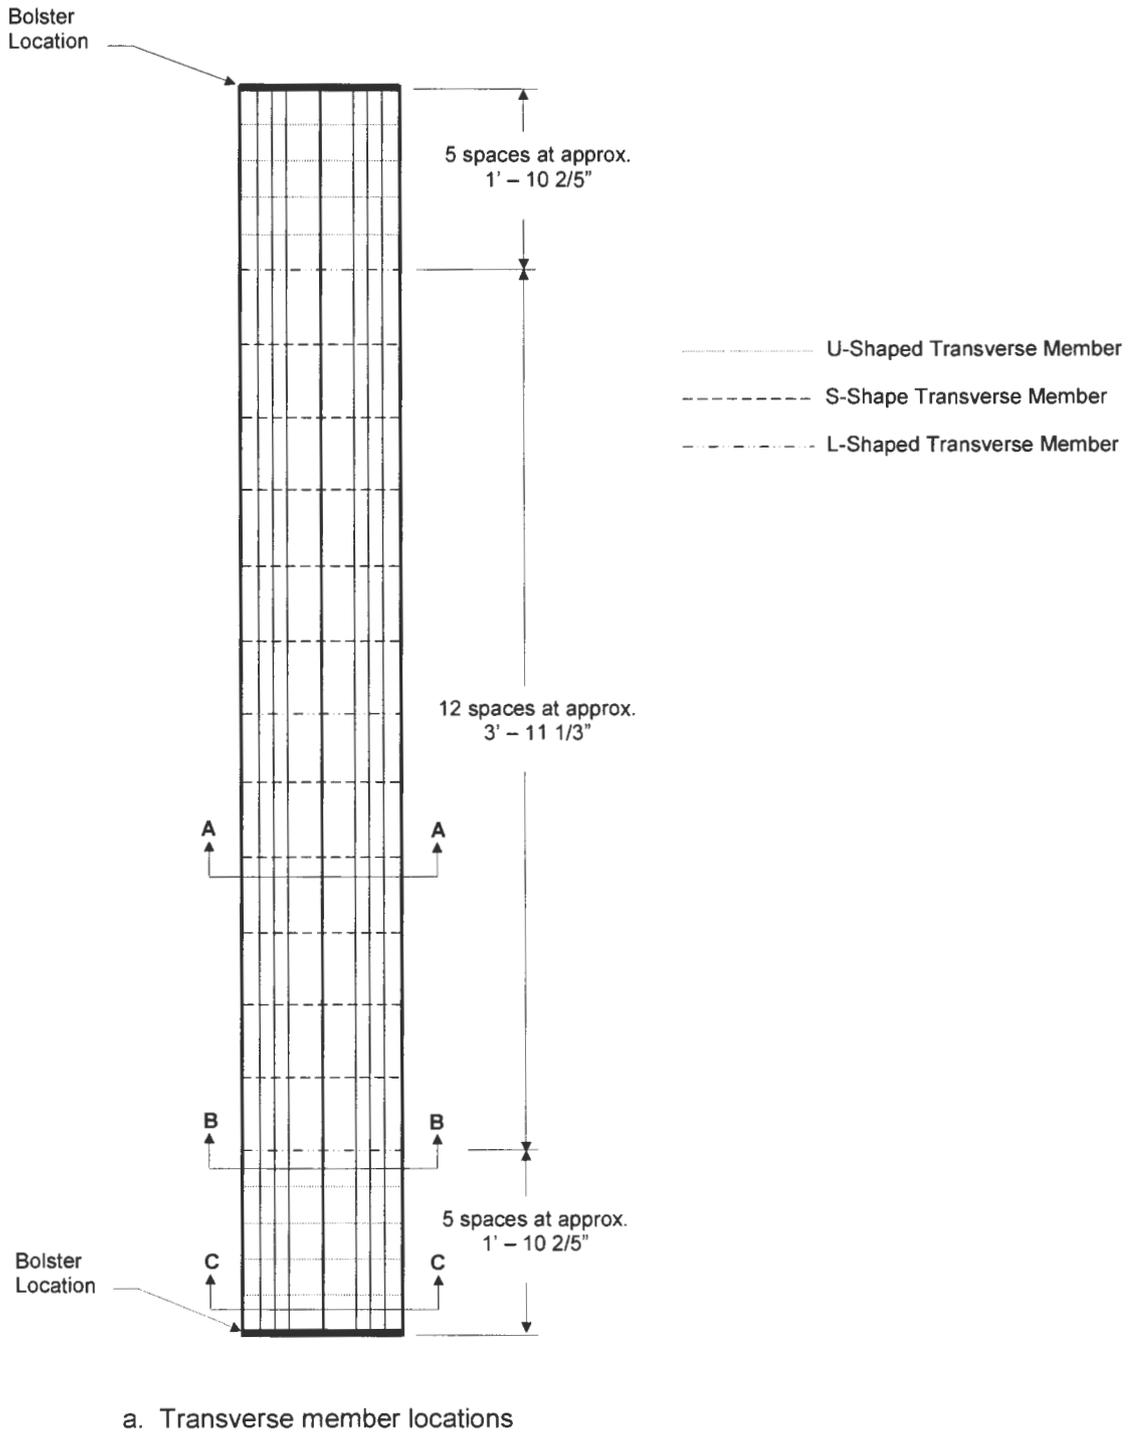
Figure 2.5. 66 ft - 2 in. RRFC cut from 89-ft RRFC.

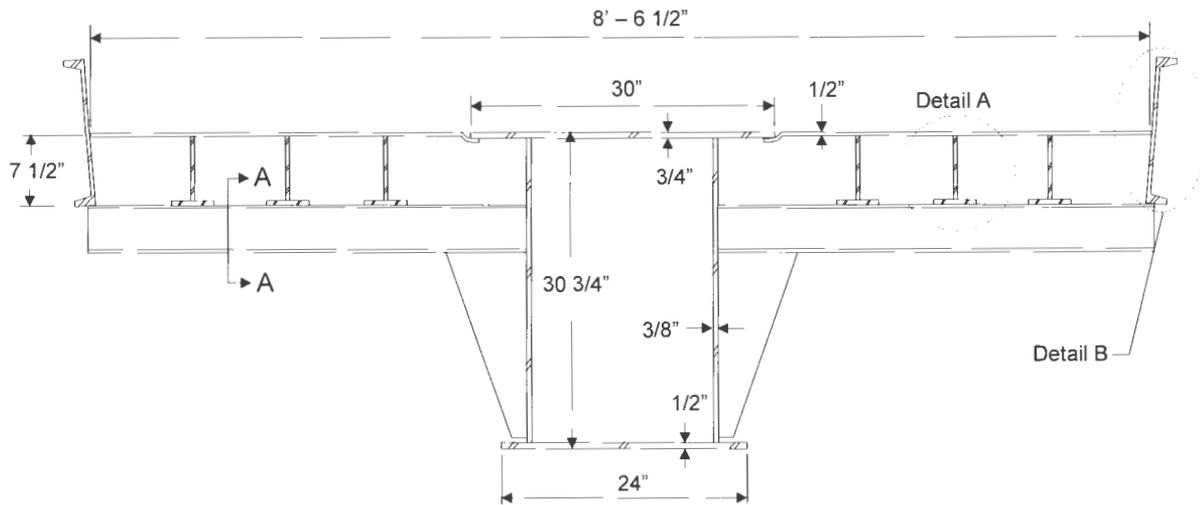
c. Section A-A: S-shape transverse member

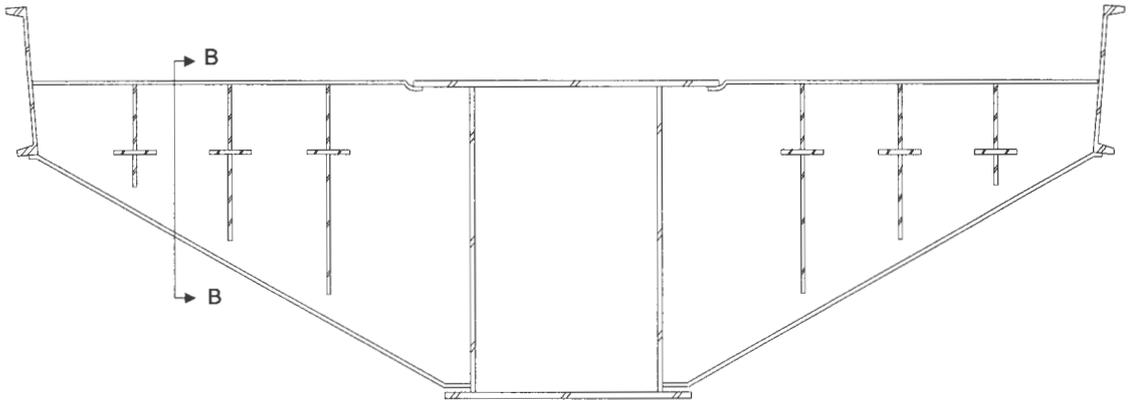
g. Section B-B: L-shaped transverse member

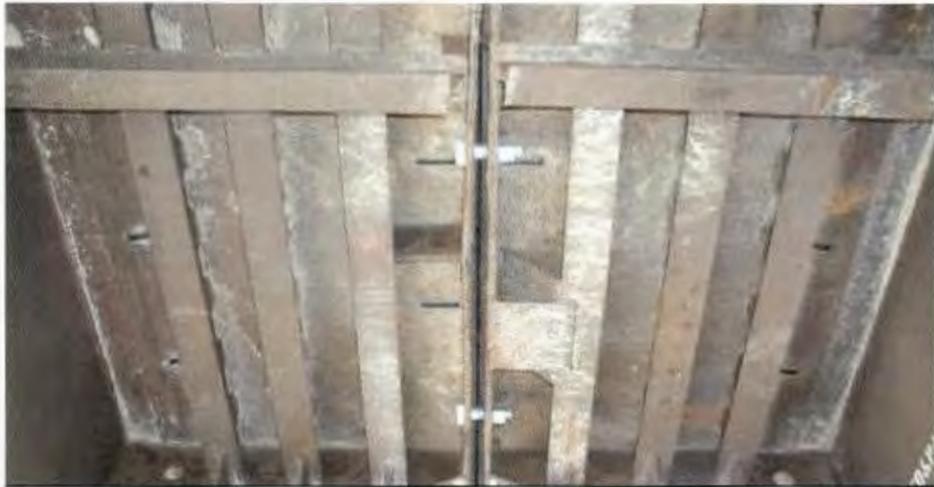
a. Photograph of the bolted connection

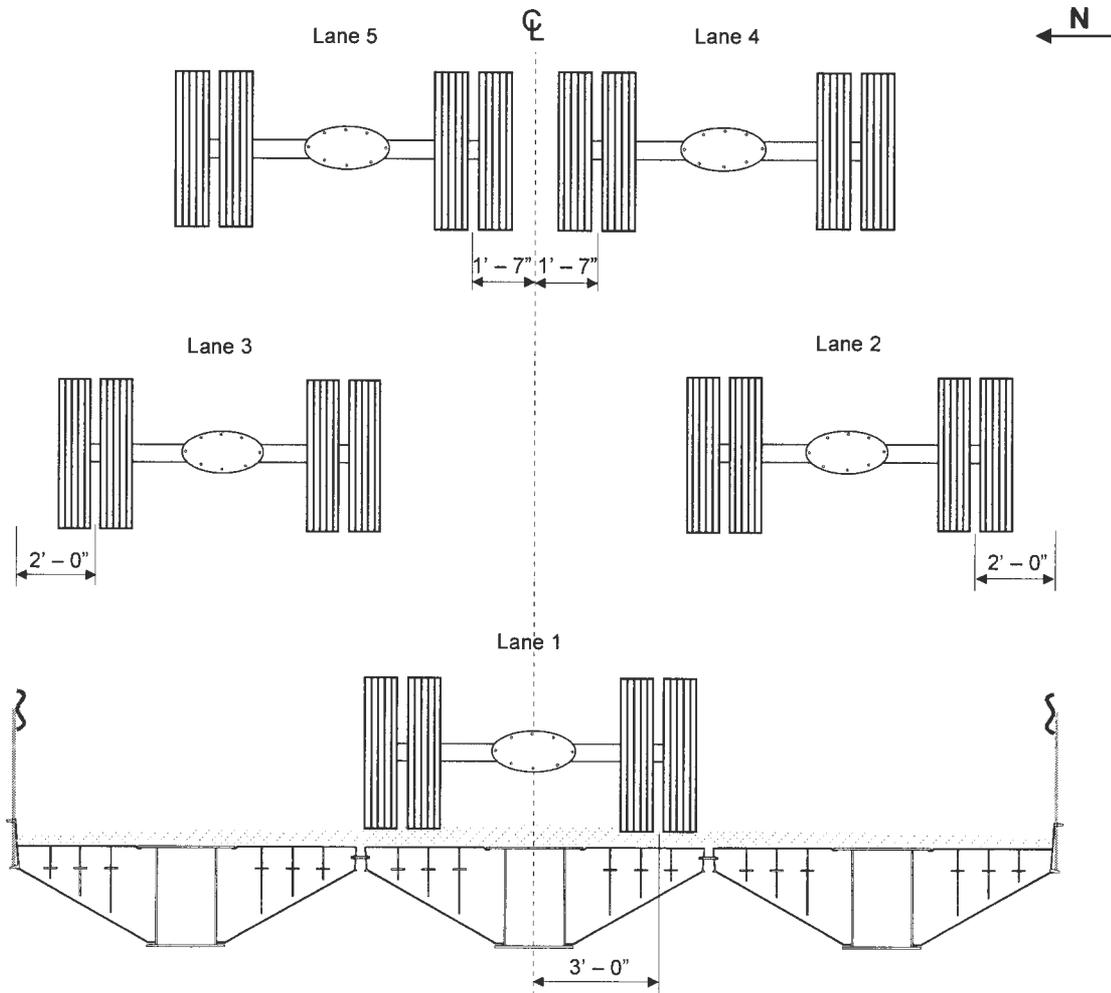
Figure 2.11. Transverse locations of the truck used in field tests.

Static testing of the BCB3 included five different transverse positions of the tandem truck across the bridge which are illustrated in Figure 2.11 and photographs of the test truck on the bridge are presented in Figure 2.12.

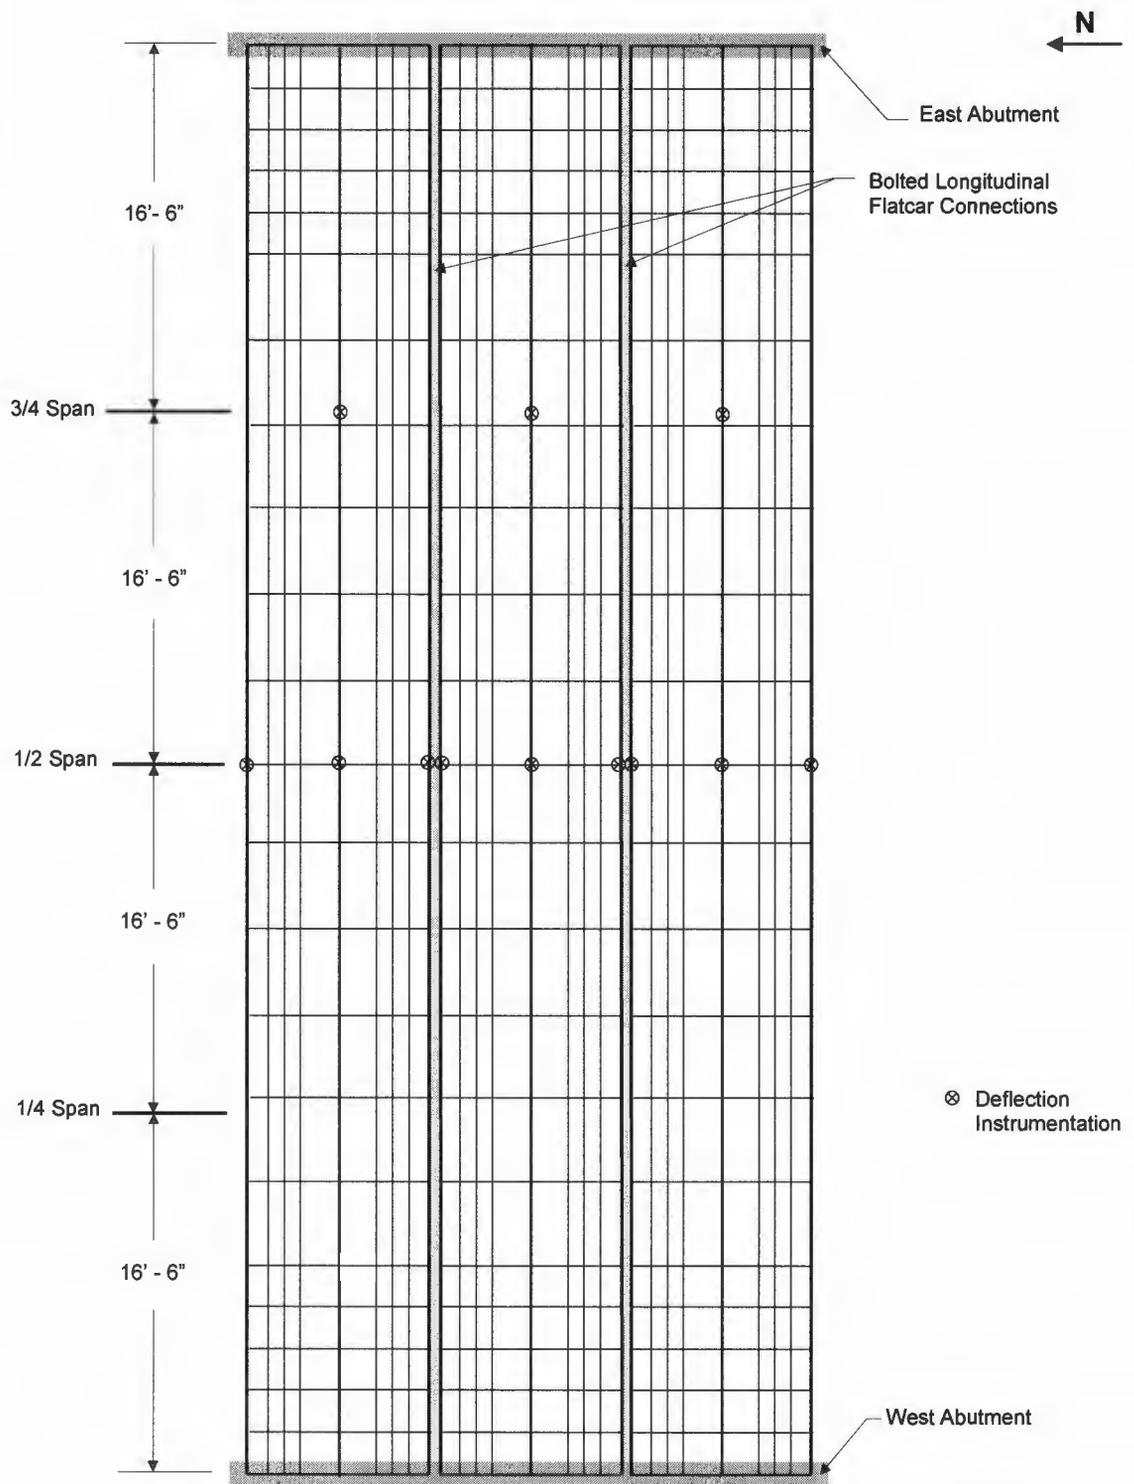
a. Deflection Instrumentation

Figure 2.13. Location of instrumentation used in BCB3 field test.

Instrumentation for the BCB3 test included both deflection and strain transducers placed on the various RRFC girders. The full instrumentation plan is presented in Figure 2.13. At the bridge midspan, deflection and strain instrumentation was placed on all interior box girders and exterior members of the three RRFCs. These data were used to perform a complete cross-sectional analysis of the member deflections and strains at the midspan, the location where maximum stresses and deflections occurred in the girder. The interior box girder of the South RRFC was instrumented with strain transducers near each abutment, at the midspan, and also at the 1/4 and 3/4 span locations. Information from instrumenting along the length of one of the RRFC enabled a time history analysis of the member when the tandem truck crossed the bridge. At the 3/4 span location, deflection instruments were placed on all three interior box girders to determine how the bridge behavior at this location differed from that at the midspan. Strain transducers were placed on the outer side of the guardrail system at the 3/4 span location of the South RRFC to determine if the guardrail system provided added stiffness to the structure. Lastly, secondary longitudinal members and a transverse member near the midspan were instrumented with strain transducers to determine the live load strains. A total of 12 deflections and 24 strains were measured in the bridge tests.

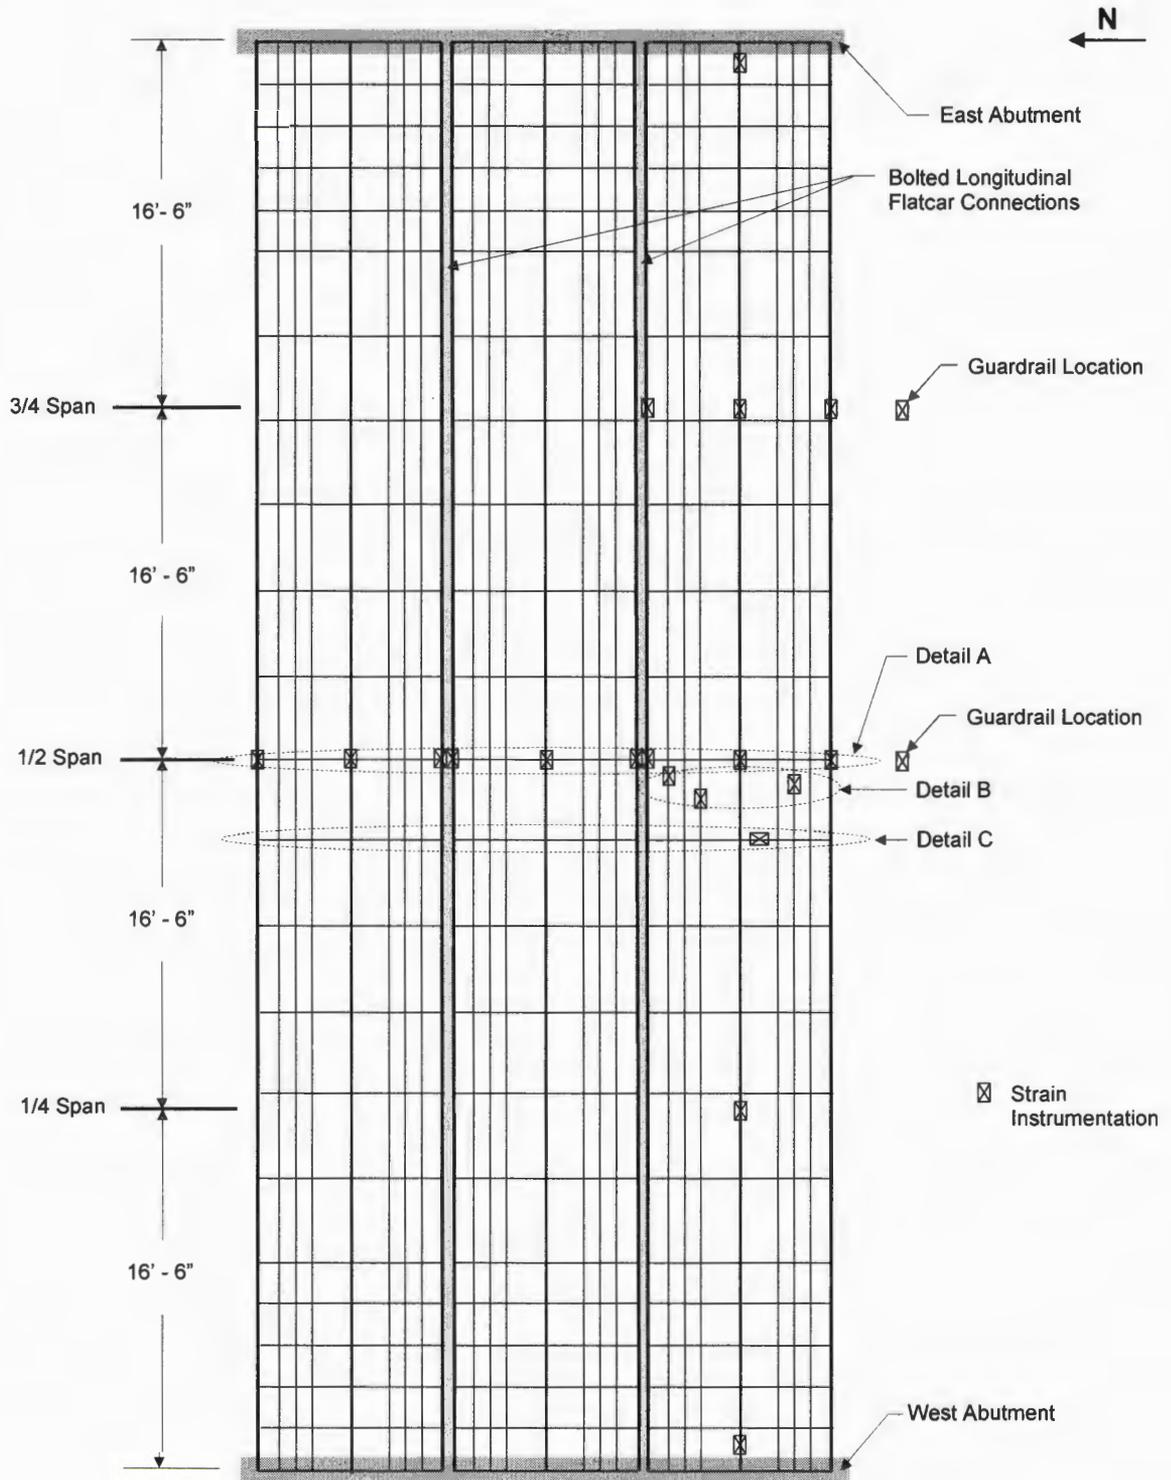
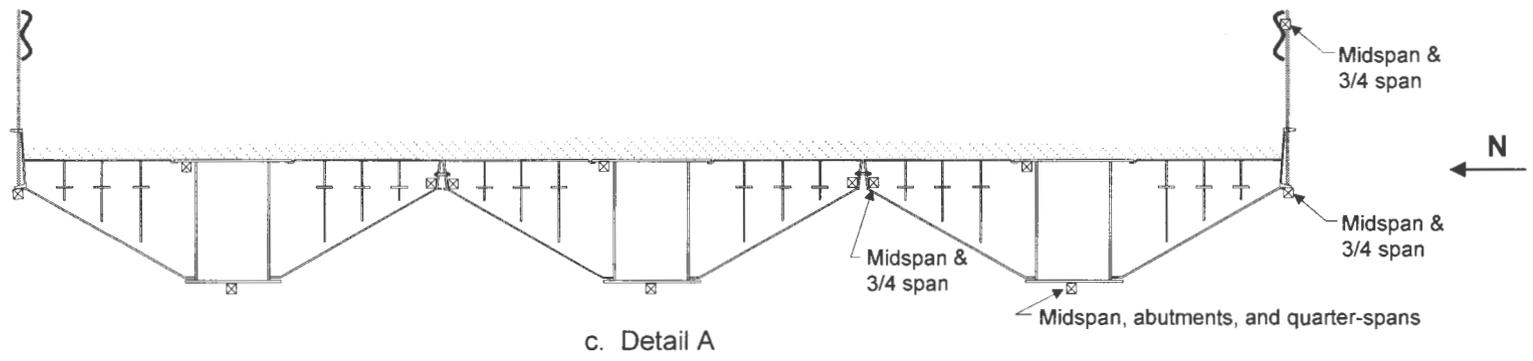
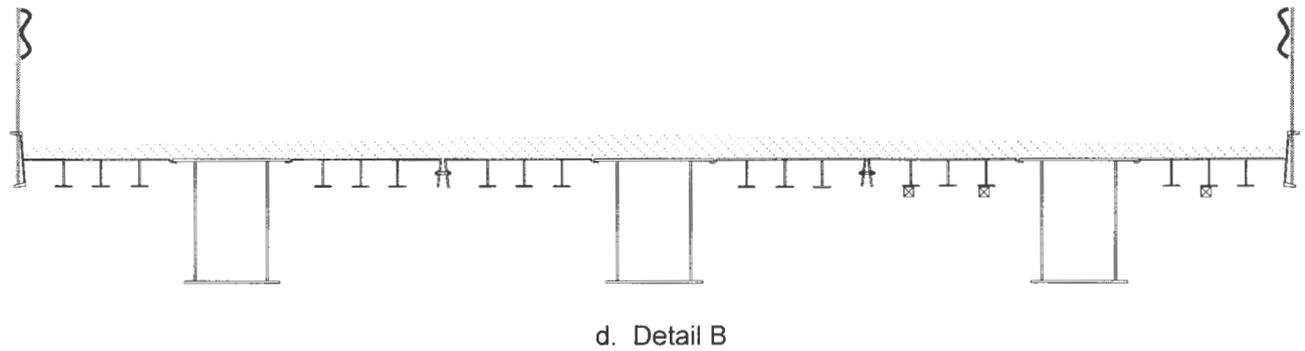
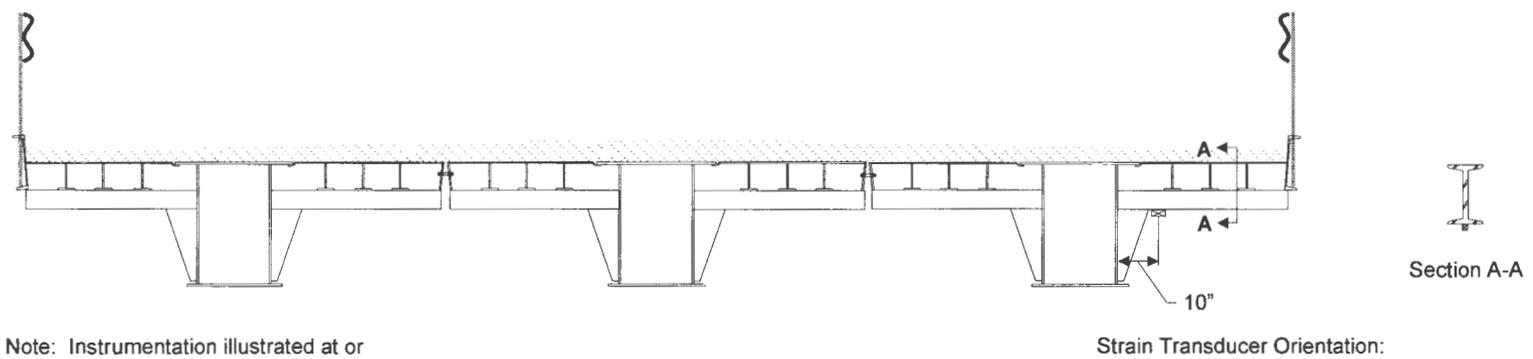
b. Strain Instrumentation

Figure 2.13. Continued.

Note: Instrumentation illustrated at or near midspan unless otherwise indicated.

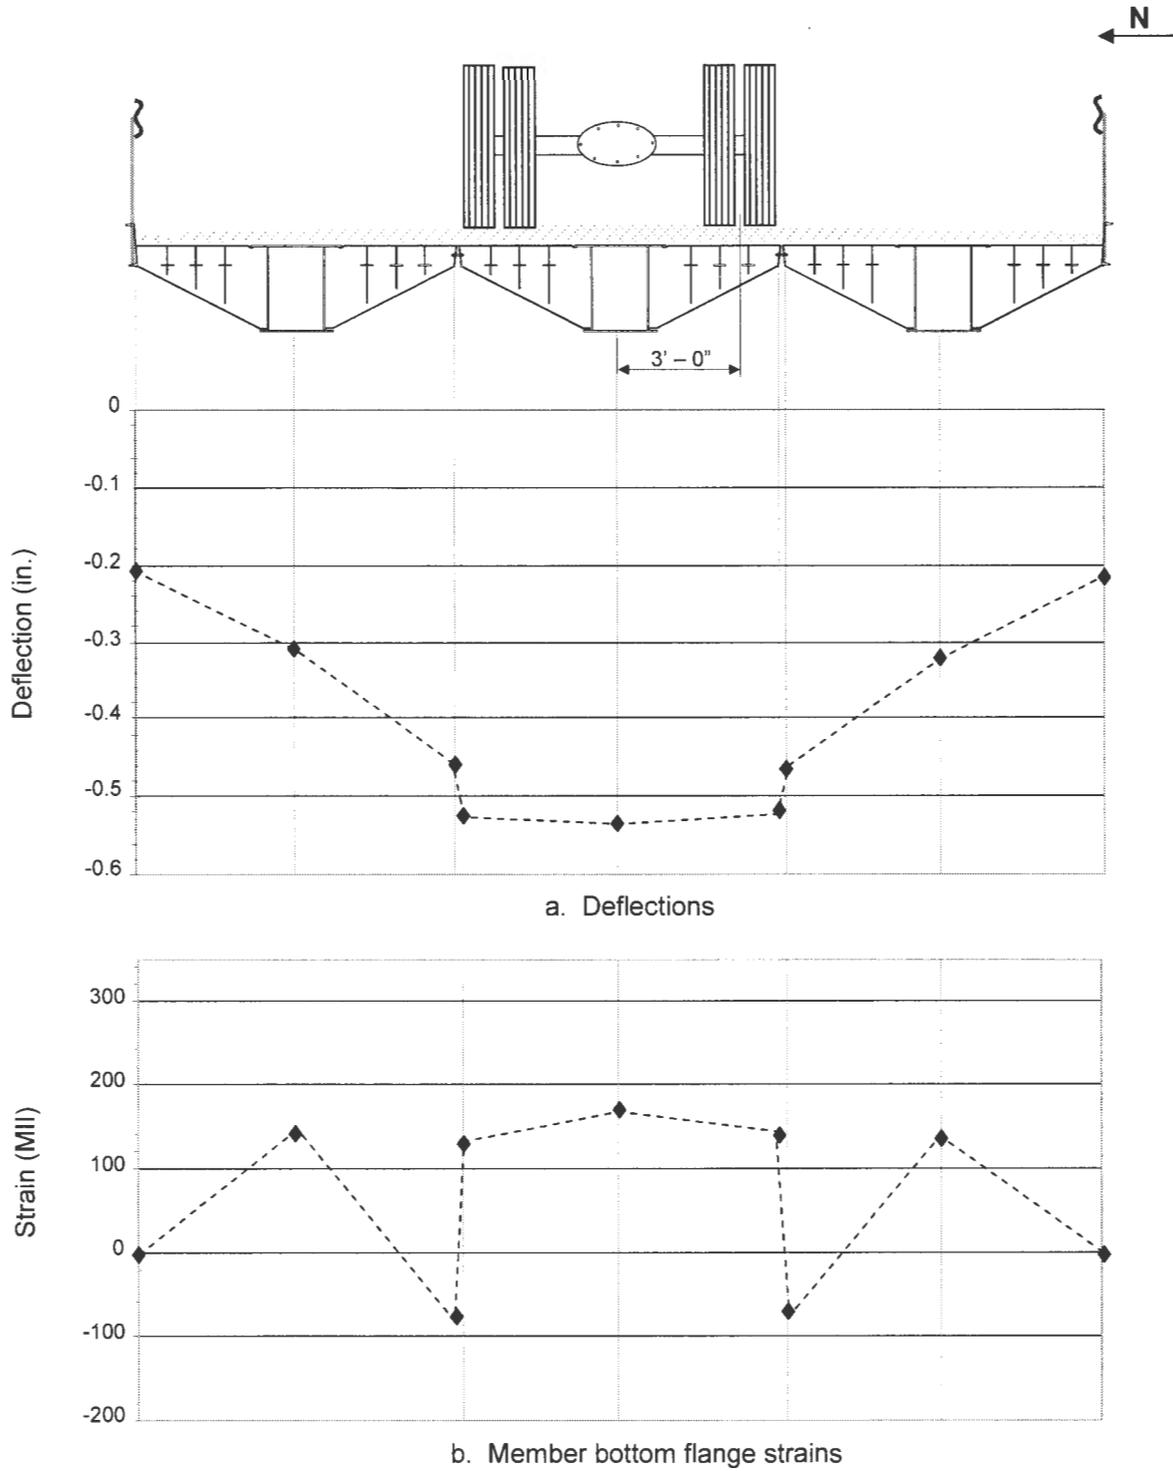
Figure 2.14. Midspan deflections and strains for tandem truck in Lane 1.

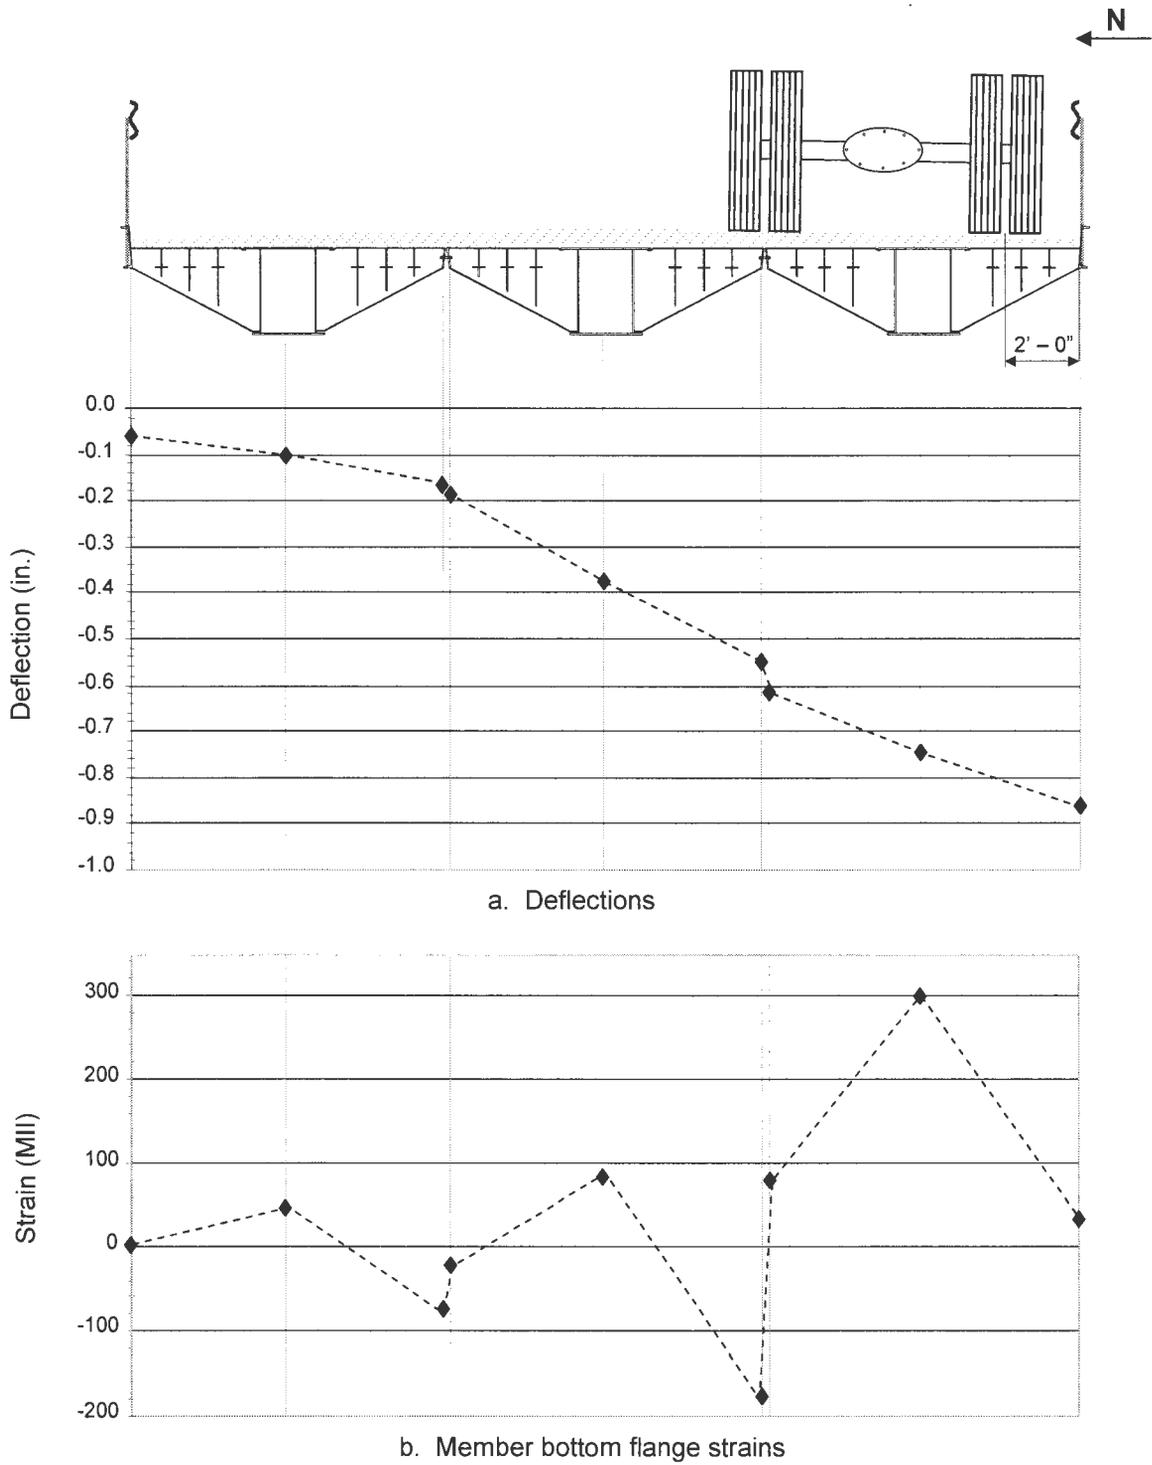
Figure 2.15. Midspan deflections and strains for tandem truck in Lane 2.

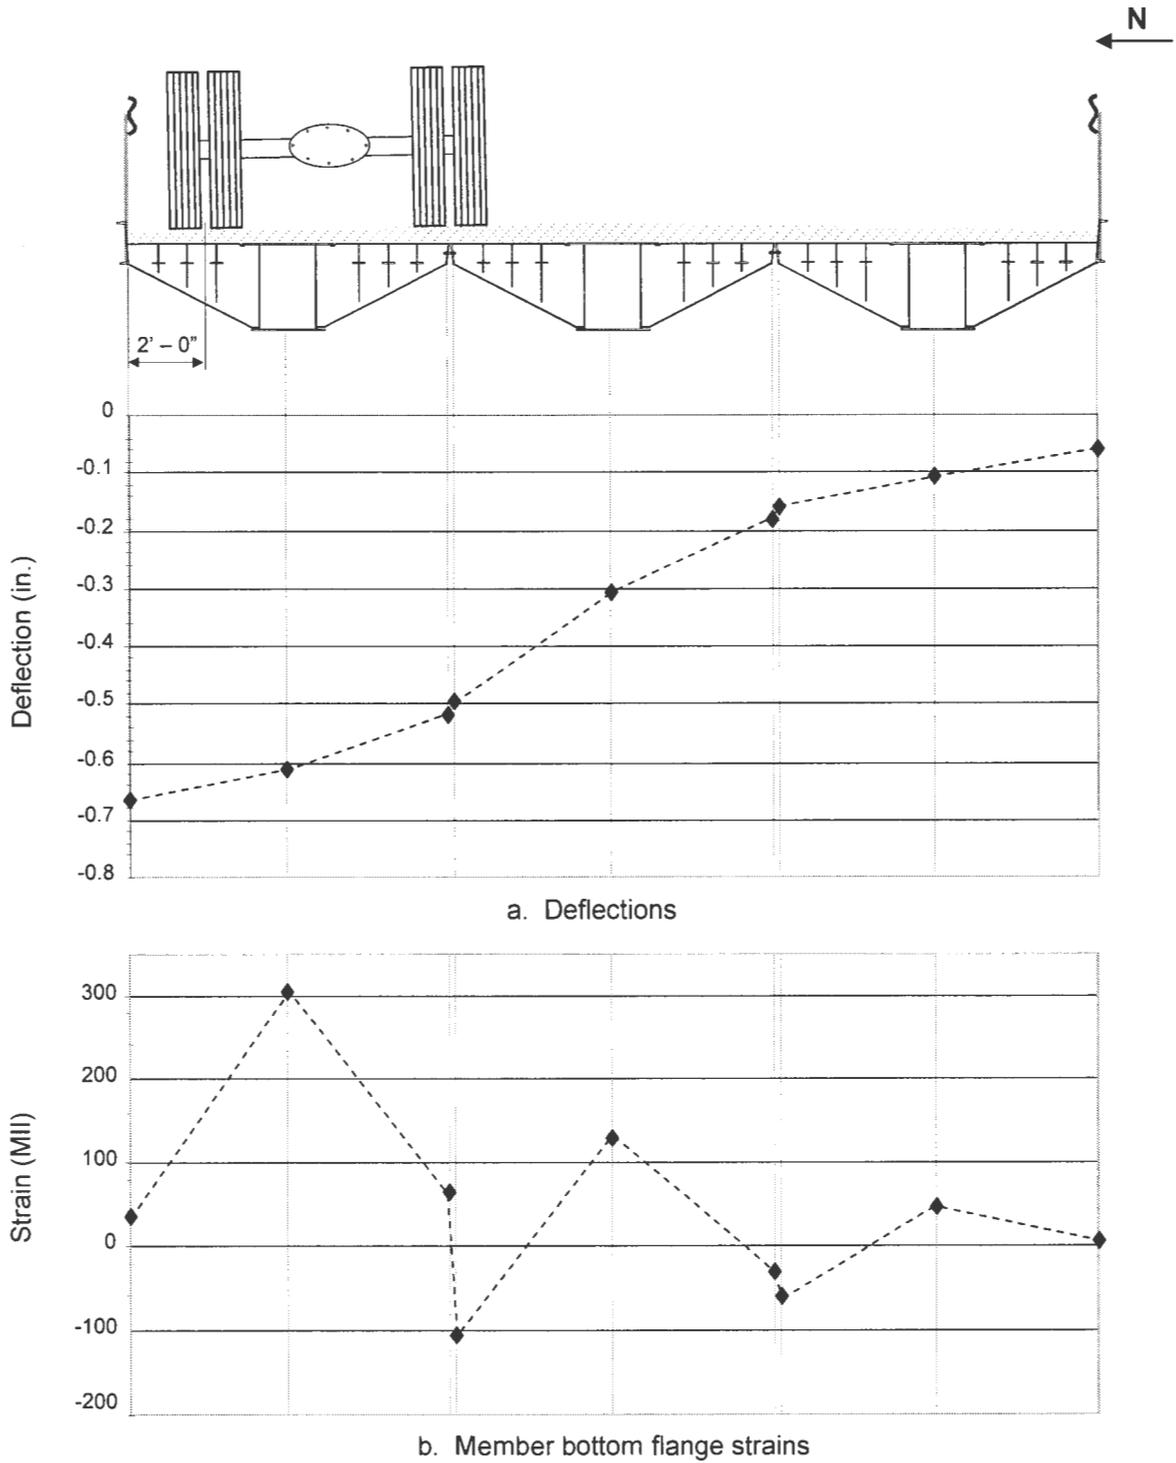
Figure 2.16. Midspan deflections and strains for tandem truck in Lane 3.

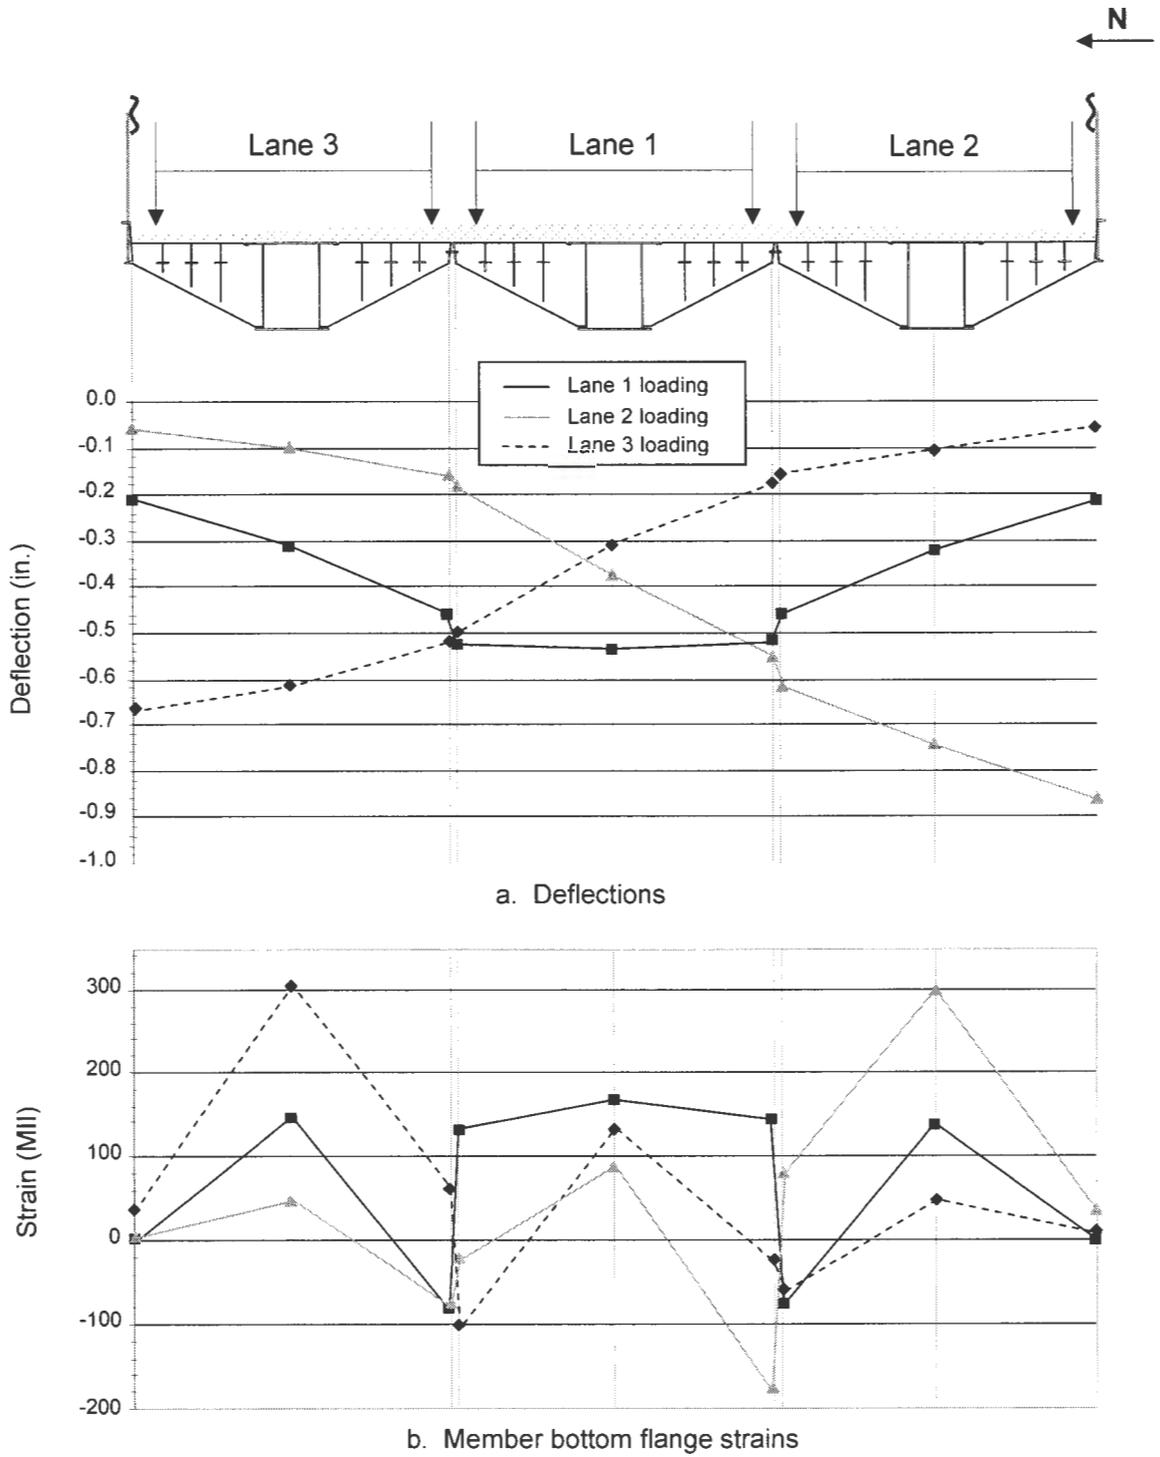
Figure 2.17. Comparison of midspan deflections and strains for Lanes 1, 2, and 3.

The maximum deflection (-0.88 in.) occurred in the South RRFC exterior girder when the test truck was located in Lane 2 (See Figure 2.17). The AASHTO LRFD Bridge Design Specifications [5] recommends a maximum deflection of ‘span’/800 for legal truck loads.

This limitation would be -0.99 in. for a clear span of 66 ft – 2 in.; hence, for this truck loading, the maximum measured deflection is below recommended values. If the measured deflection were increased in proportion of the test truck load to an HS-20 loading, the experimental deflection would be -1.31 in., which is significantly above AASHTO limits.

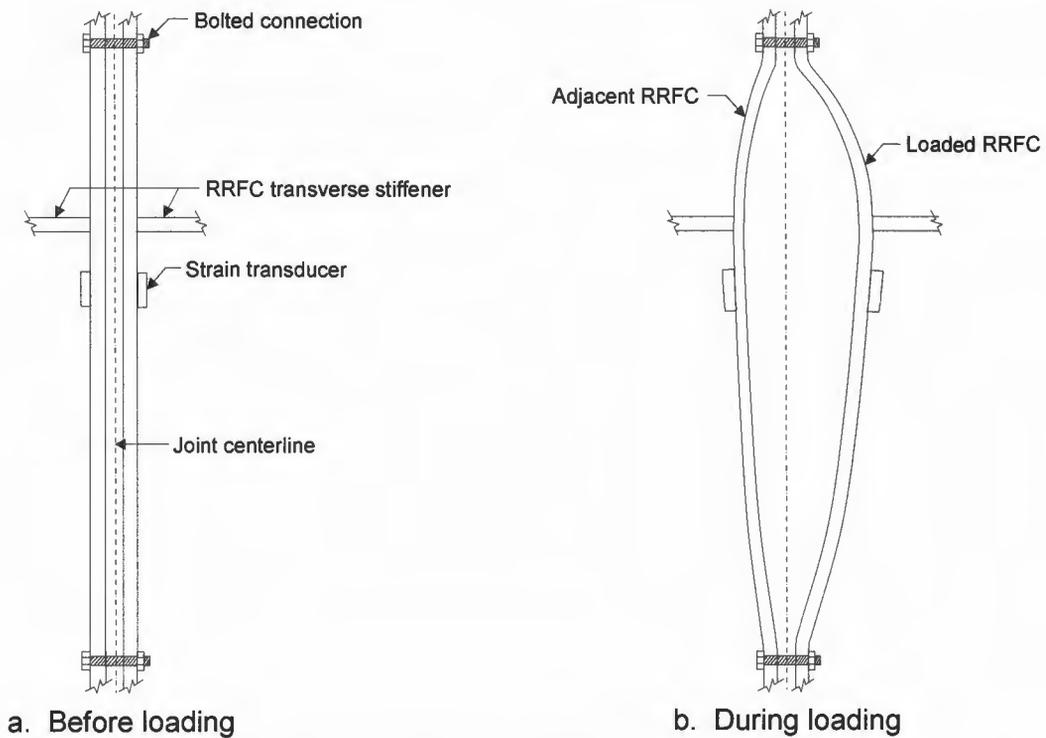
Figure 2.21. Plan view of the longitudinal connection joint.

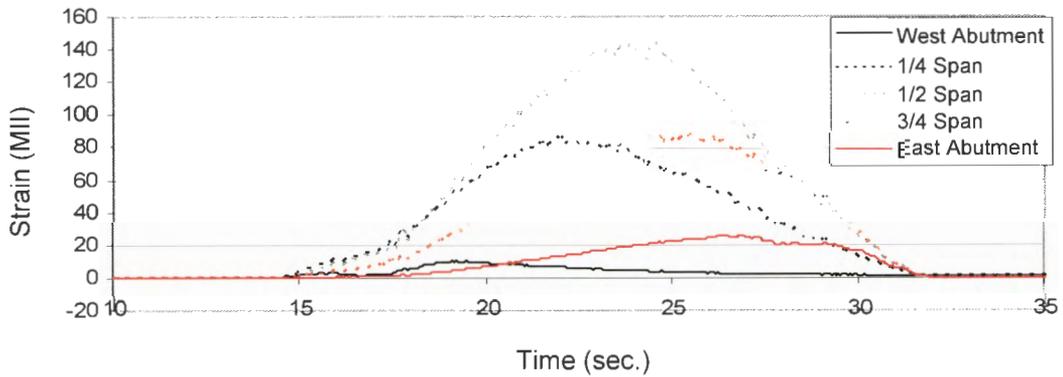
a. Truck in Lane 1

Of the five dynamic test runs that were performed, it was found that the maximum dynamic amplification occurred at a truck speed of 25 mph. A plot of the time history comparison of the deflections and strains during the static and dynamic field testing are presented in Figures 2.24 and 2.25, respectively. These graphs illustrate the dynamic amplification that occurred in the interior box girders of the North, Middle, and South RRFCs.

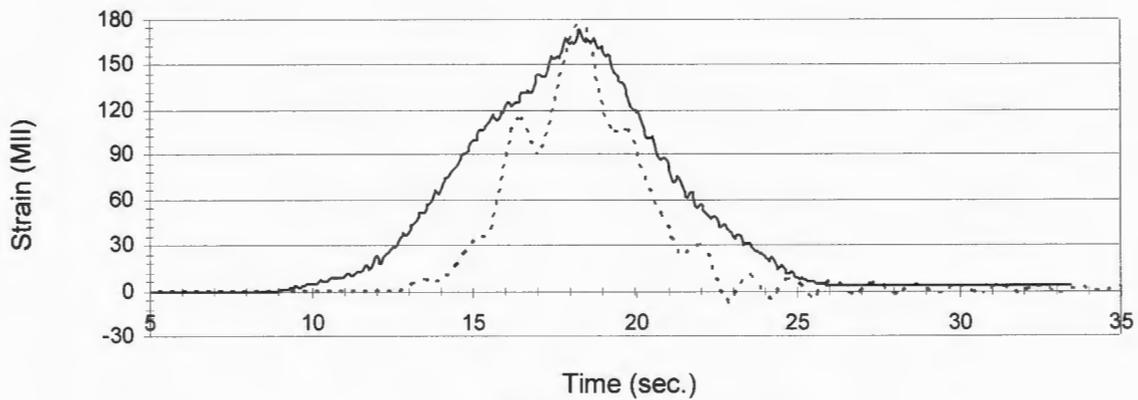
b. Middle RRFC interior girder
