Field testing of railroad flatcar bridges on low-volume roads

A thesis submitted to the graduate faculty
in partial fulfillment of the requirements for the degree of
MASTER OF SCIENCE

Major: Civil Engineering (Structural Engineering)

Iowa State University

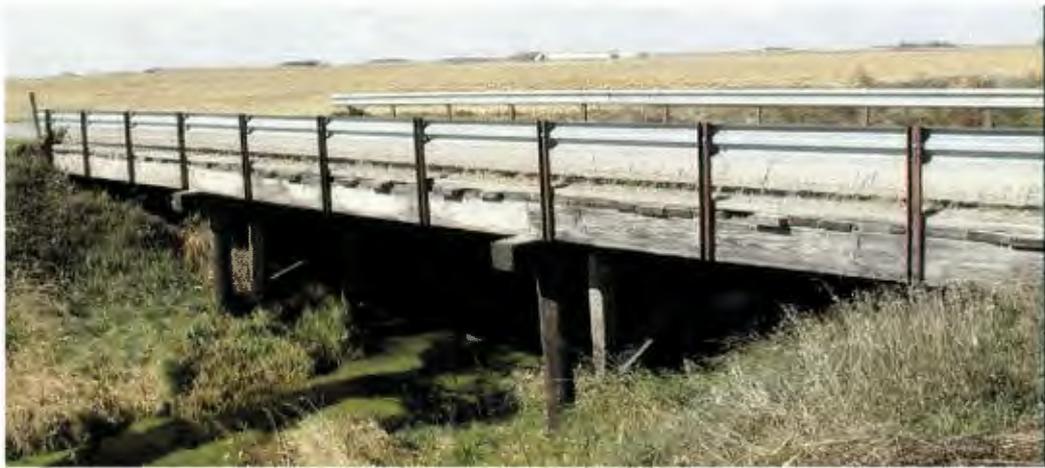
Figure 3.2. Original three-span, timber bridge at the WBC2 site.

The previous three-span timber bridge (FWHA No. 344890) at the WBC2 site (See Figure 3.2) had a total length of 62 ft from center to center of the abutments and a central span length of 23 ft. The timber substructure consisted of 6 timber piles at each abutment and pier, and 12x12 creosoted timbers were used for the abutment caps. The stringers were 6x16 creosoted timber and the deck was constructed with 3x12 creosoted timber plank.

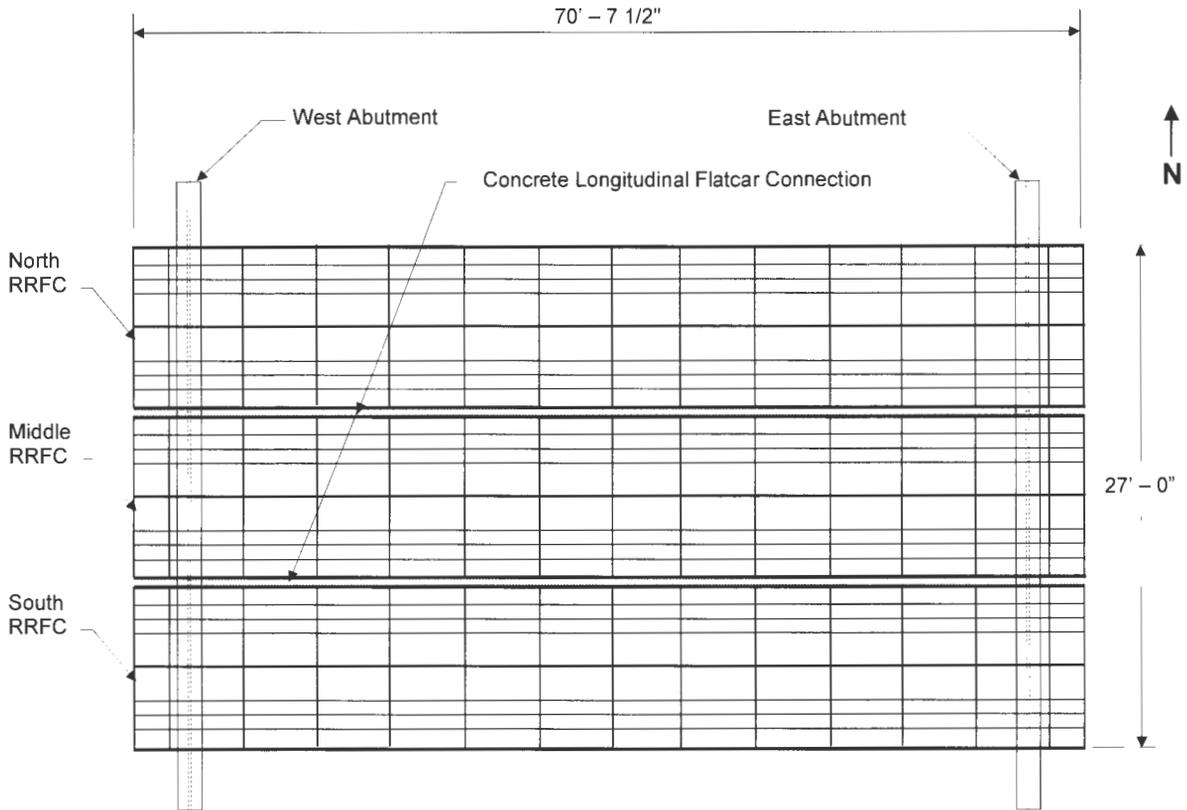
b. Plan View

Figure 3.3. Winnebago County RRFC Bridge 2.

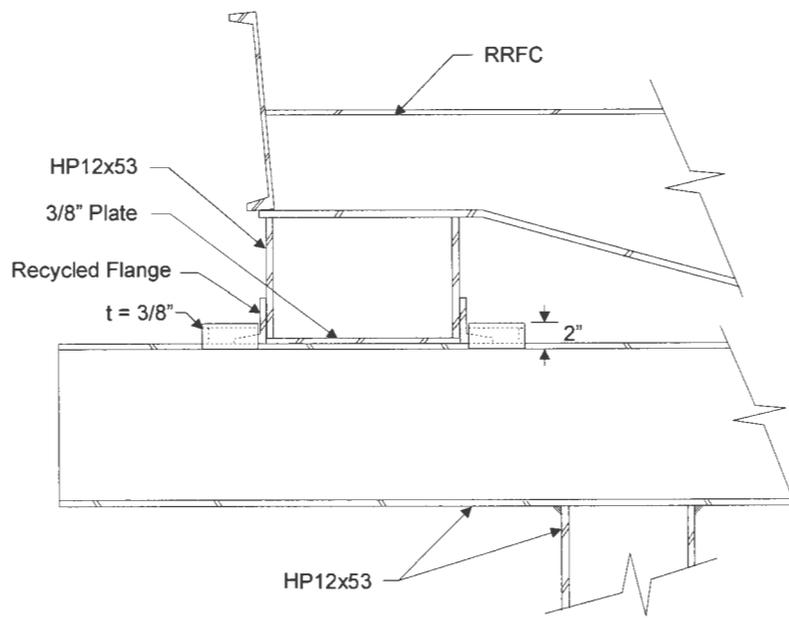
a. Exterior girder support at the west abutment

Figure 3.5. Exterior girder supports for the WCB2.

Supports for the exterior girders were necessary at the abutments because the elevation of the bottom of these girders was higher than rest of the RRFC. Recycled HP12x53 sections from the abutments and piles, which are shown in Figure 3.5, were used to create the needed supports. The supports at the east abutment were welded to the steel cap beam. At the west abutment, a roller condition was created to allow for expansion and contraction of the bridge. Recycled flanges from the trimmed portions of the exterior girders were welded on to either side of the west support. A “box” fabricated out of 3/8 in plates allows the recycled RRFC flange on either side of the support to move horizontally (parallel to the bridge length) and restricts movement vertically and horizontally (perpendicular to the bridge length).

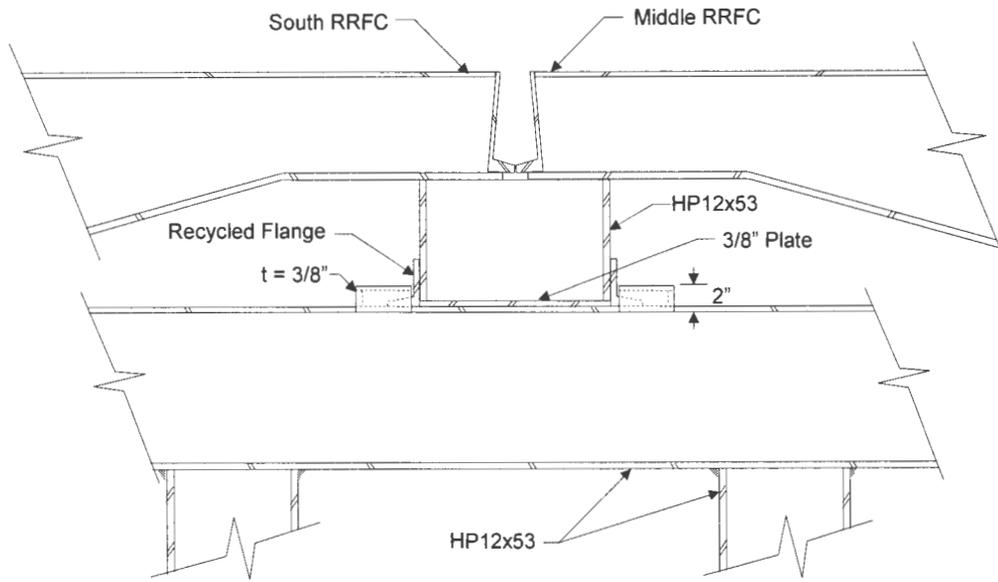
c. Connection support at the west abutment

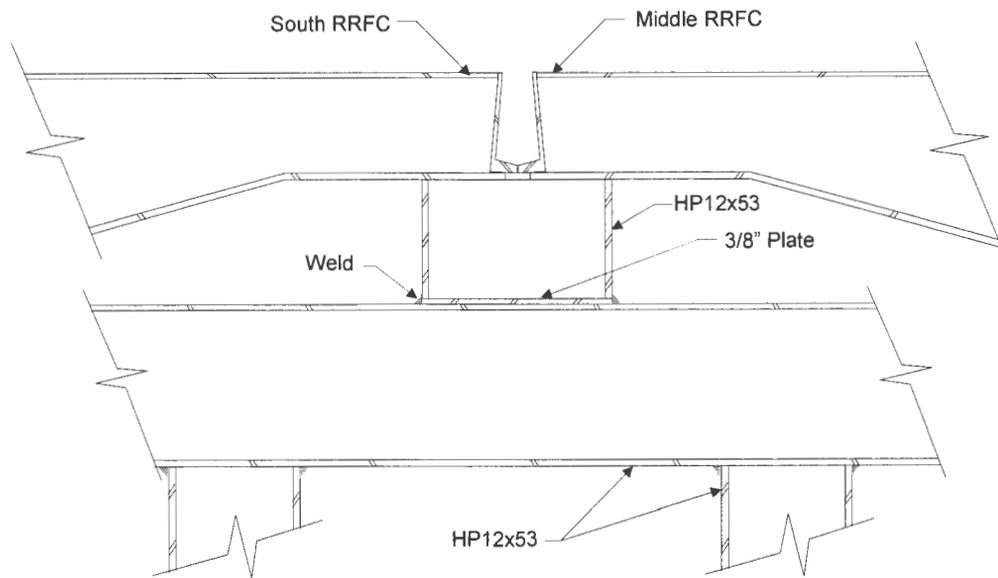
d. Connection support at the east abutment

Figure 3.5. Continued.

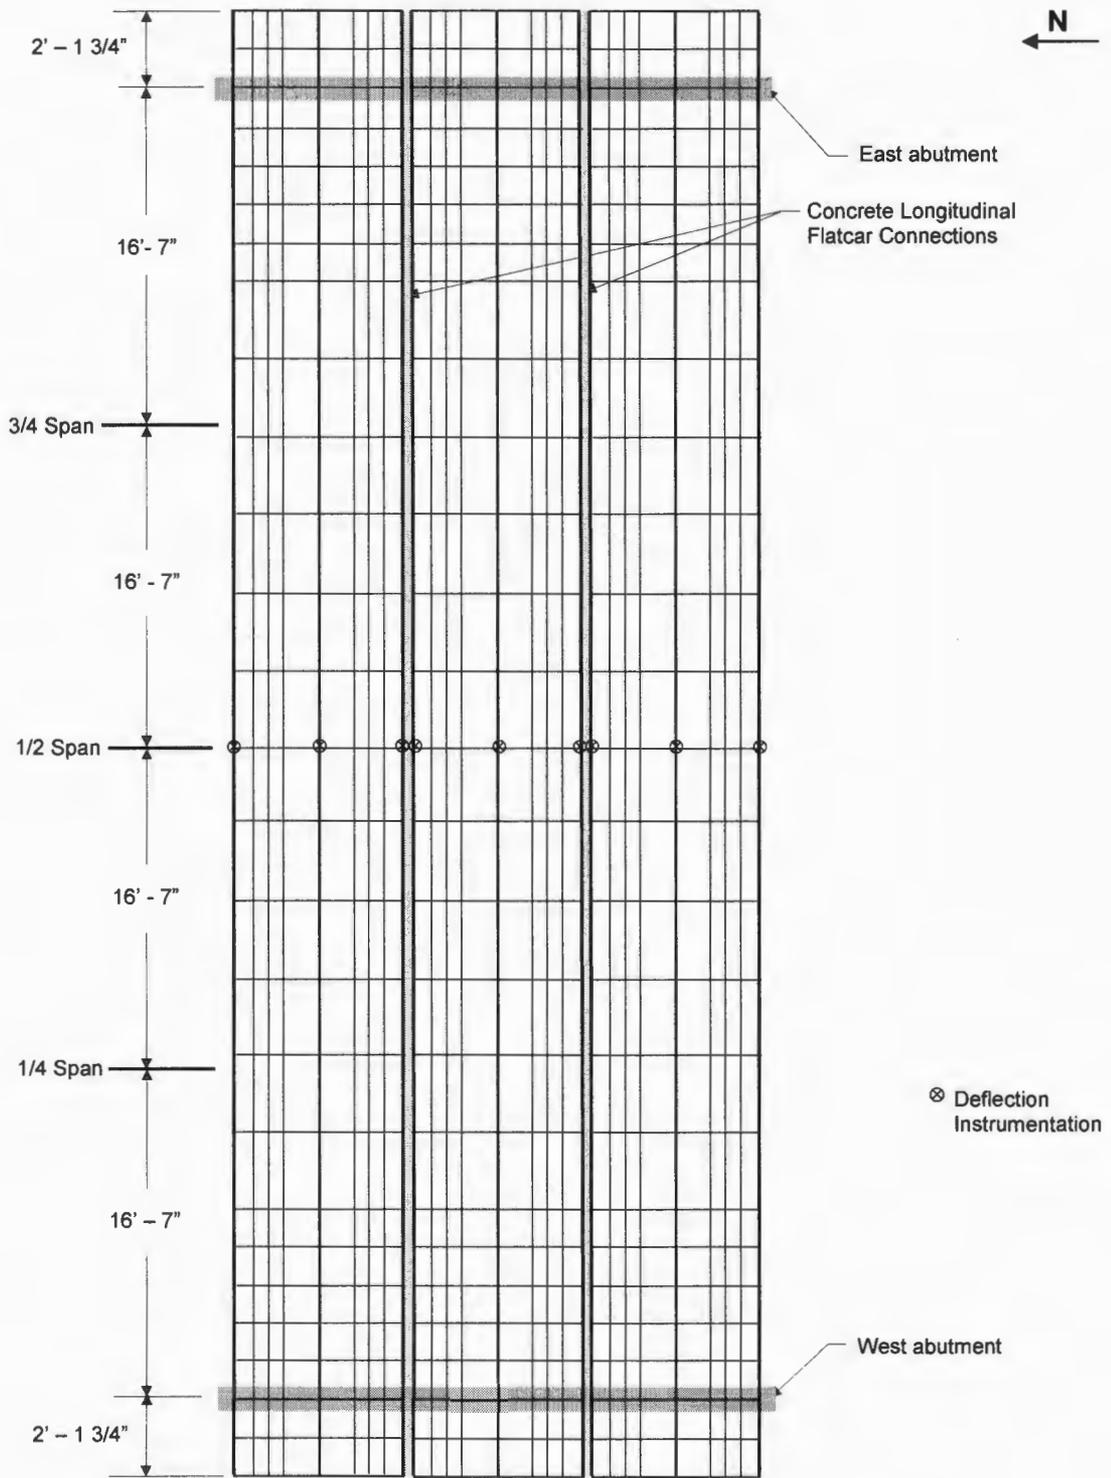
a. Deflection Instrumentation

Figure 3.7. Location of instrumentation used on the WCB2.

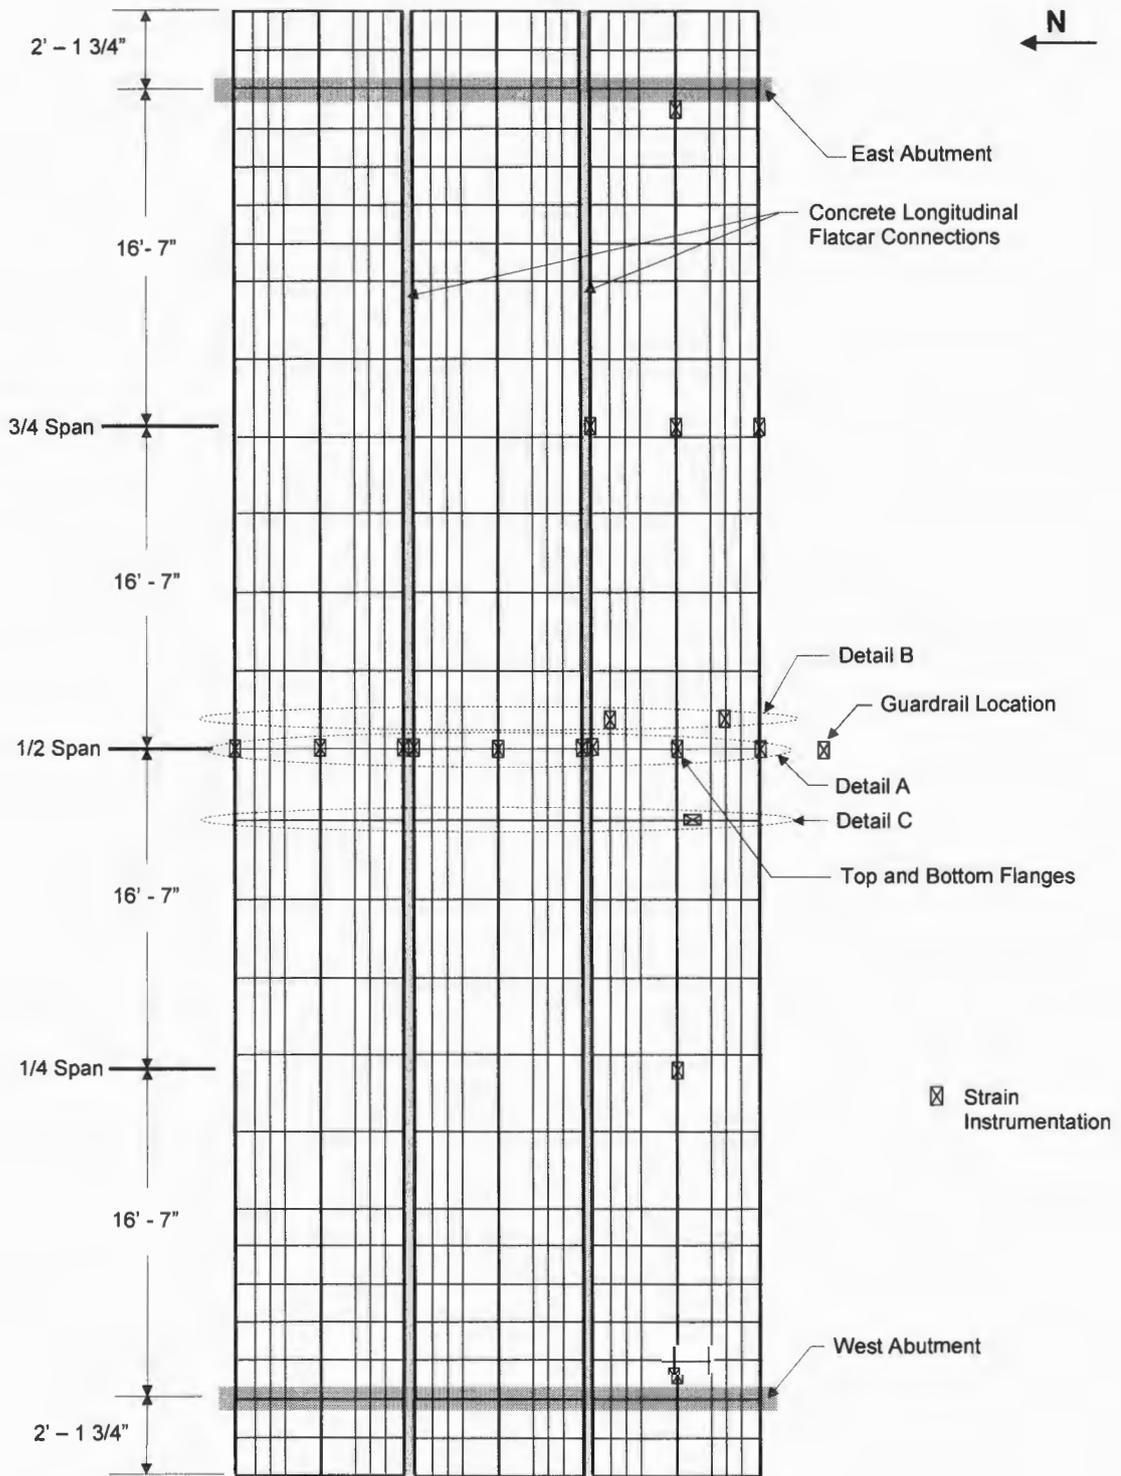
b. Strain Instrumentation

Figure 3.7. Continued.

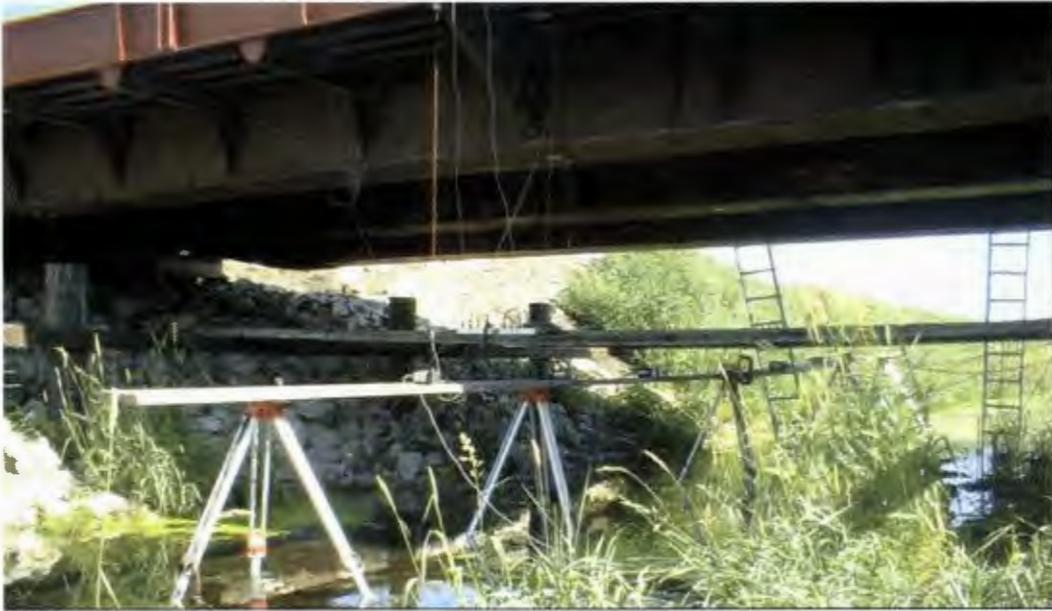
a. Installed deflection instrumentation on the WCB2

Figure 3.8. Deflection and strain instrumentation on the WCB2.

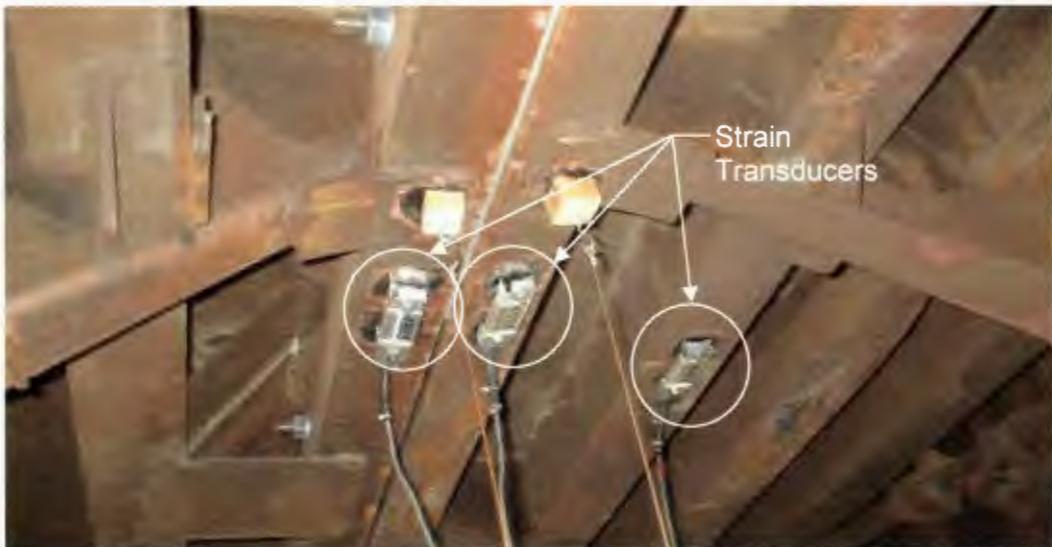
b. Instrumentation at the south longitudinal concrete connection

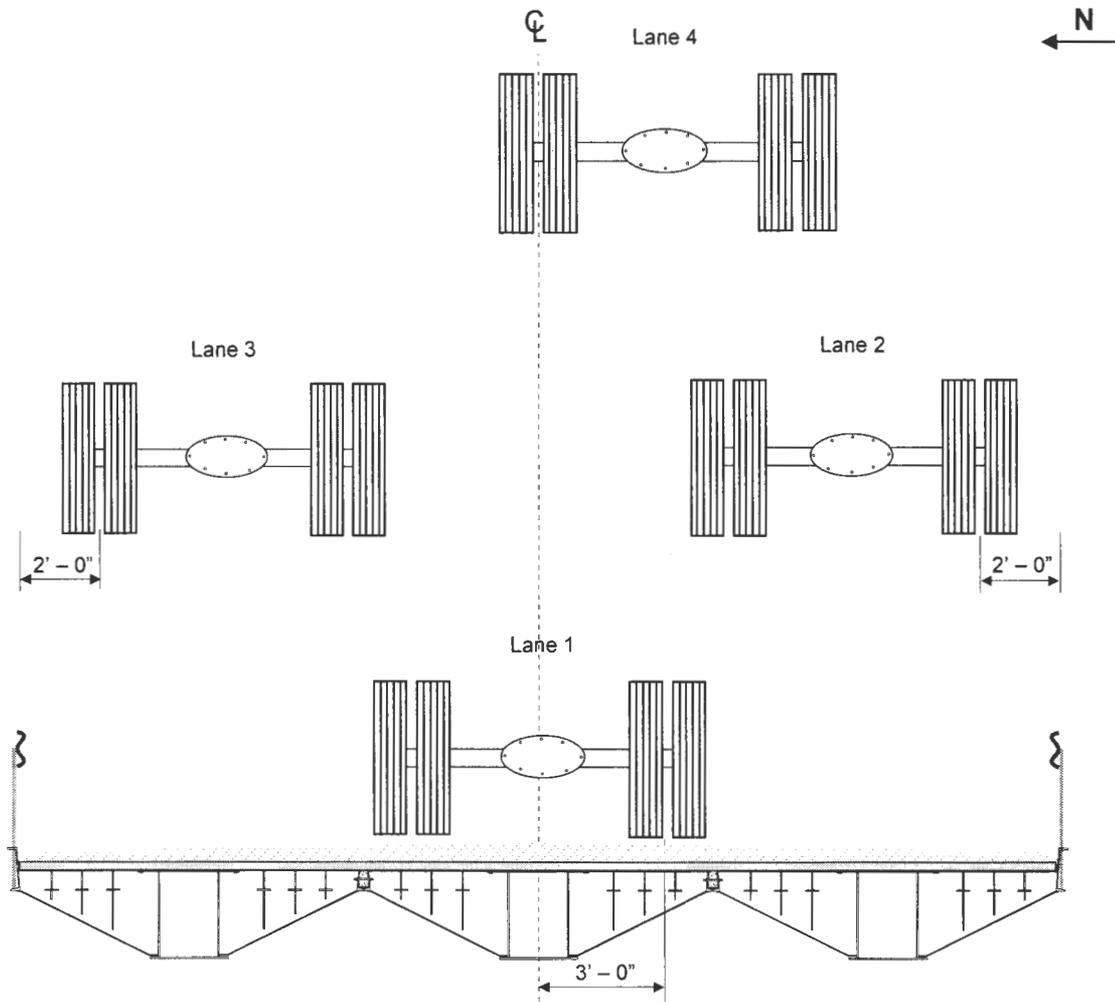
Figure 3.9. Transverse truck locations during the WCB2 load testing.

Continuous data were measured and recorded as the tandem truck traveled across the bridge during each test run. Data were recorded as the truck's tandem crossed each abutment and at 1/4, 1/2, and 3/4 span locations. To determine the bridge's behavior at different transverse loading locations, four transverse truck positions across the width of the bridge were used as illustrated in Figures 3.9 and 3.10.

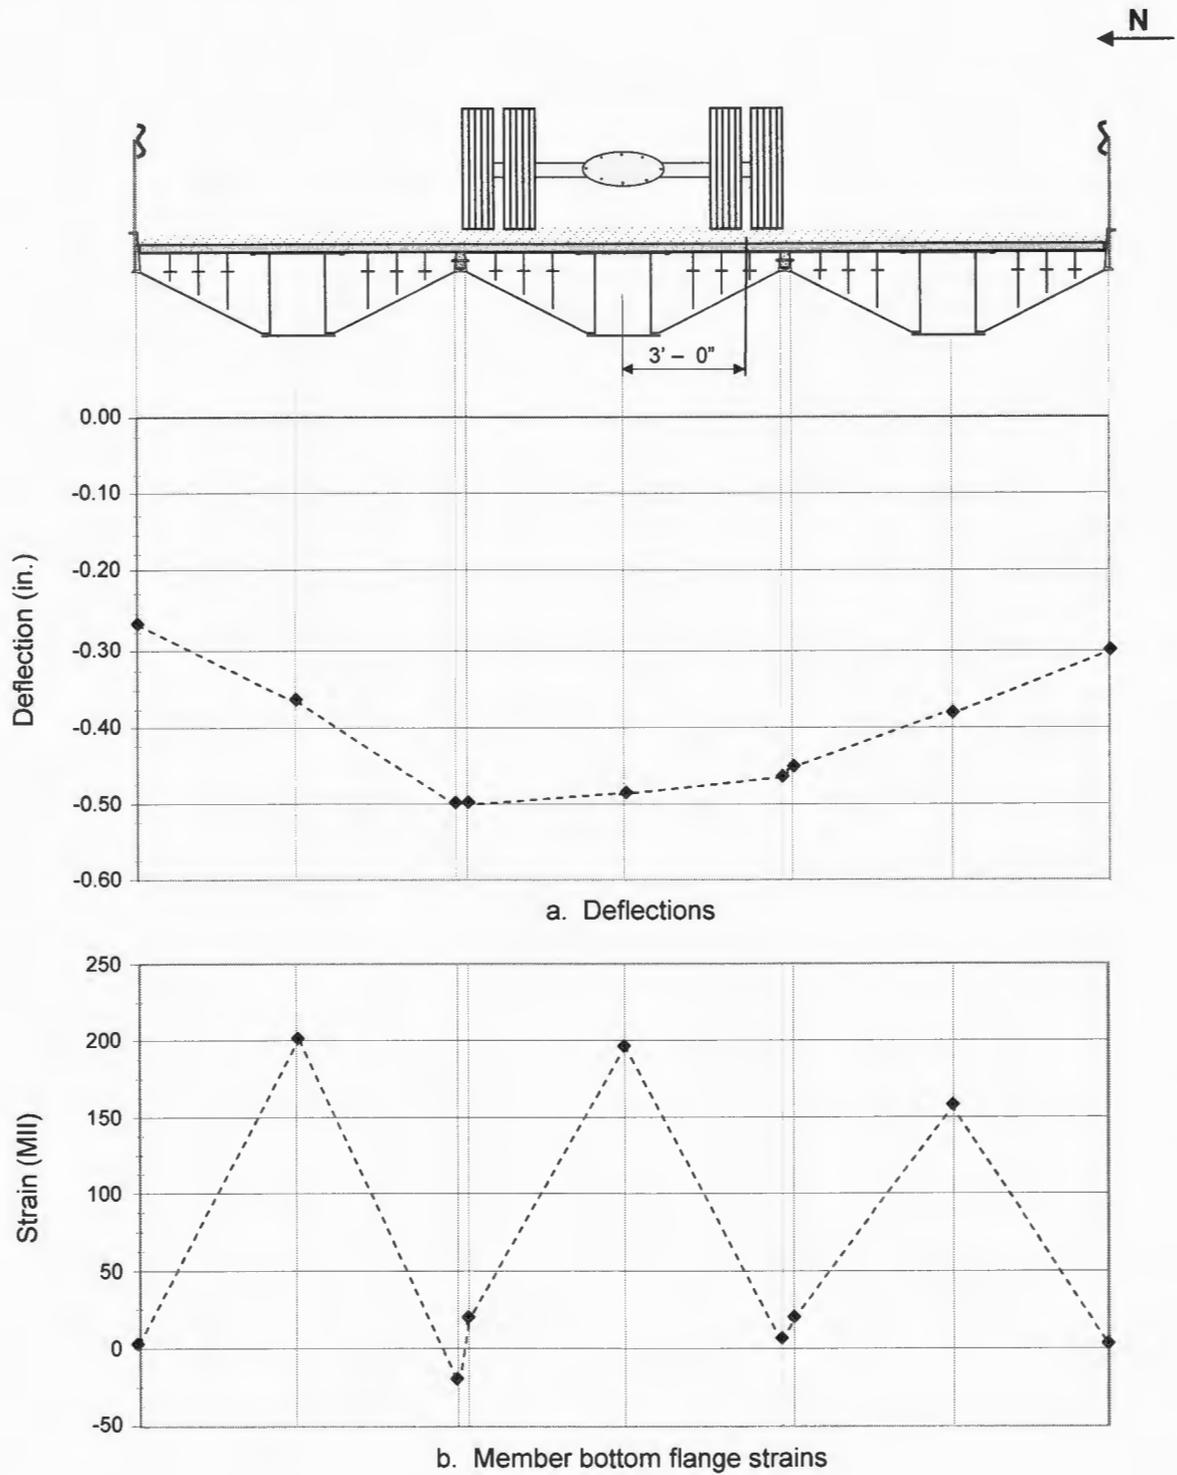
Figure 3.11. WCB2 midspan deflections and strains when the truck was in Lane 1.

The midspan deflections and strains that were measured on the interior and exterior girders across the width of the bridge are presented in Figures 3.11-3.14. In these figures, trend lines are used to connect deflection and strain data points measured during the field testing. The maximum midspan deflection (-0.86 in.) occurred at the exterior girder of the

South RRFC when the truck was in Lane 2 (See Figure 3.12), and the maximum midspan strain (+343.7 MII) occurred during the Lane 3 loading at the interior girder of the North RRFC (See Figure 3.13). As can be seen in Figures 3.11-3.14, measured midspan strain and deflection values that occurred when the truck load was in Lanes 1-4 (truck rear tandem at midspan) for all other members are below the maximum midspan values previously noted.

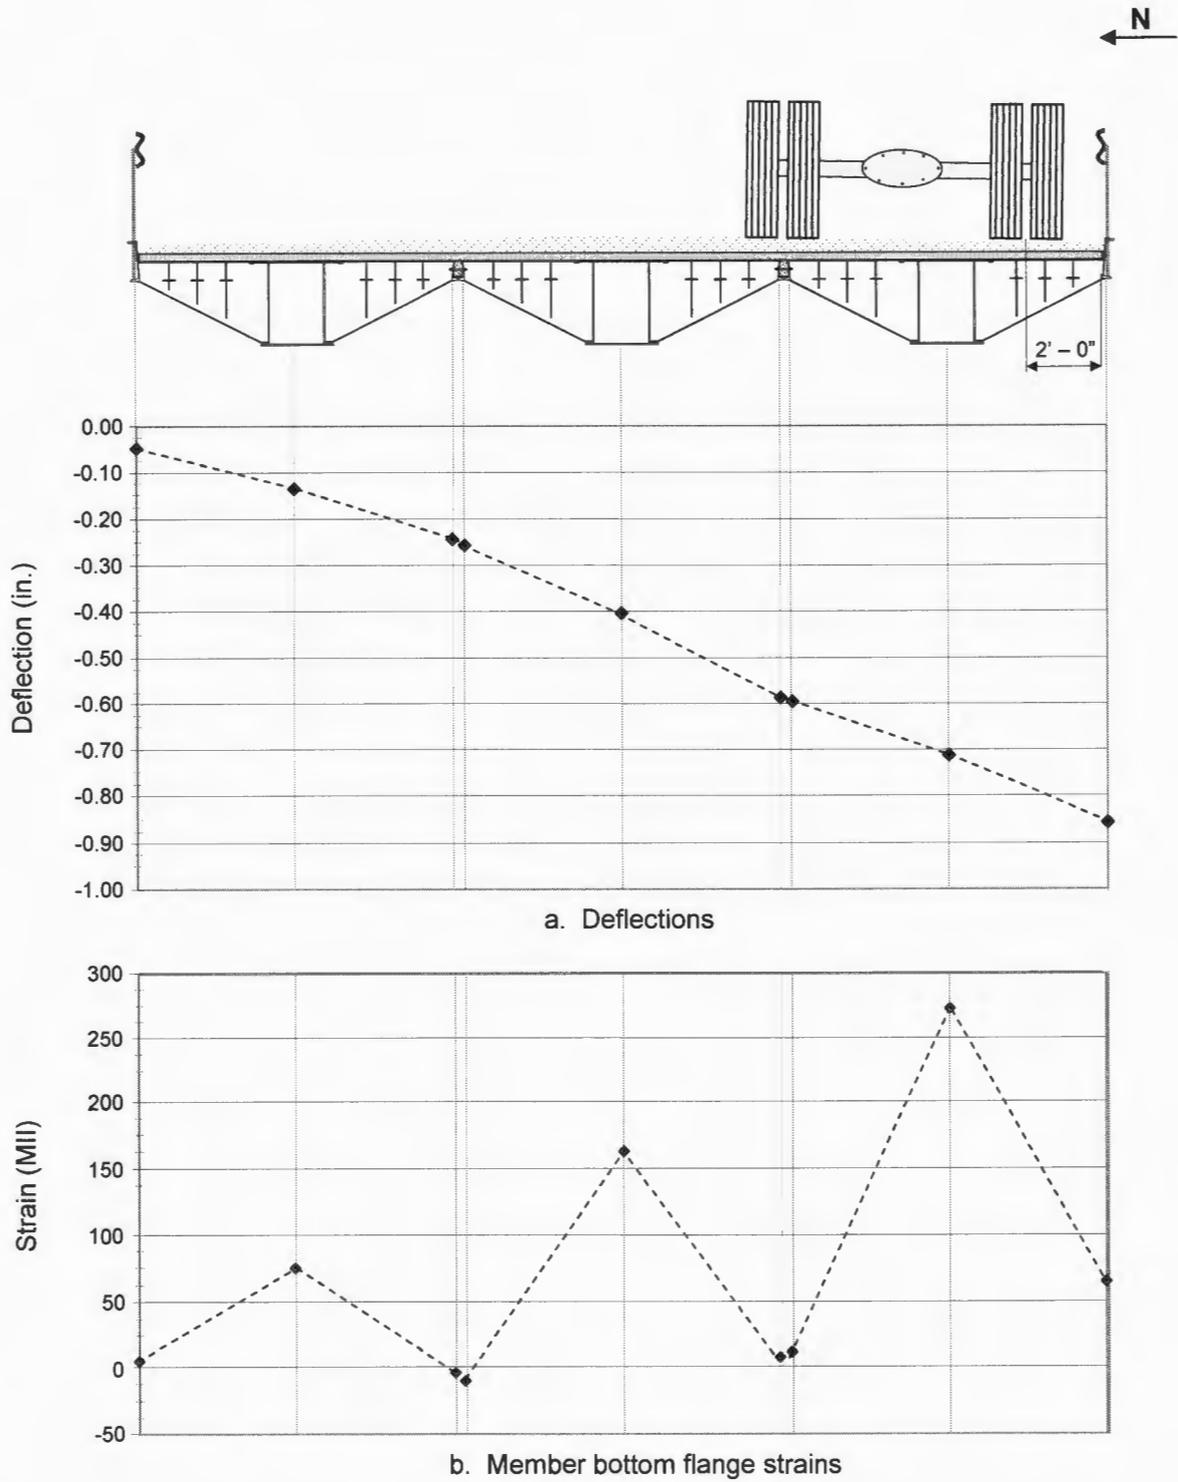
Figure 3.12. WCB2 midspan deflections and strains when the truck was in Lane 2.

The maximum deflection measured (-0.92 in.) occurred near the midspan and was measured in the South RRFC exterior girder when the test truck was located in Lane 2. Following the AASHTO LRFD Bridge Design Specifications [5], a recommended maximum deflection was 'span'/800 for legal truck loads. For the WCB2 with a clear span of 66 ft – 4 in., this legal load deflection limitation would be -1.00 in. Hence, for this truck loading, the maximum measured deflection was below recommended values. If the measured deflection were increased in proportion of the test truck load to an HS-20 loading, the experimental deflection would be -1.27 in., which is significantly above AASHTO limits.

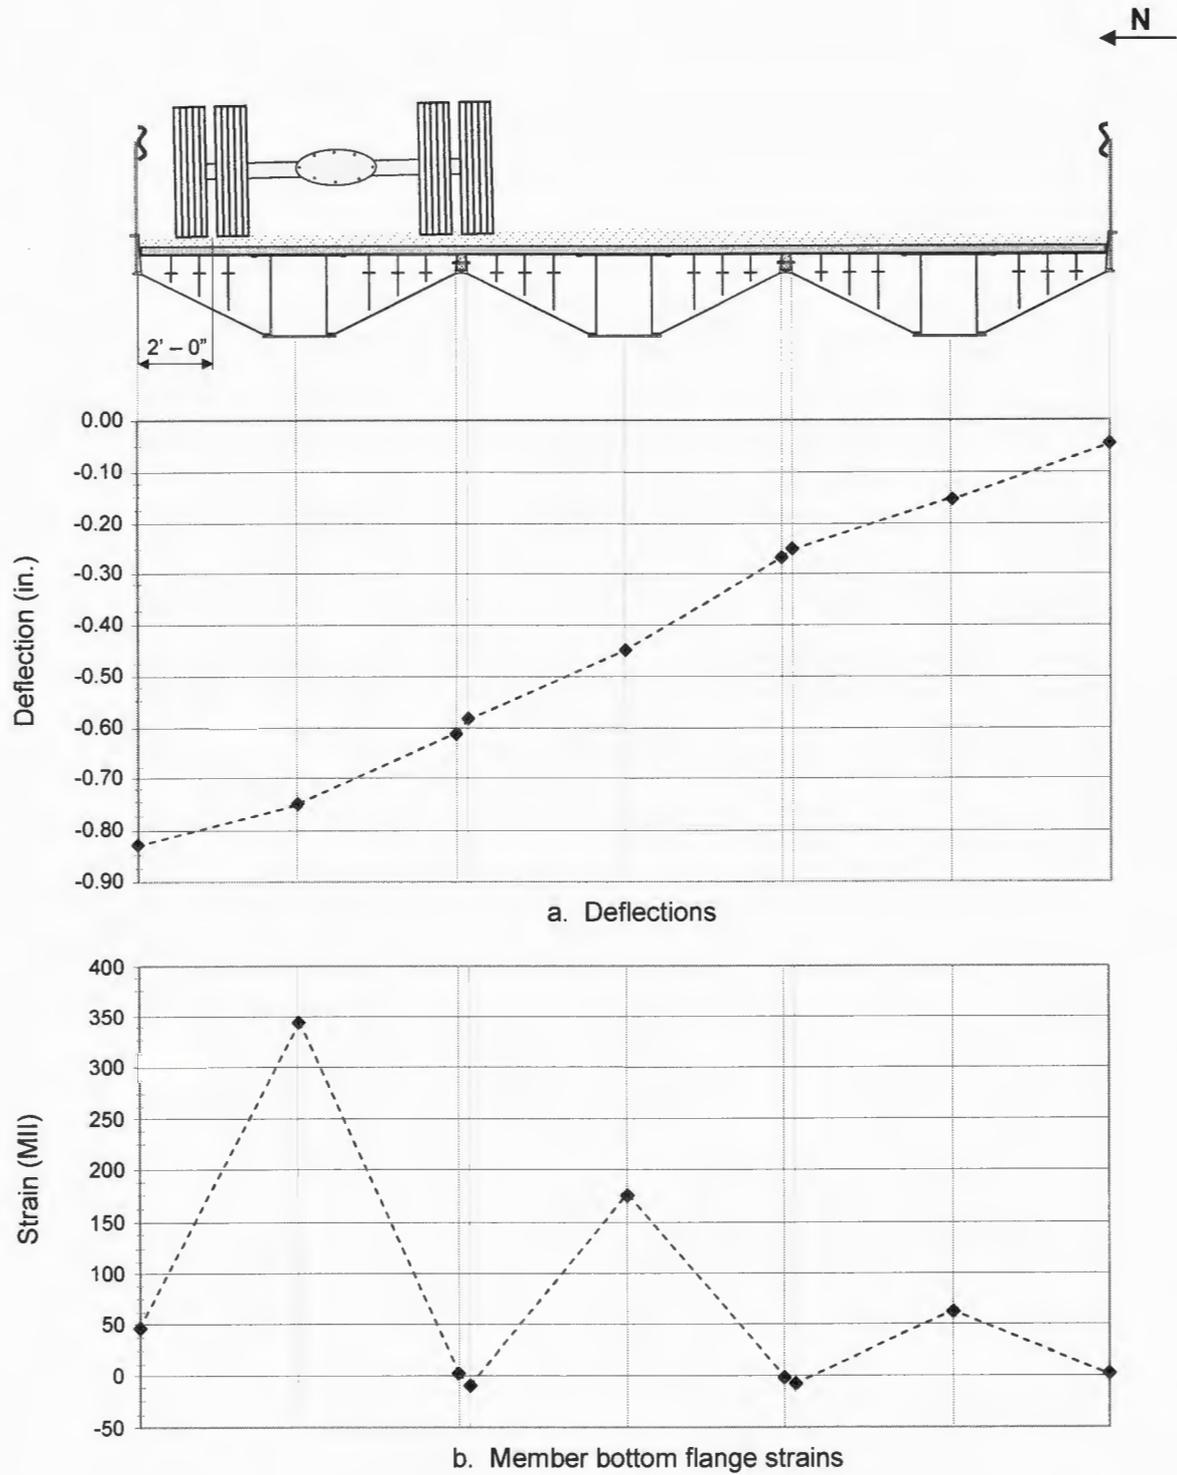
Figure 3.13. WCB2 midspan deflections and strains when the truck was in Lane 3.

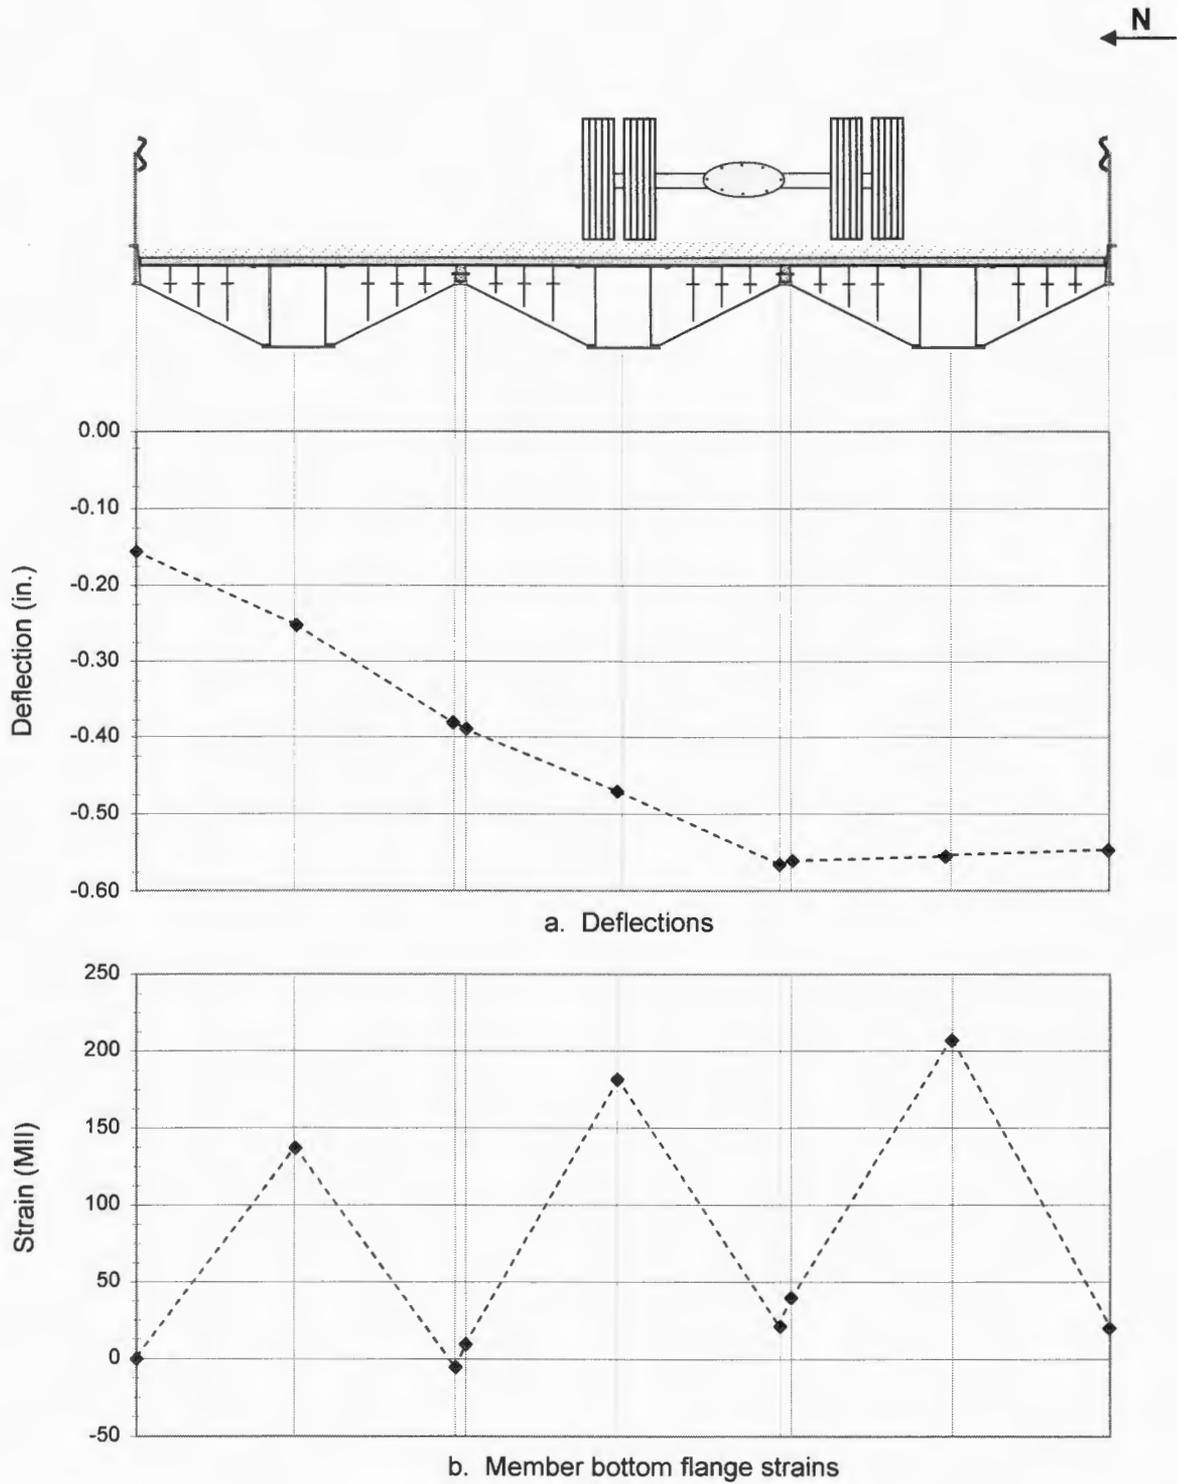
Figure 3.14. WCB2 midspan deflections and strains when the truck was in Lane 4.

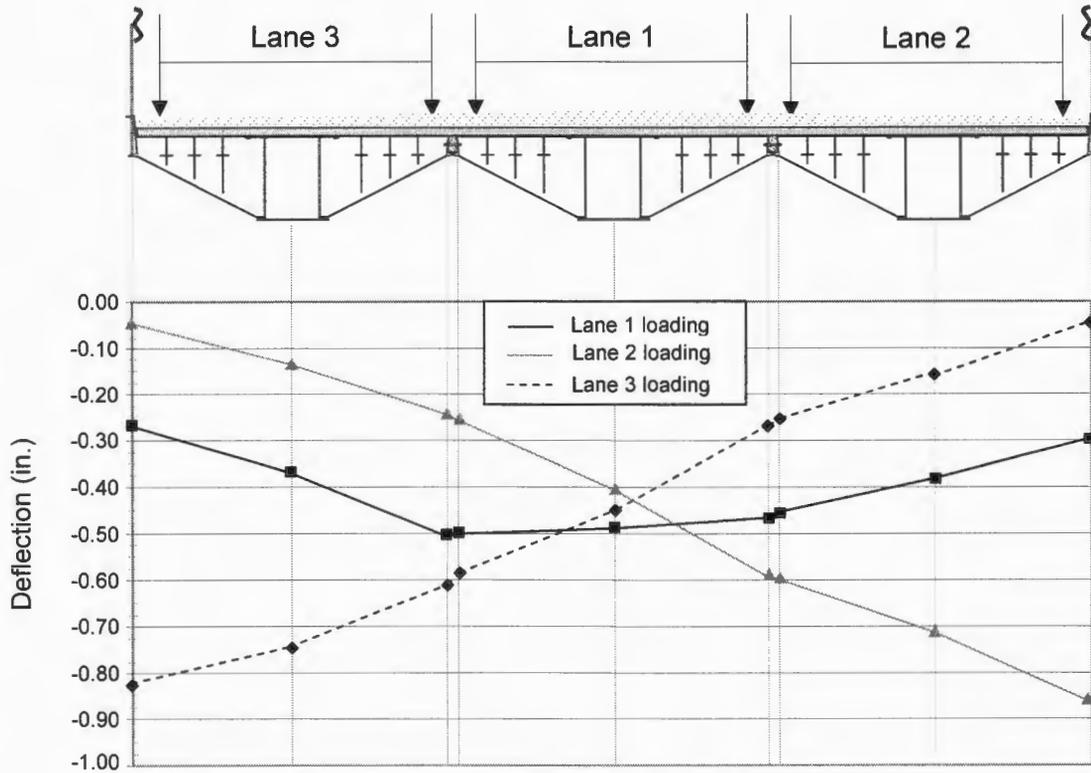
a. Deflections

Lateral load distribution as shown in Figure 3.15 was different on the north and south sides of the WCB2 because of the different timber planking used on each side of the centerline of the bridge. The south side, which had tongue-and-groove plank, distributed loads better than the north side planks. When the truck was positioned in Lane 1, larger deflections and strains were measured in the North RRFC than the South RRFC due to the better distribution on the south side. The tongue-and-groove timber planks could also distribute loads longitudinally to other secondary members, thus decreasing the deflections and strains on the bridge's south side. When the truck was in Lane 3, the distribution of loads was less, thus the interior girder of the North RRFC resisted more of the load and little was transferred to other members. This distribution can also be seen in the South RRFC's interior girder during Lane 2 loading in which there was better distribution and the load was

transferred to other members, thus reducing the strains measured in the interior girder of the South RRFC. The live load distribution factor needed for design was found from analyses of the deflection data from the various loading positions. The maximum live load strains (stresses) and deflections occurred on the interior and exterior girders of an exterior RRFC when the truck was positioned on that side of the bridge. The live load moments in each girder, resulting in the maximum strains (stresses) was a function of the live load distribution factor. Using the areas under the deflection curves during loading in these truck positions, the moment distribution was found to be 55%.

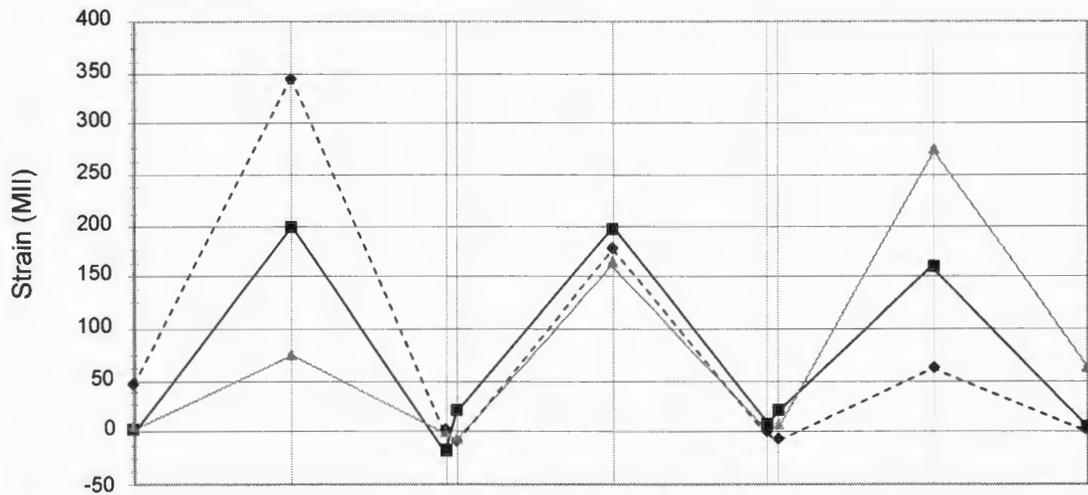
b. Member bottom flange strains

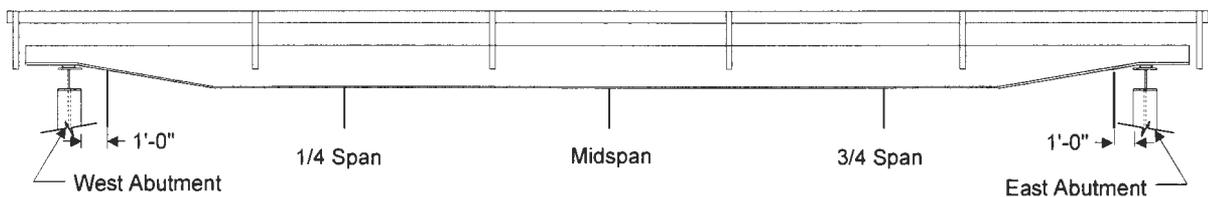
Figure 3.16. Strain instrumentation locations for WCB2 time history analysis.

With continuous data collected during a truck crawl speed (approximately 4 mph test), a time history analysis of the interior girder of the South RRFC was performed from strain transducers placed 1 ft from both abutments, at the 1/4 span, midspan, and 3/4 span locations (See Figure 3.16). It should be noted that the test truck traveled westward; hence peak values in the girders occurred first near the east abutment and lastly near the west abutment.

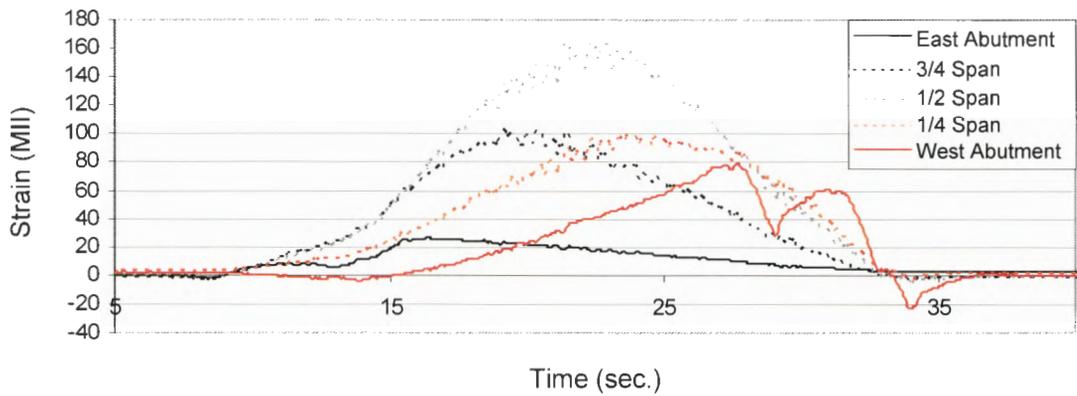
a. Truck in Lane 1

As previously noted, the maximum dynamic deflections and strains occurred at a truck speed of 10 mph. A plot of the time history comparison of the deflections and strains during the static and dynamic field testing are presented in Figures 3.18 and 3.19, respectively. The dynamic testing was performed in Lane 1; therefore, the data from static load testing is also from Lane 1 loading. The largest amplification occurred in the North RRFC interior box girder: the deflection was increased by 41% while the strain was amplified

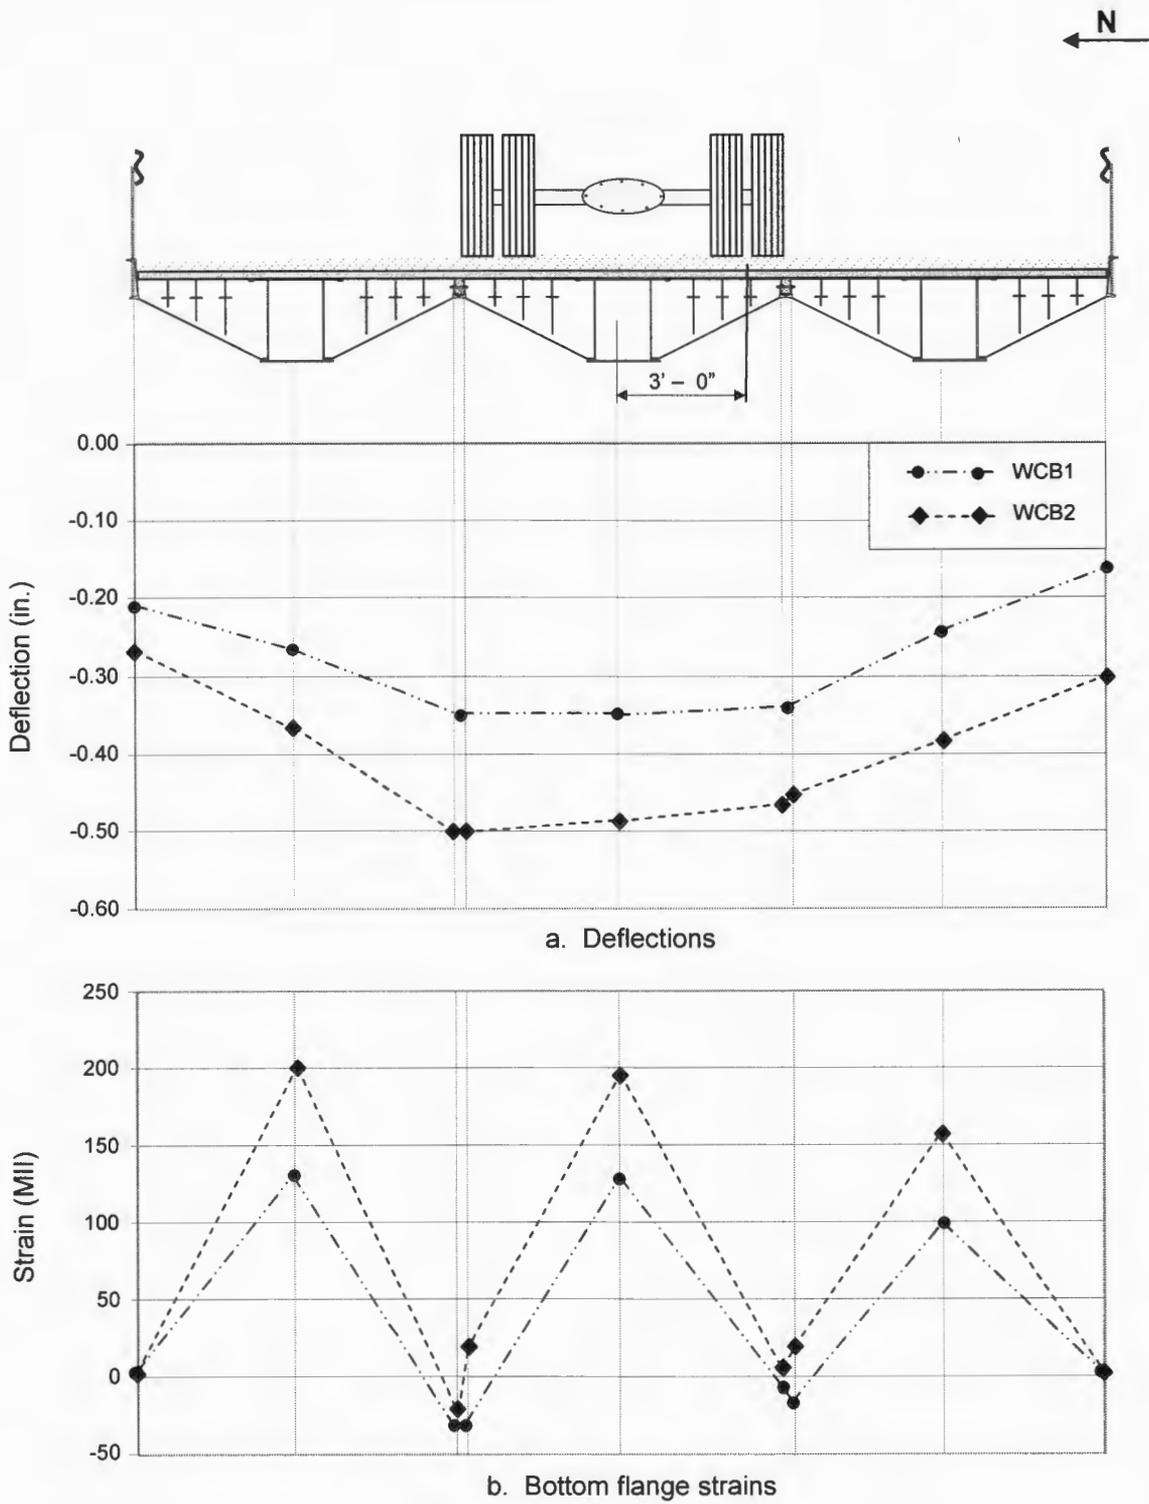
Figure 3.20. Comparison of field data from WCB1 and WCB2 (Lane 1).

A comparison of midspan field data collected from WCB1 and WCB2 during load testing is presented in Figures 3.20 - 3.22. The WCB1 and WCB2 bridges both have reinforced concrete longitudinal connections between adjacent railcars and are composed of three 89-ft RRFC superstructures; the length of the WCB2 railcars were "trimmed" to satisfy site specifications while the WCB1 utilized the entire railcars' lengths. The WCB2 bridge construction resulted in simply supported conditions while the WCB1 bridge was a three span continuous bridge. The difference in structural behavior of these two bridges was representative of these different support conditions, although the trends tended to be similar. The smaller deflections and strains measured in the WCB1 were expected due to the continuity of the bridge. Since the field truck weights varied little between the bridges (WCB1 = 51.1 k, WCB2 = 52.0 k), the increase in bridge length and support conditions were the controlling factors in the deflection and strain values. During Lane 1 loading, the deflection from WCB1 field test was, on average, 71% of that measured in the WCB2 test, while the strains measured in WCB1 were approximately 64% of WCB2 strains.
