Field testing of railroad flatcar bridges on low-volume roads

A thesis submitted to the graduate faculty
in partial fulfillment of the requirements for the degree of
MASTER OF SCIENCE

Major: Civil Engineering (Structural Engineering)

Iowa State University

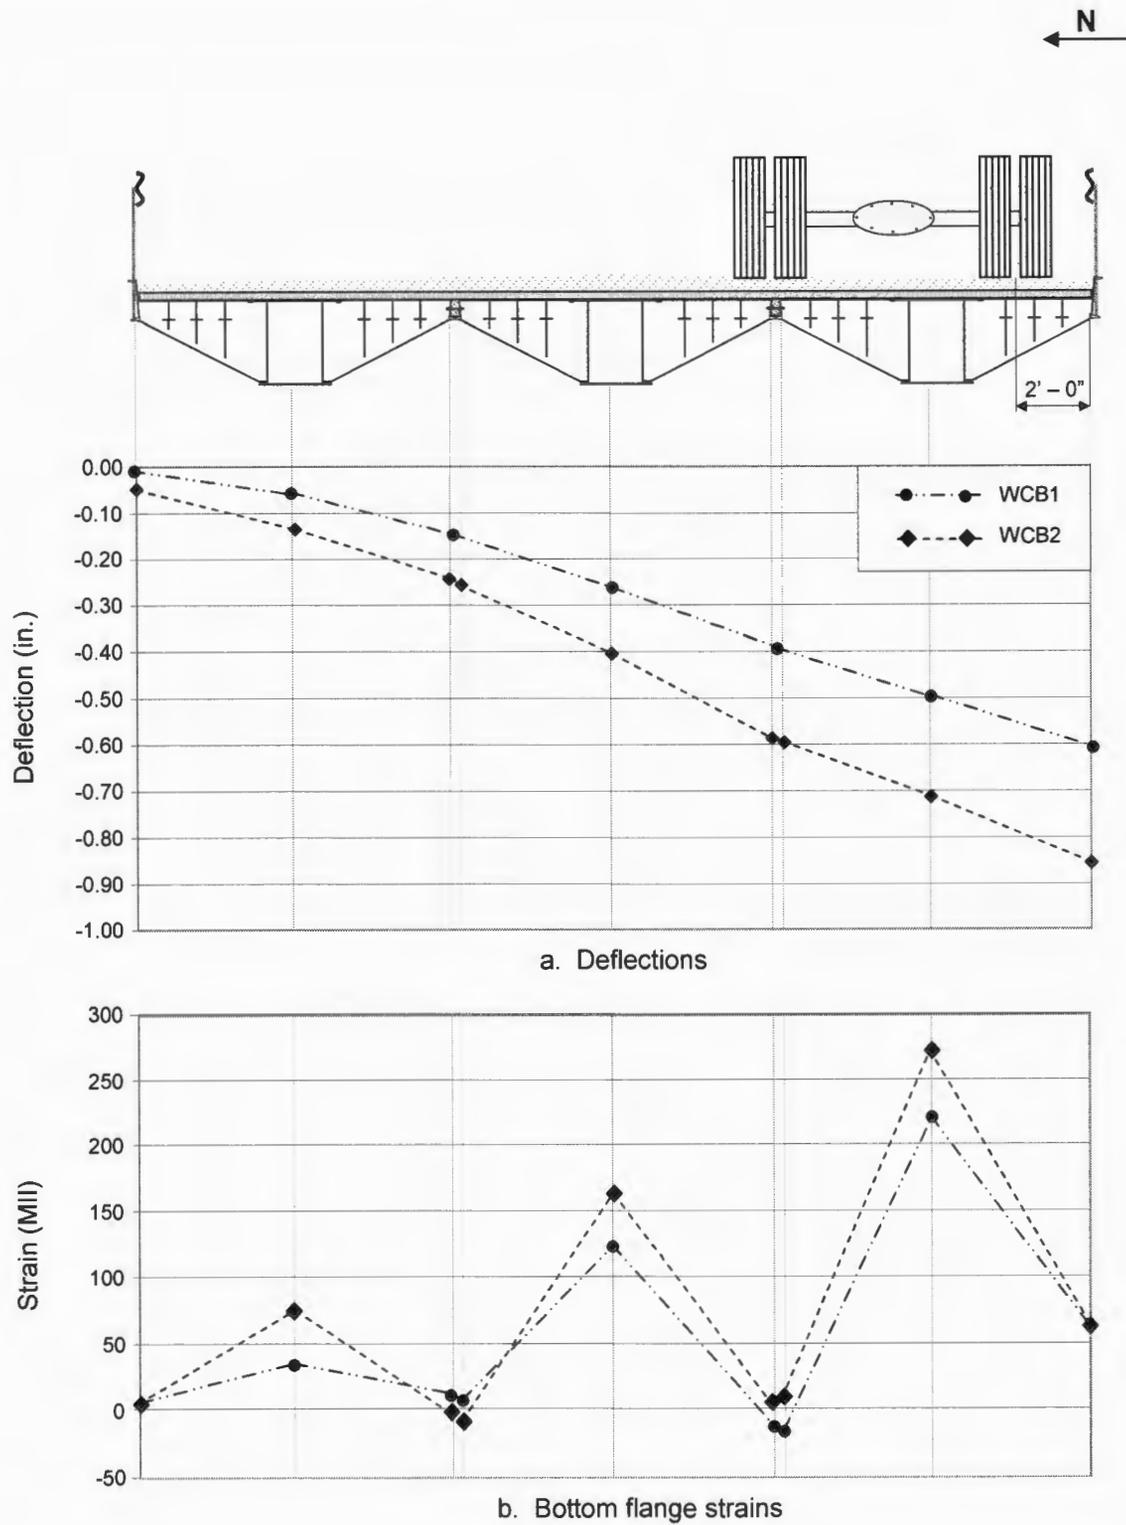
Figure 3.21. Comparison of field data from WCB1 and WCB2 (Lane 2).

A comparison of midspan field data collected from WCB1 and WCB2 during load testing is presented in Figures 3.20 - 3.22. The WCB1 and WCB2 bridges both have reinforced concrete longitudinal connections between adjacent railcars and are composed of three 89-ft RRFC superstructures; the length of the WCB2 railcars were "trimmed" to satisfy site specifications while the WCB1 utilized the entire railcars' lengths. The WCB2 bridge construction resulted in simply supported conditions while the WCB1 bridge was a three span continuous bridge. The difference in structural behavior of these two bridges was representative of these different support conditions, although the trends tended to be similar. The smaller deflections and strains measured in the WCB1 were expected due to the continuity of the bridge. Since the field truck weights varied little between the bridges (WCB1 = 51.1 k, WCB2 = 52.0 k), the increase in bridge length and support conditions were the controlling factors in the deflection and strain values. During Lane 1 loading, the deflection from WCB1 field test was, on average, 71% of that measured in the WCB2 test, while the strains measured in WCB1 were approximately 64% of WCB2 strains.

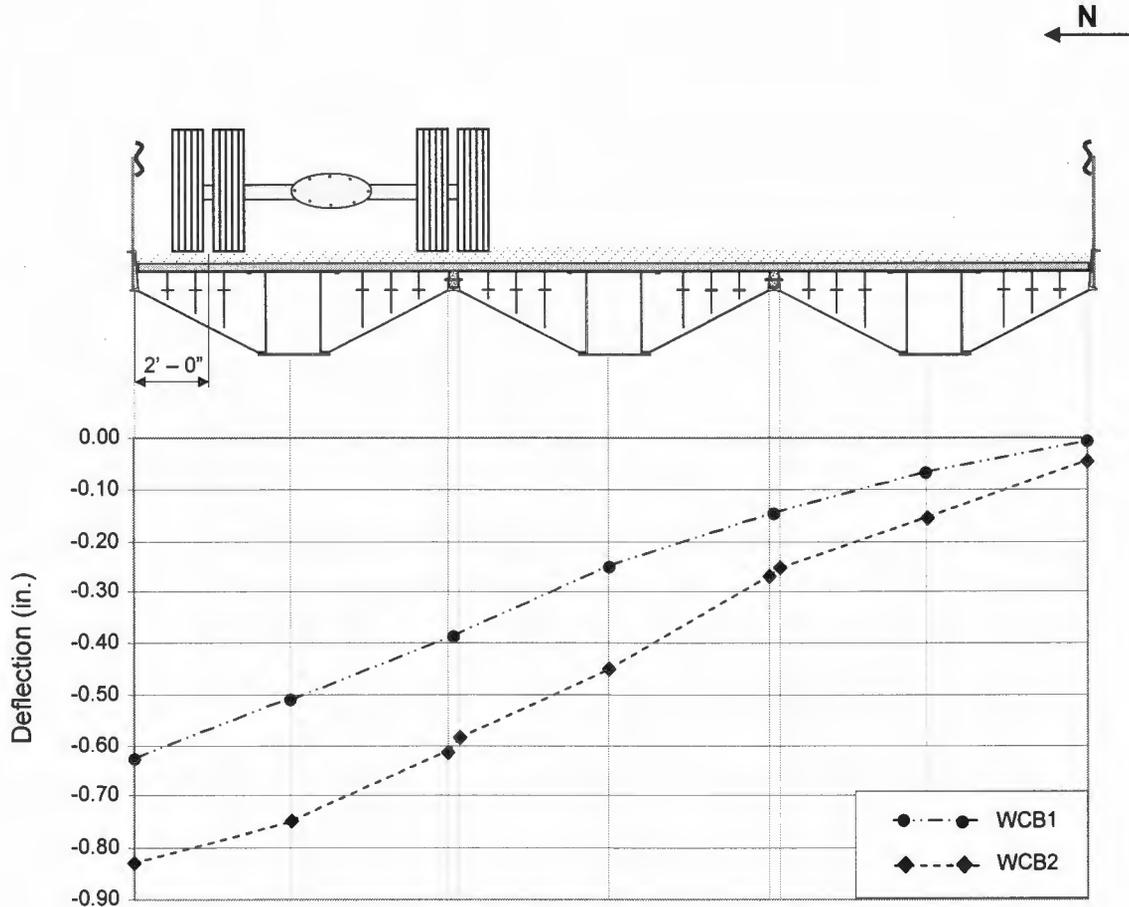
a. Deflections

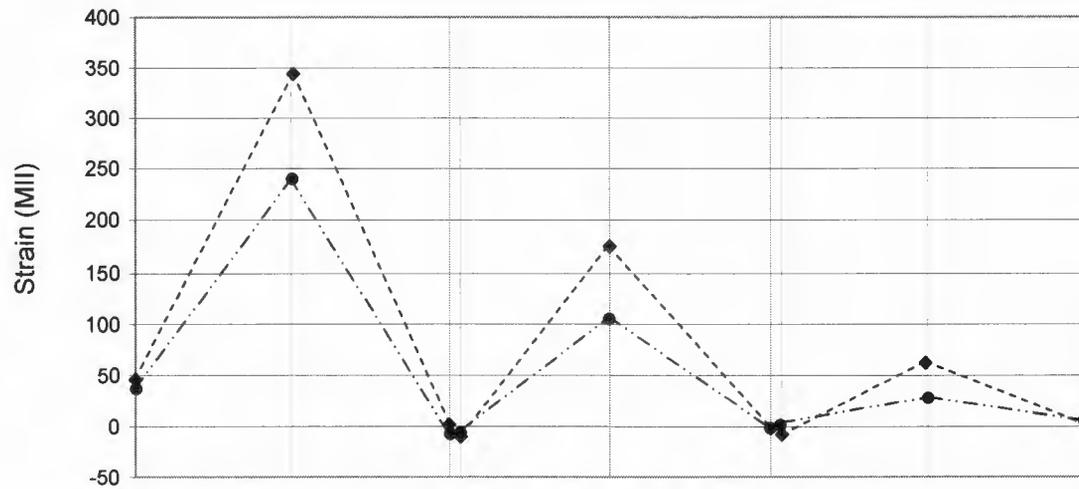
b. Bottom flange strains

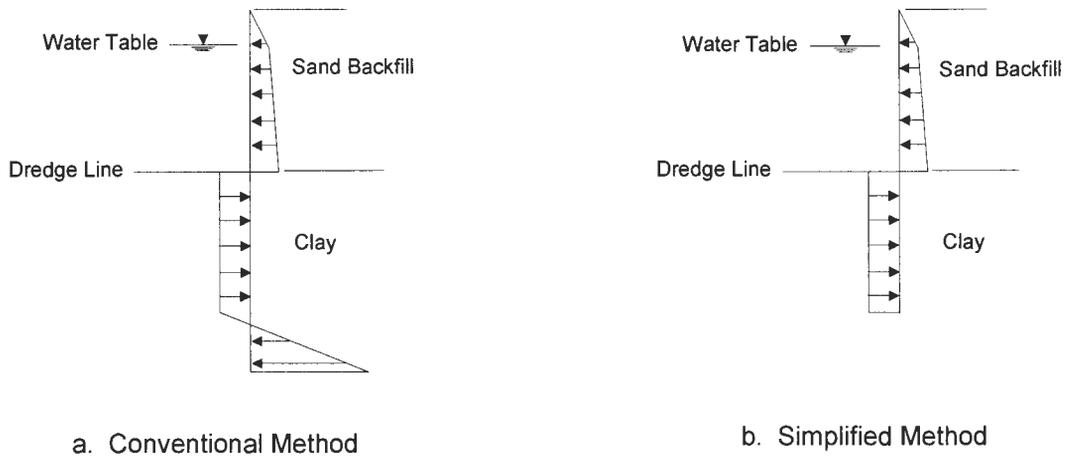
Figure A.1. Design lateral forces for a cantilevered sheet pile [10].

Lateral earth pressures on the sheet pile walls are dependent upon soil conditions, location of the water table, embedment depth, and if cantilever or anchored sheet piles are used. Guidelines for the design of steel sheet piles for use as retaining walls are documented in the United States Steel (USS) Steel Sheet Piling Design Manual [10]. Cantilevered sheet piles are designed by creating a zero net lateral pressure on the wall, thus resulting in stability of the sheet pile wall. Figure A.1 illustrates the design lateral forces exerted on a cantilevered sheet pile assuming granular backfill and penetration into clay. As described in the Design Manual previously noted, cantilevered sheet piles may be designed according either by a conventional method (Figure A.1a) or by the simplified method (Figure A.1b). The Fixed Earth and Free Earth Support Methods are the basic methods of sheet pile design, with the Free Earth Support Method being the most commonly used due to its simplicity. The Fixed Earth Support Method assumes a hinge (zero bending moment) at the point of contraflexure, and the portions above and below this point are treated as separate freely supported beams. The Free Earth Support Method assumes that there is no pivot point below the dredge line. A sketch of the design lateral forces acting on an anchored sheet pile in cohesive soil backfilled with granular soil using the Free Earth Support Method is shown in Figure A.2 [10].

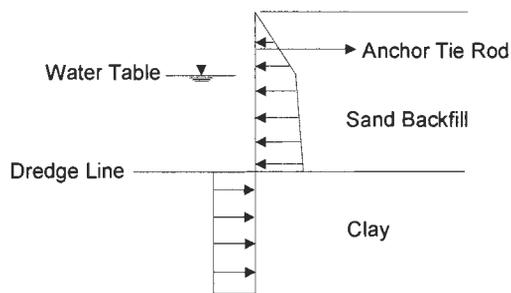
Figure A.2. Design lateral forces for an anchored sheet pile using free-earth method [10].

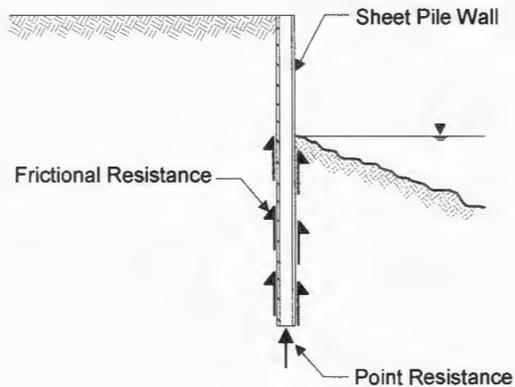
Figure A.3. Point and frictional resistance.

Pile bearing capacity is composed of both the point resistance and the skin frictional resistance of the pile (See Figure A.3). The point resistance is a function of the cross sectional area of the pile, while the skin friction is proportional to the perimeter of the pile throughout the embedment depth. The behavior of steel sheet piles may be compared to that of a steel H-pile whereas the cross section is not a boxed or circular section, but instead is an open cross section. A plug situation may be created in the void areas of the cross section when penetrated into cohesive soil conditions; however, a complete plug situation is

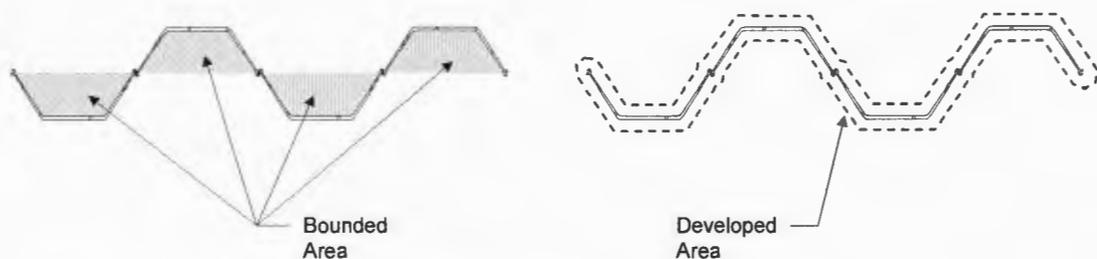
Figure A.4. Bounded and developed areas.

The sheet pile cross sectional area bearing the lateral forces has been defined in numerous ways. Bustamante and Gianceselli [11] describe the bearing cross sectional area as the entire inside area bounded by the flanges of the profiles as shown in Figure A.4. However, McShane [12] considers the instance in which complete plug conditions may not exist; hence, in cohesive soils it is suggested 50% of the gross area (steel sheet pile cross sectional area + soil plug area) be considered.

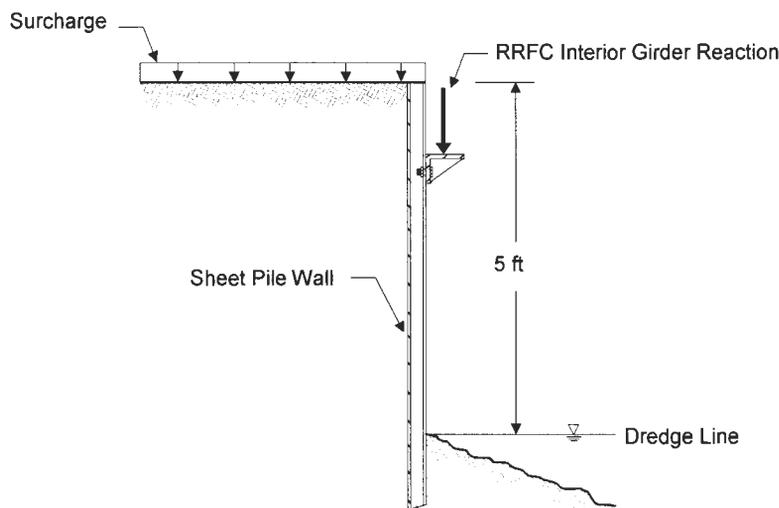
Figure A.6. Sketch of sheet pile analysis.

Manual [15], and an external moment resulting from eccentric loading of the RRFC onto the abutment (See Figure A.6). A required penetration depth was found and a 40% increase, as specified in the USS Sheet Piling Design Manual [10], was applied for a safety factor to obtain the design embedment depth. The calculated stresses in the retaining wall were then used to select a required steel sheet pile section.

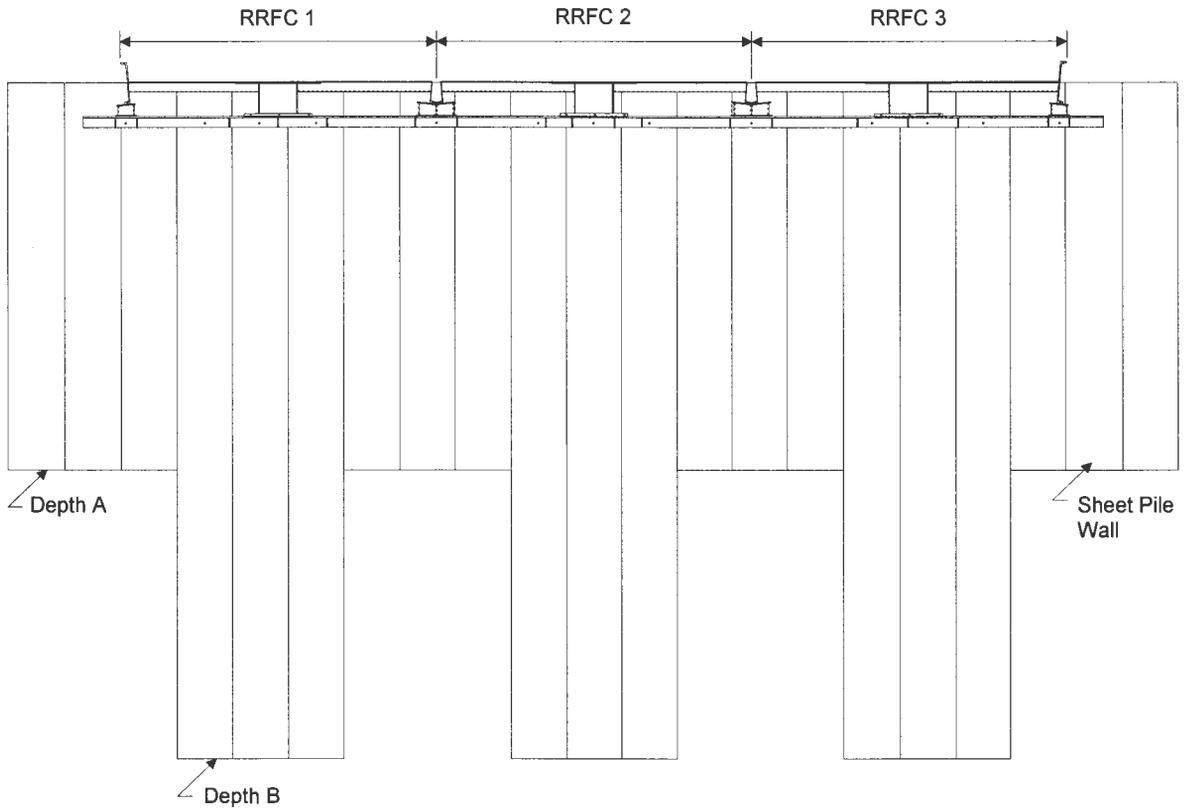
Depth A	Depth B
East Abutment	11 ft	25 ft
West Abutment	20 ft	35 ft

Figure A.7. Sheet pile abutment design for the theoretical WCB.

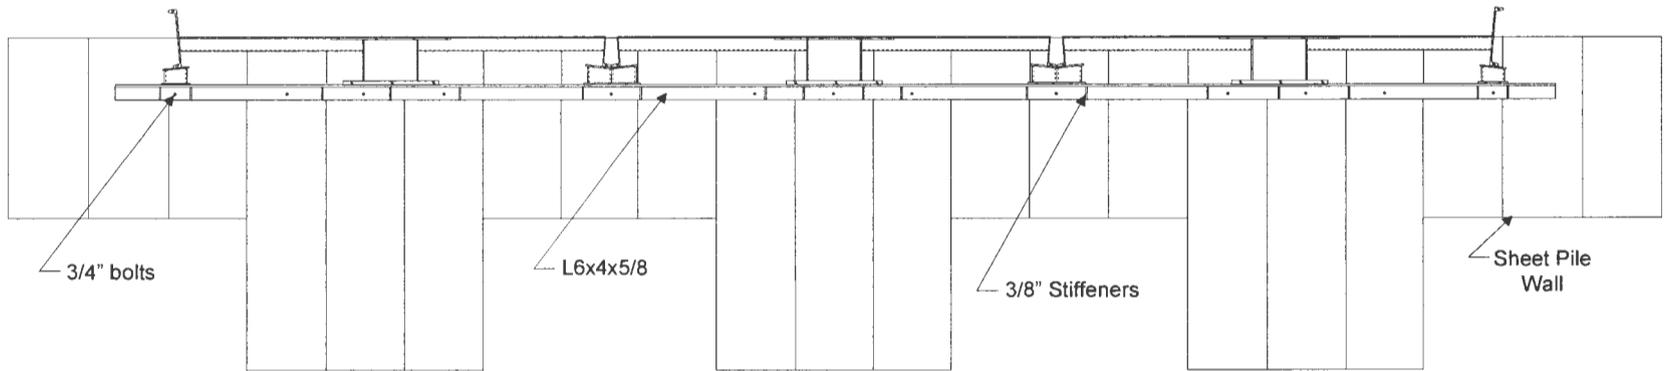
a. Cross sectional view of the RRFC stiffeners and bolt locations at the sheet pile abutments

Figure A.8. Theoretical WCB sheet pile abutment bearing support design.

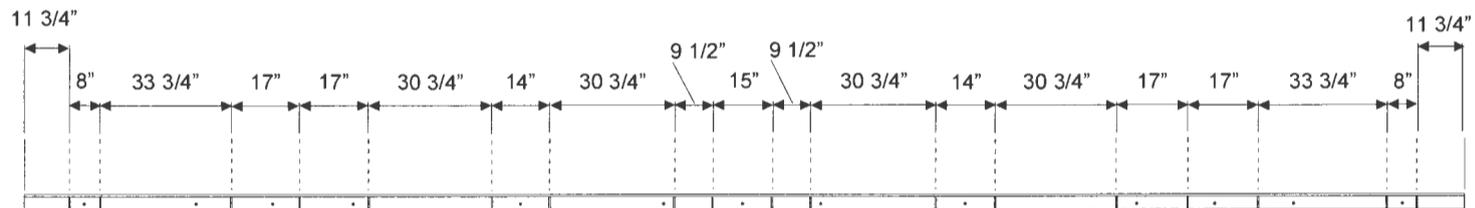
c. Approximate spacing between centerline of angle stiffeners*

*Dimensions may need to be adjusted for field conditions.

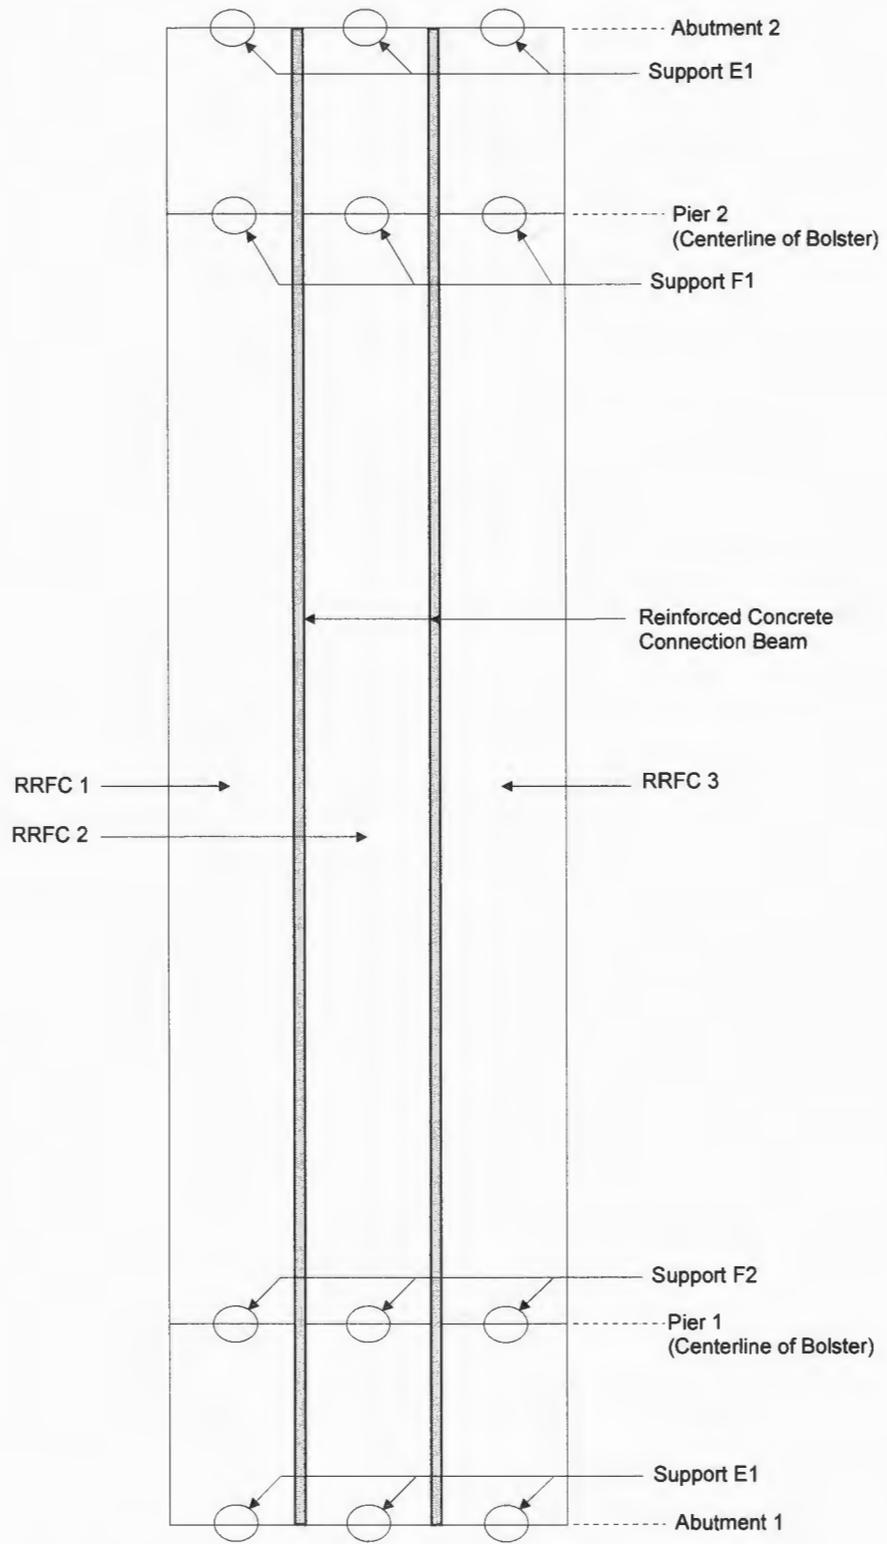
Figure A.9. Location of interior girder supports.

Figures A.9 – A.16 show details of the support conditions for the interior and exterior girders at the piers and abutments. The height of the interior girders is larger than that of the exterior girder, so a built-up support was designed to allow the exterior girders to rest on the pier caps and abutments. Recycled H-pile sections used for the piers are also used as the built-up supports for the exterior girders at the piers. At the abutments, the H-pile built-up supports could not be used since the bearing angle does not have a sufficient bearing width; therefore, at the abutments, hollow tube sections (HSS 6x6x1/4) were designed to support the exterior girders.

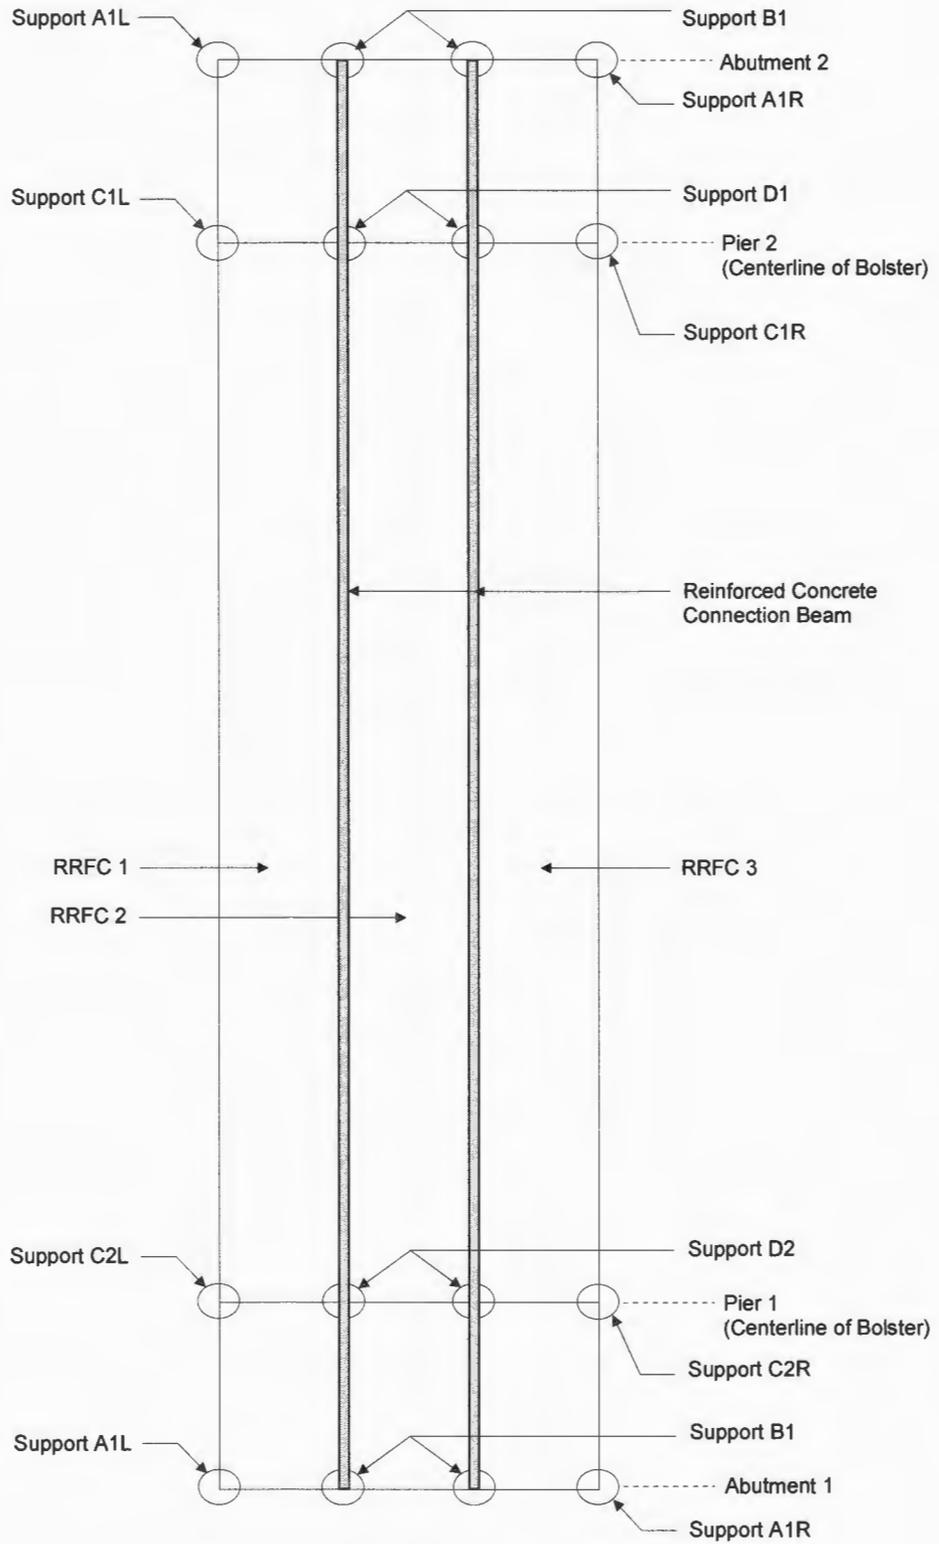
Figure A.10. Location of exterior girder supports.

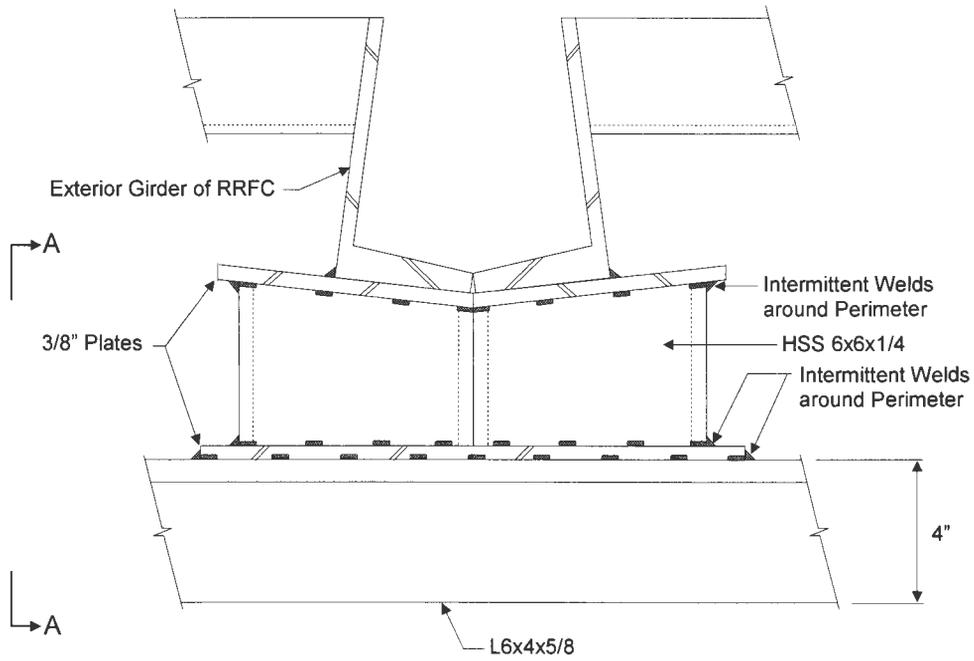
a. Support B1

Figure A.12. Exterior girder support at reinforced concrete connection beam located at the sheet pile wall abutment.

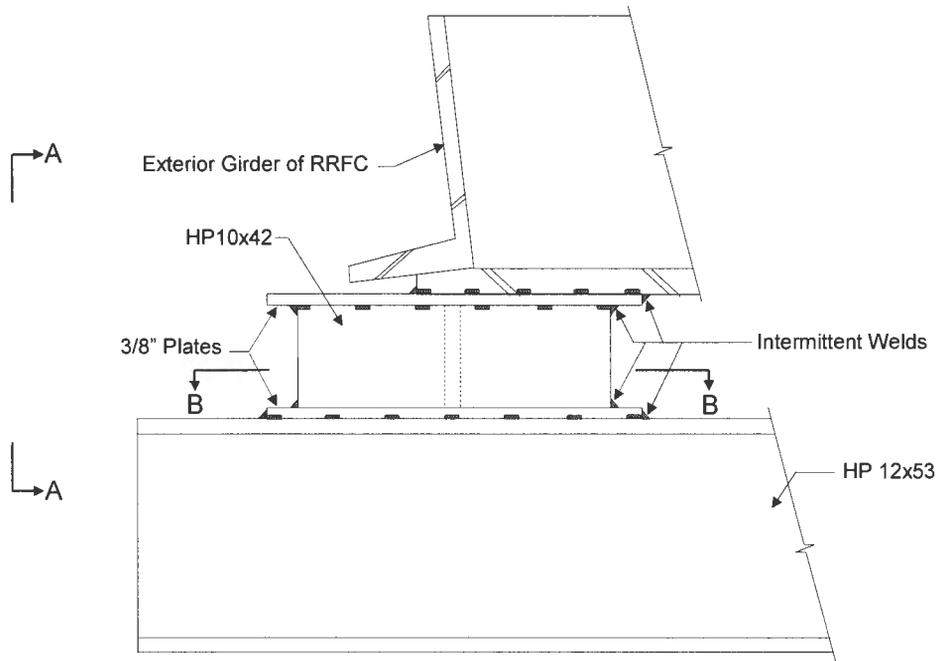
a. Support C2L

Figure A.13. Exterior girder support at the pier (bolster location).

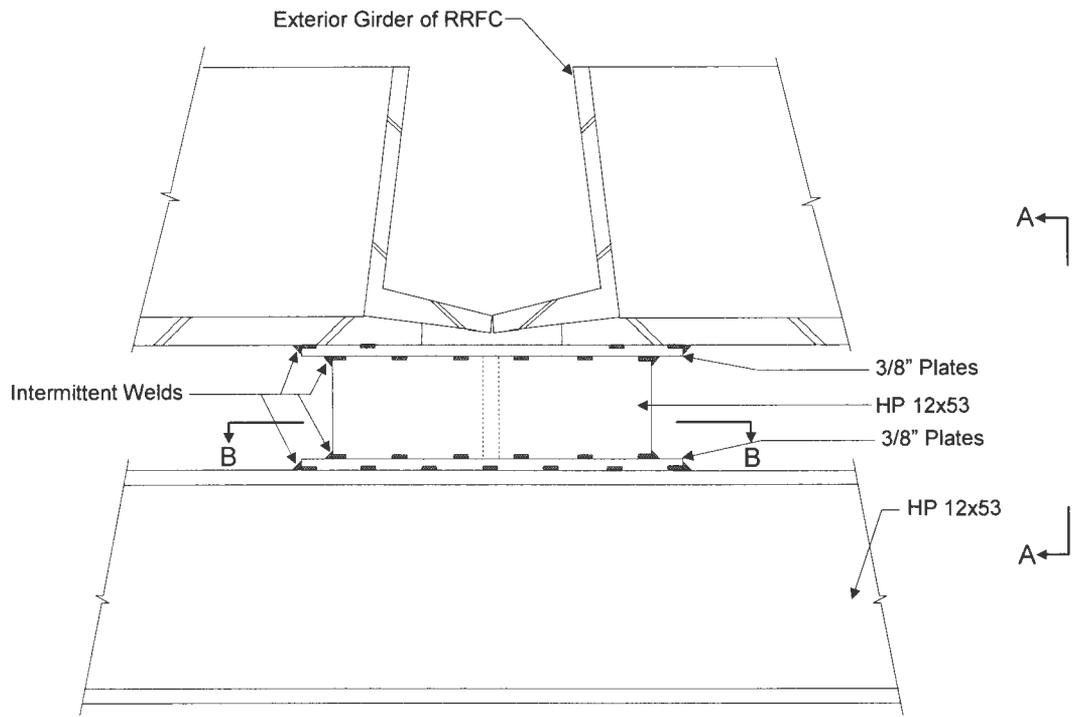
a. Support D2

Figure A.14. Exterior girder support at the reinforced concrete connection beam located at the pier (bolster location).

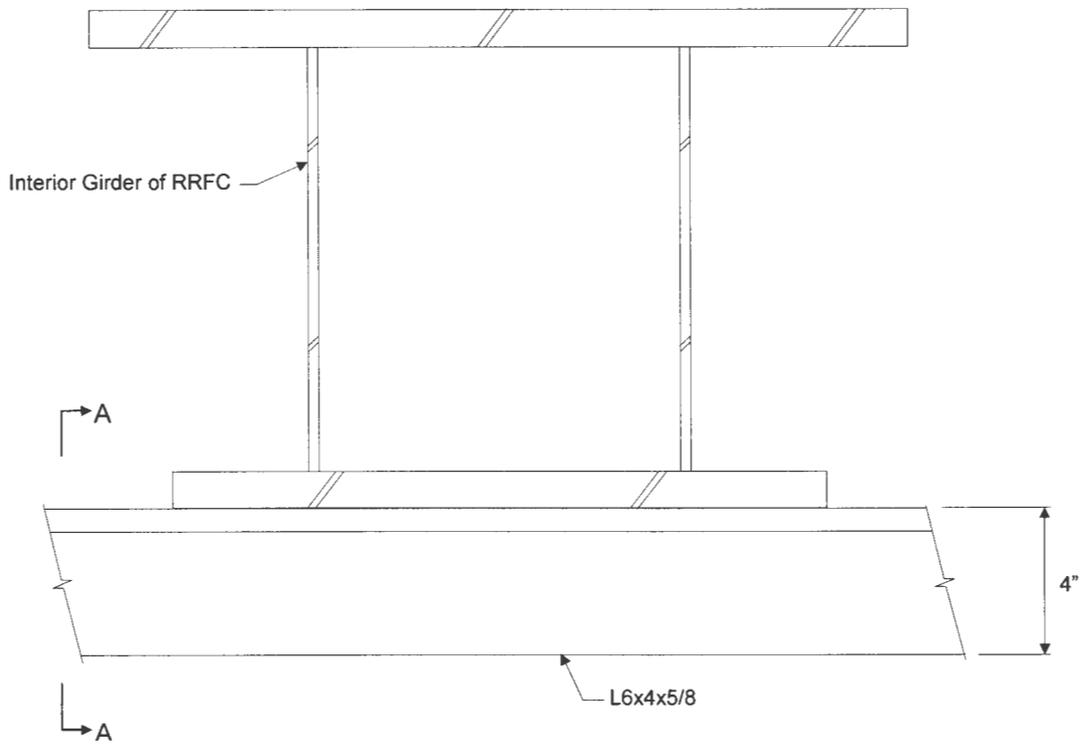
a. Support E

Figure A.15. Interior girder support at the sheet pile wall abutment.

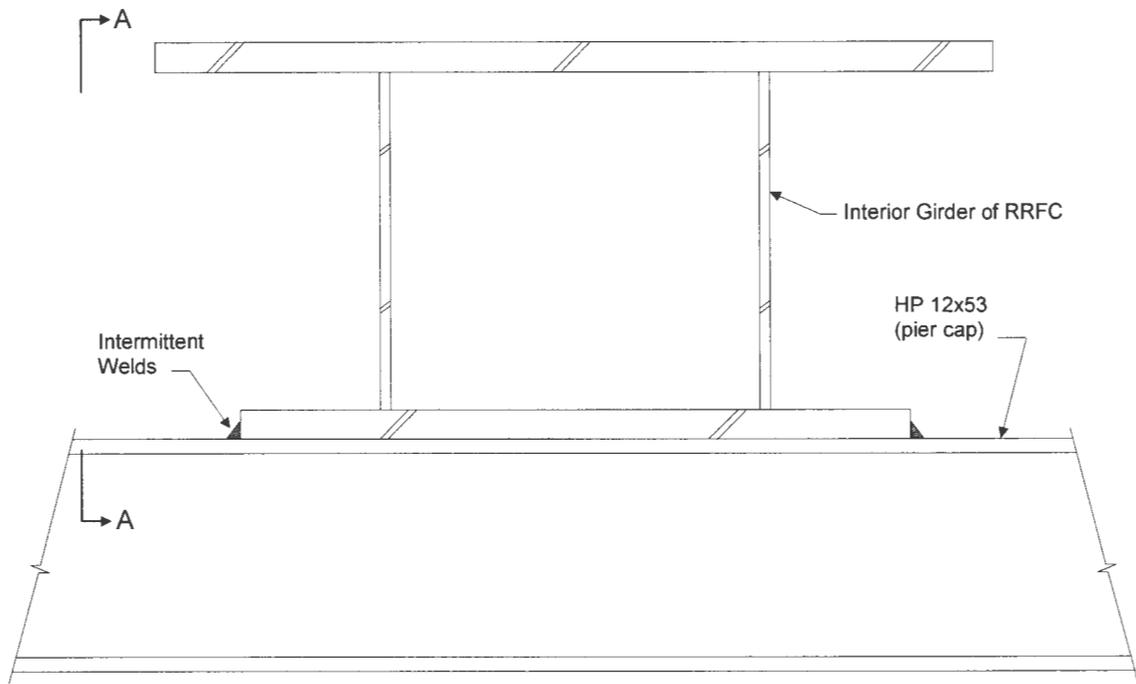
a. Support F

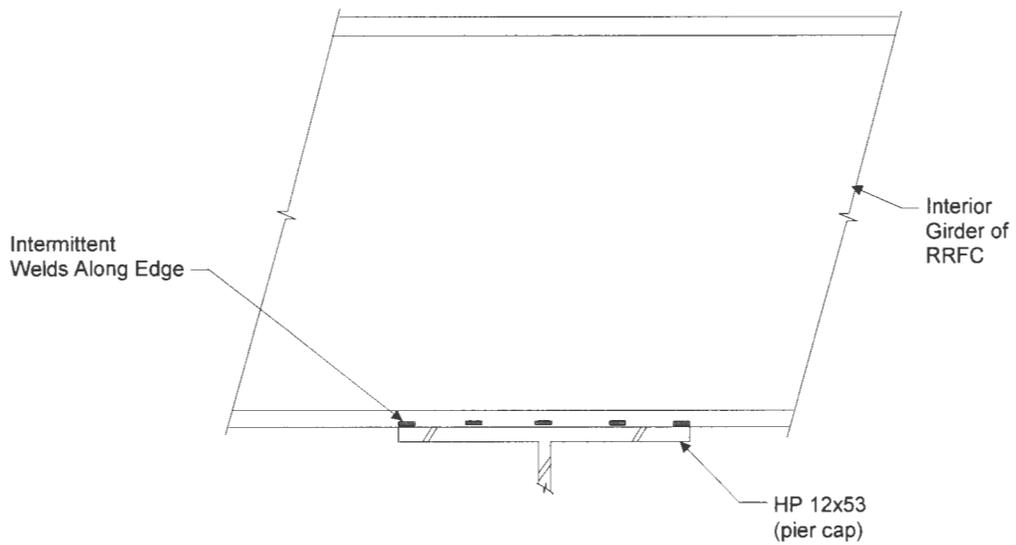
b. Section A-A

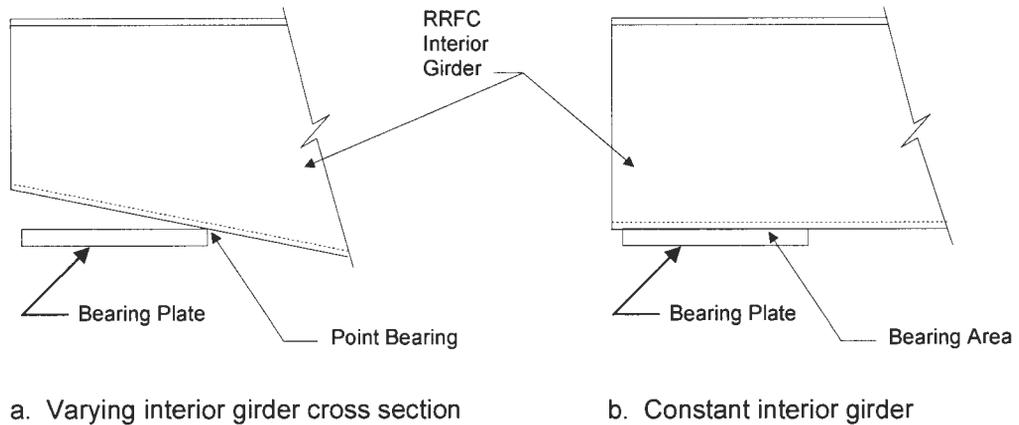
Figure B.2. Bearing conditions for the RRFC interior girders.

Modifications for bearing are required in the region in which the interior girder tapers. The inclined interior girder at the bearing locations results in a very small bearing point, instead of a flat bearing surface (See Figure B.2).

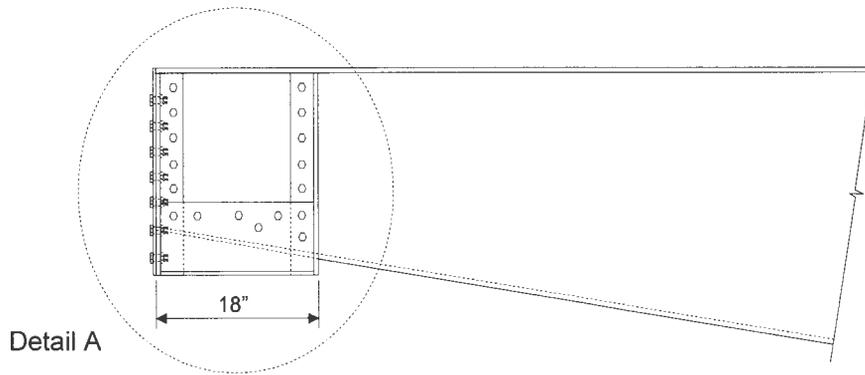
a. Concrete abutment support

Figure B.3. Support at tapered end of RRFC interior girder for concrete abutment.

One possibility is to position four vertical angles, 2 on either side of the interior box girder to act as bearing stiffeners, to distribute the load evenly to the abutment. Another angle, positioned perpendicular to the bearing stiffener angles, would then be placed at the base to complete the framed box on either side of the interior girder. Detailed sketches of this design for both concrete and steel abutments are presented in Figures B.3 and B.4, respectively.

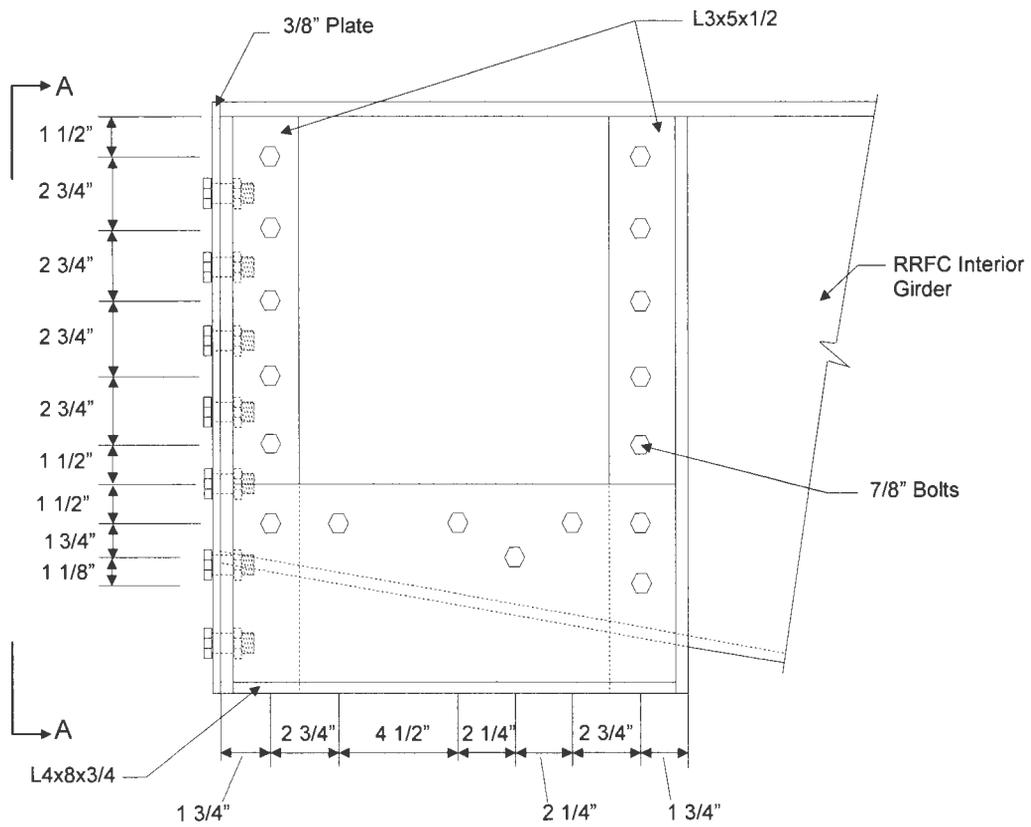
b. Detail A

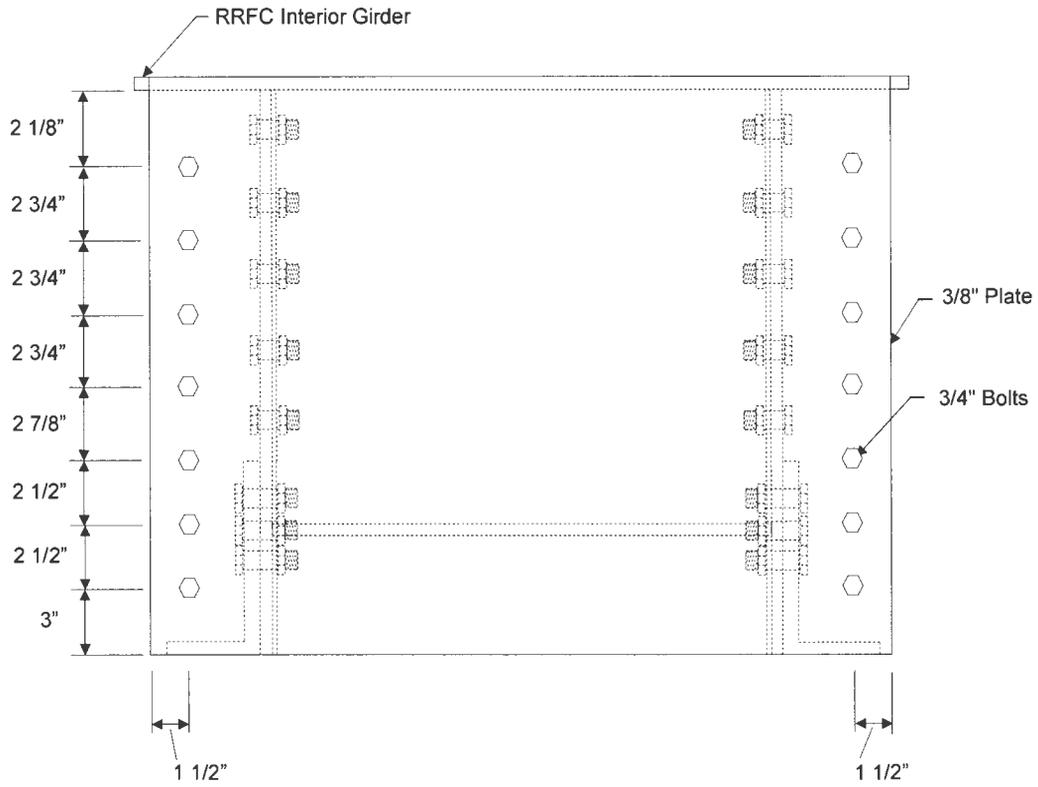
c. RRFC interior girder cross-section

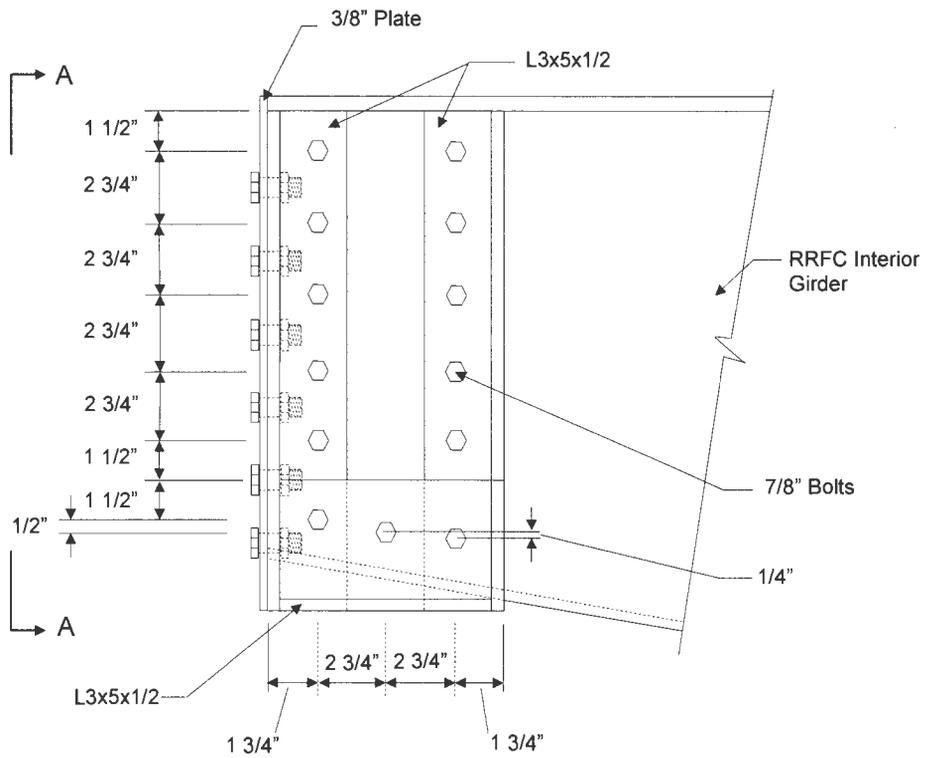
b. Detail A

Figure B.4. Support at tapered end of RRFC interior girder for steel abutment cap.

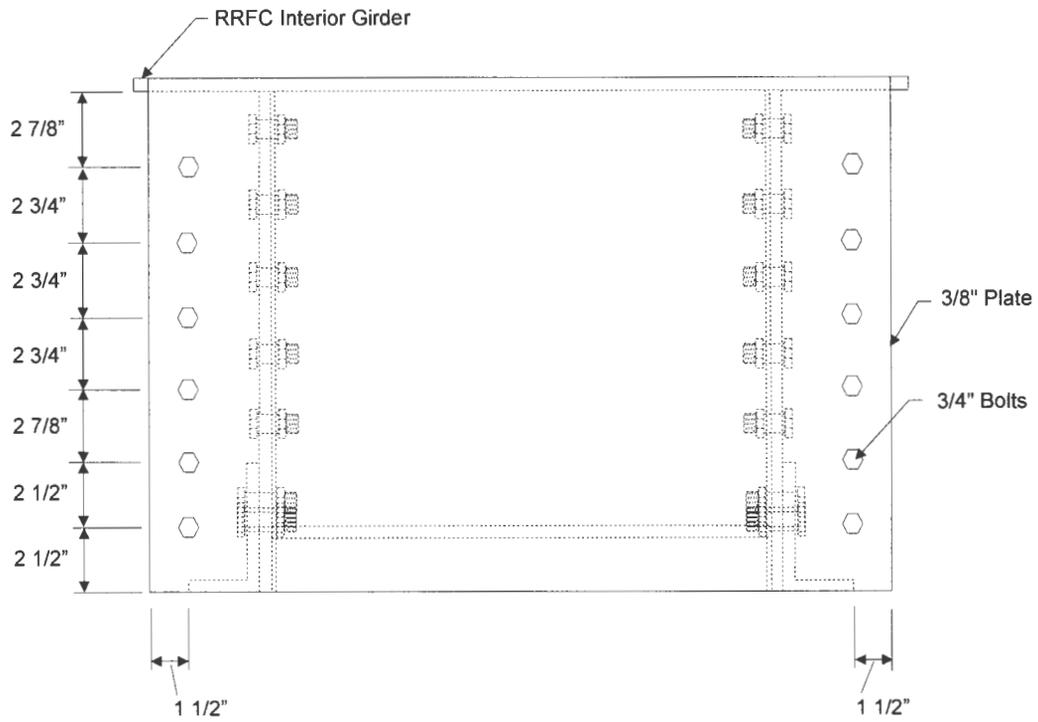
c. RRFIC interior girder cross-section
