Lead-free, bronze-based surface layers for wear resistance in axial piston hydraulic pumps

A thesis submitted to the graduate faculty
in partial fulfillment of the requirements for the degree of

Iowa State University

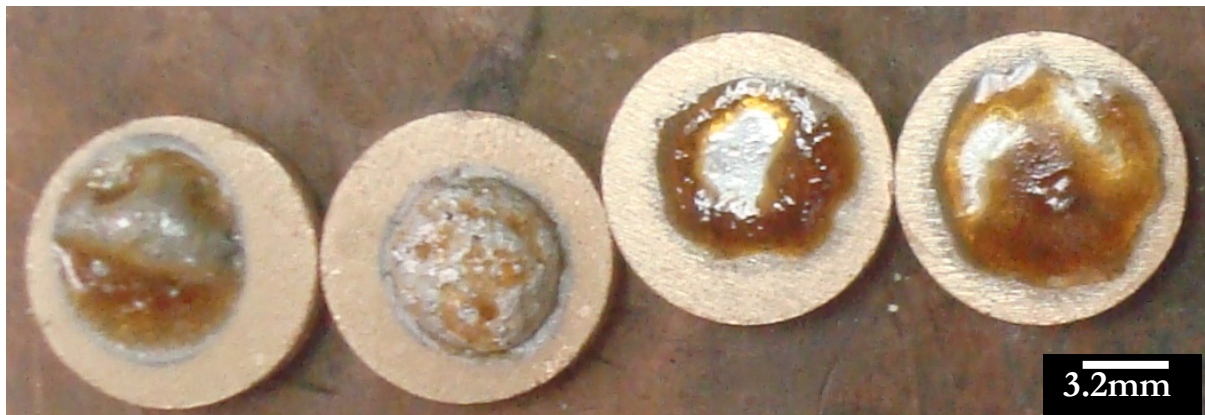
Figure 111. Macroscopic view of a) Sn-1.37Mn and b) Sn infiltration samples.
