Evaluation of corrosion resistance of different steel reinforcement types

A thesis submitted to the graduate faculty
in partial fulfillment of the requirements for the degree of
MASTER OF SCIENCE

Major: Civil Engineering (Structural Engineering)

Iowa State University
Ames, Iowa
2004

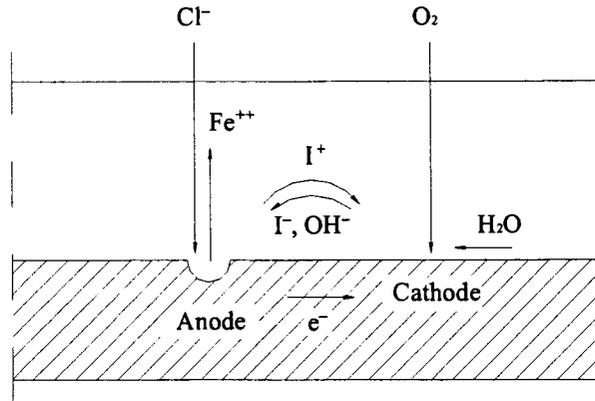
Figure 2.1 – Schematic of corrosion process.

The surface of the iron where oxidation occurs serves as an anode. The two free electrons, $2e^-$, created in the anodic reaction must be consumed elsewhere on the steel surface to preserve electrical neutrality. In other words, it is not possible for a large amount of electrical charge to build up at one location. Another chemical reaction must consume the electrons. Oxidation and reduction are coupled together as electrons are transferred between them. This reaction consumes water and oxygen.

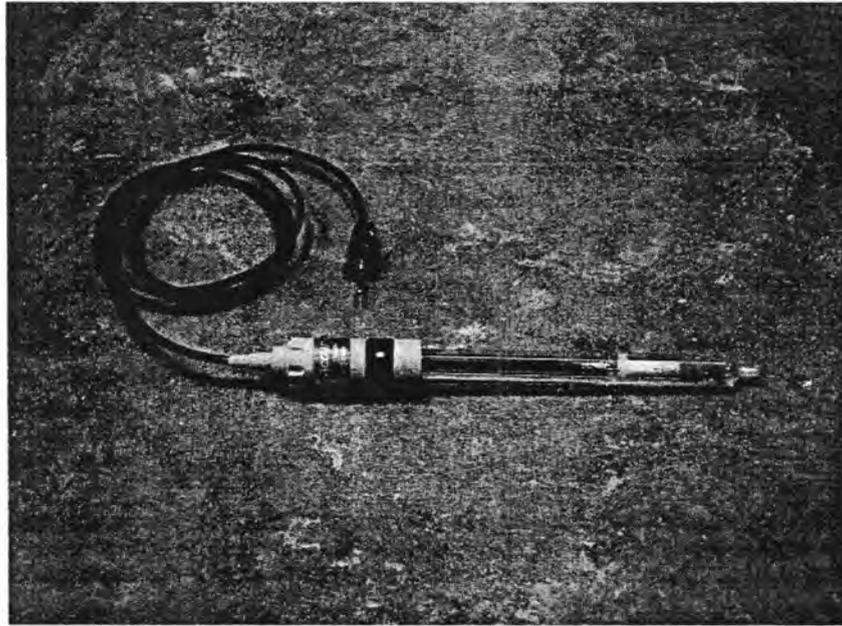
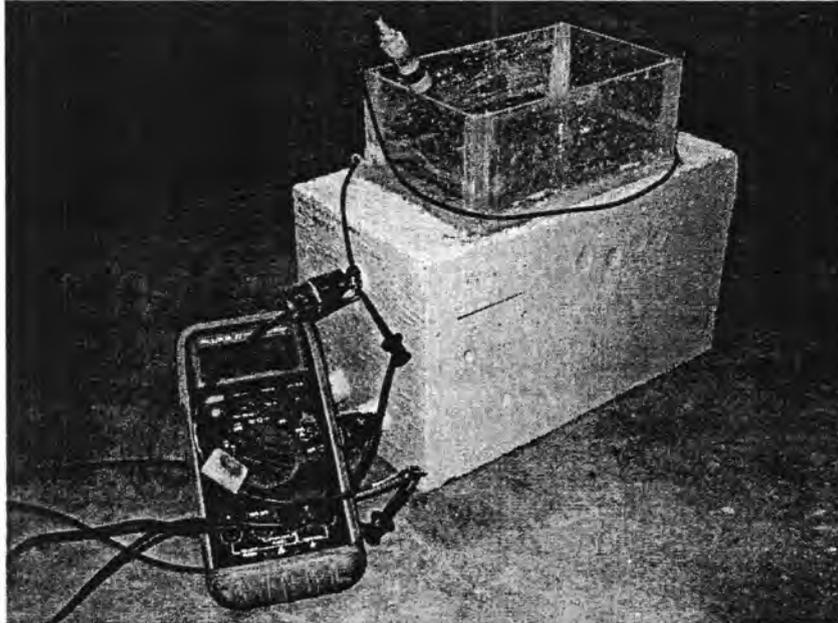
(a) – Saturated calomel reference electrode

(b) – Measure of half-cell corrosion potential for the top layer of reinforcement

Figure 2.2 – Half-cell corrosion potential monitoring method.

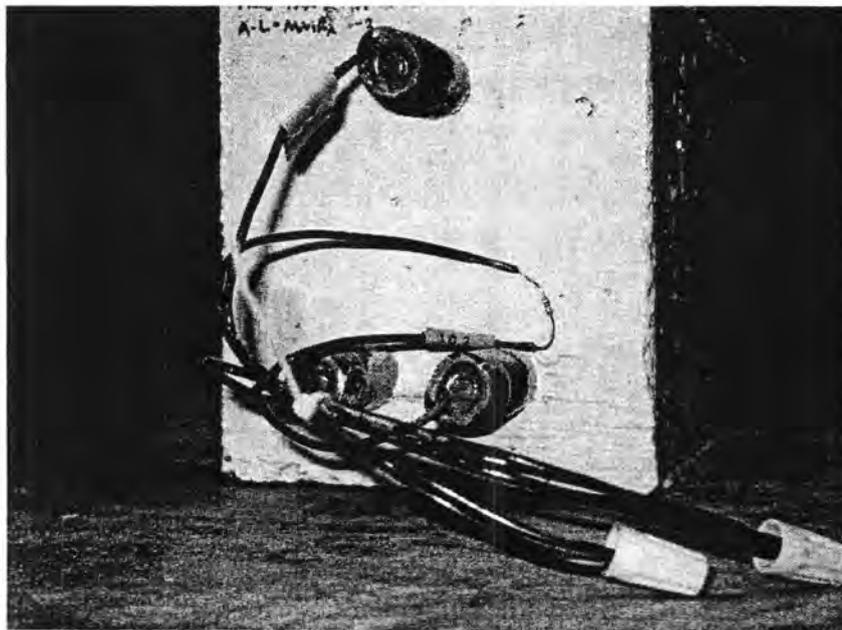
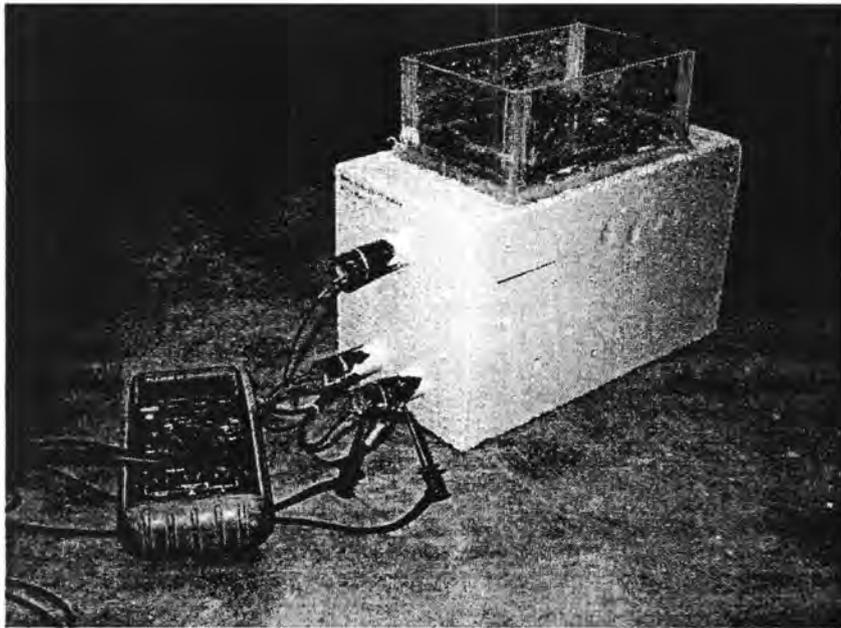
(a) – Top and bottom reinforcement layers connected via resistor

Figure 2.3 – Macrocell corrosion monitoring method.

(b) – Measurement of macrocell corrosion

In North America, the macrocell is used as a way of measuring the corrosion rate. The current flow between the top and bottom steel reinforcement layers is monitored from the measure of voltage across a resistor connecting the layers of reinforcement, as illustrated in Figure 2.3. By Faraday's Law, the mass loss rate (i.e., corrosion rate) is directly proportional to the monitored corrosion current.

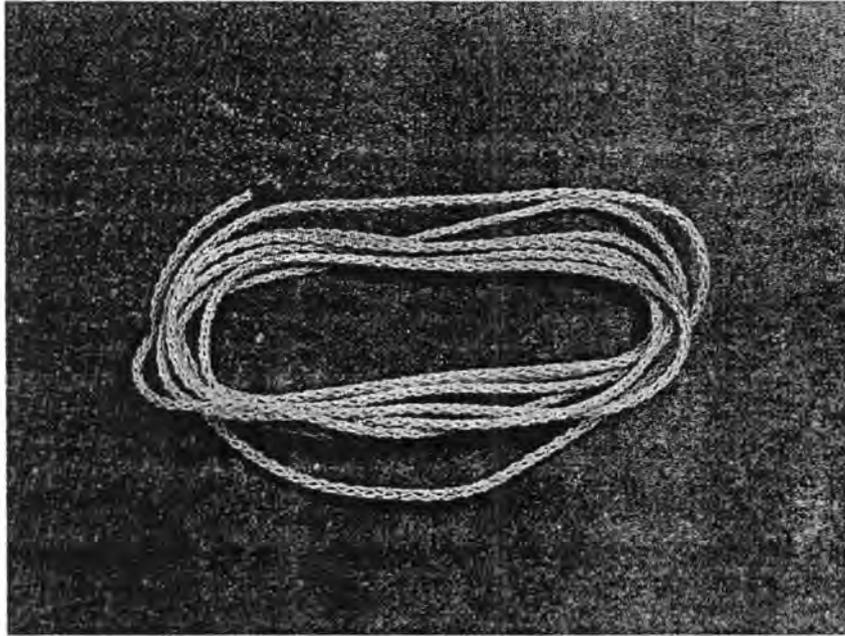
Figure 2.4 – CMS V2000 silver-silver chloride electrode.

However, while the electrochemical process of corrosion causes current through the flow of free electrons the V2000 electrode generates a second, independent current, as a function of the dissimilarity of the metals, the amount of moisture and chlorides present, etc. The two processes are additive.

By measuring the induced voltage and current, the corrosion risk and corrosion rate can be determined. This makes the V2000 electrode a viable, permanent embedded sensor for the long-term monitoring of bridge deck steel reinforcement.

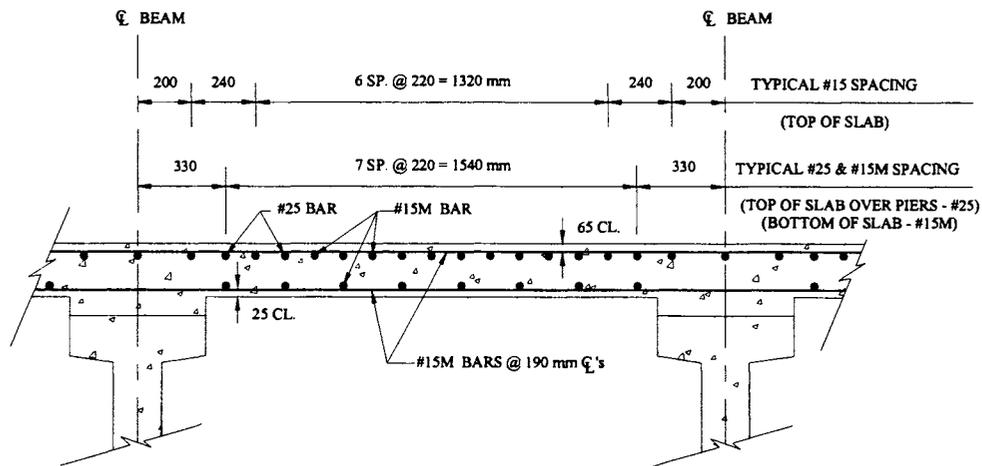
Figure 2.5 – Typical cross-section.

Both bridges were constructed identically. As shown in Figure 2.5, the top transverse reinforcement in both bridge decks was placed parallel to the top of the slab with a clear distance of 65 mm, while the bottom transverse reinforcing steel was placed parallel to the bottom of the slab with a clear distance of 25 mm. Approximately 50 mm of clear distance from the face of concrete to near reinforcing bar was used. The bridge deck is supported by five prestressed concrete beams spaced at 2,200 mm on center.

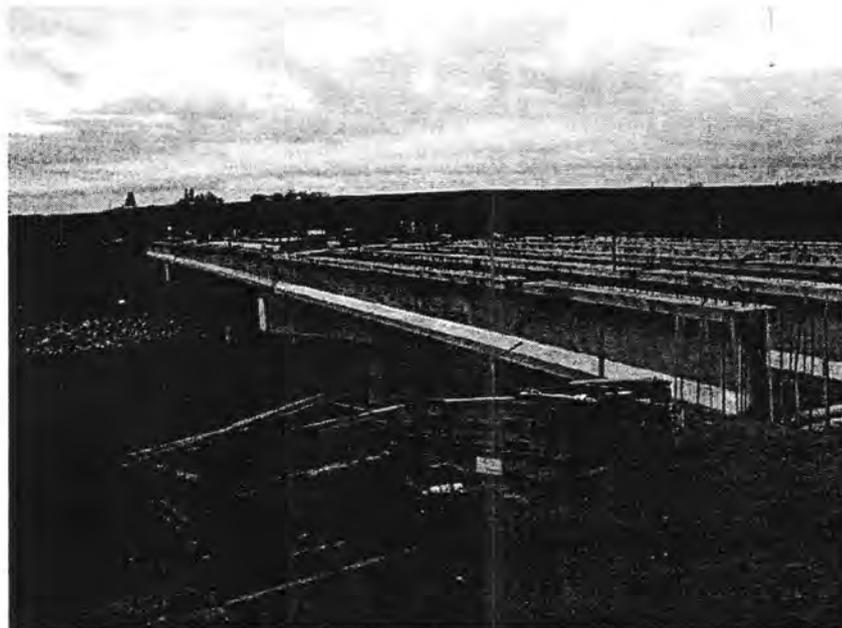
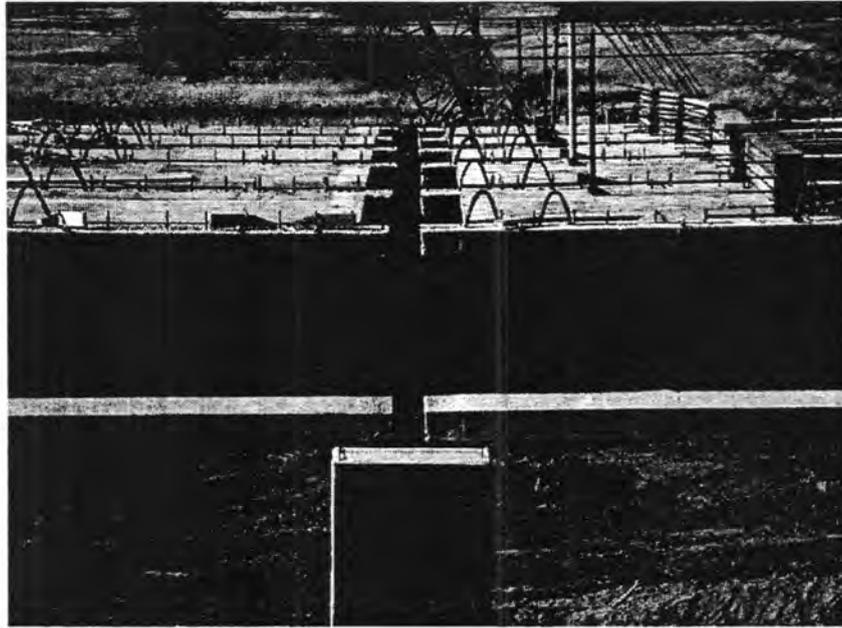
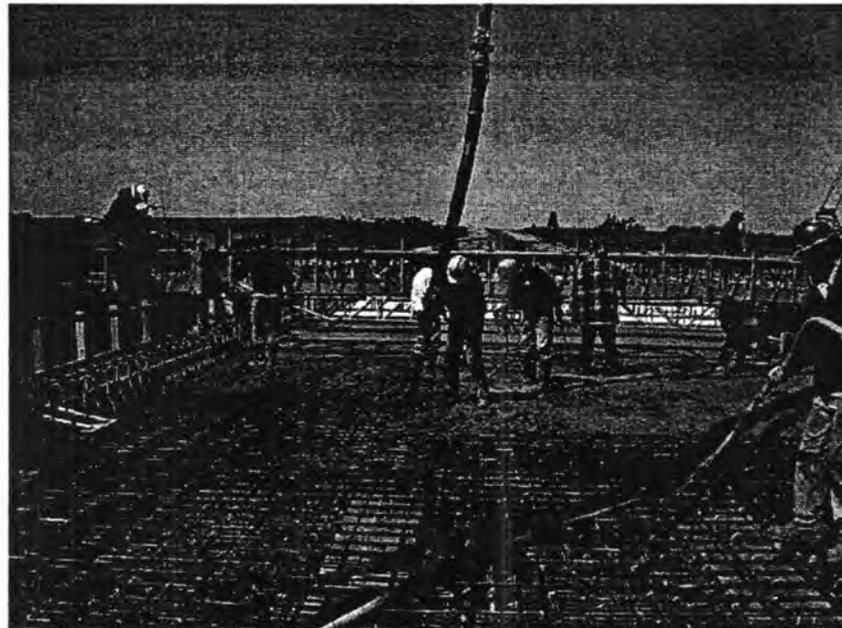
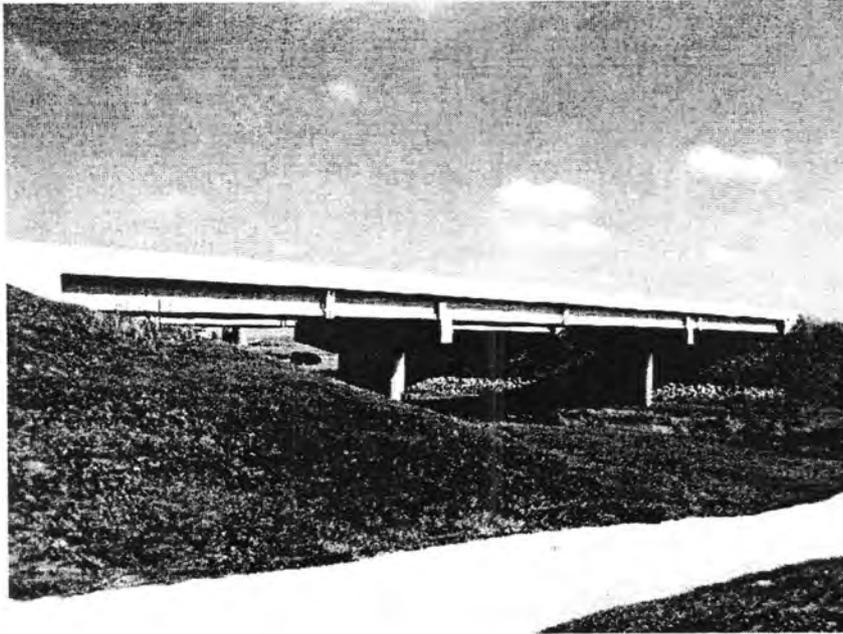
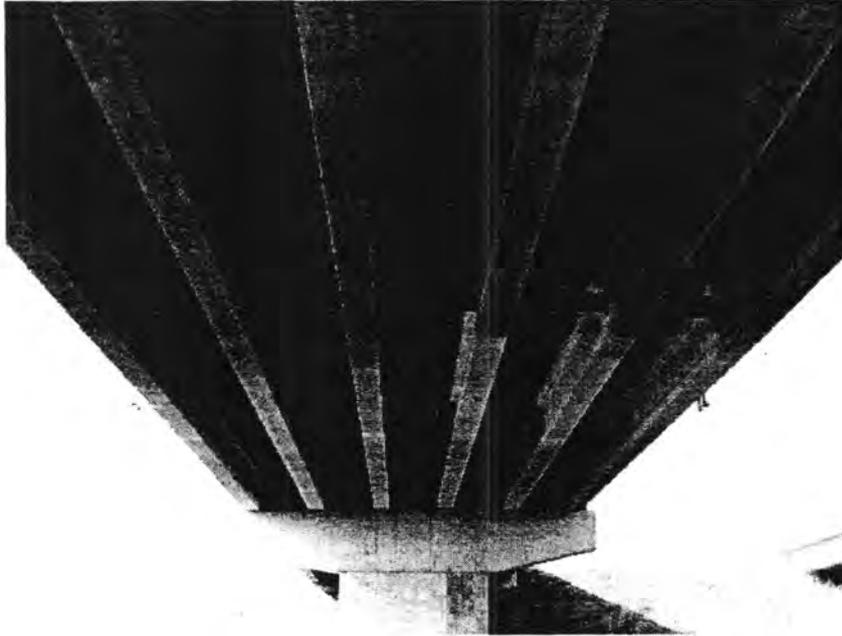
(a) – Side view of girders and piers

(b) – Typical girder connection at pier

(c) – Concrete placement for MMFX Bridge

(d) – Completed MMFX Bridge

(e) – Completed inner span and west pier

Typical photographs of subject bridges taken during construction through completion are shown in Figure 2.6. No special construction techniques were required for the MMFX Bridge. In fact, it appeared to be easier to construct the MMFX Bridge because special handling care was not needed, unlike the care needed to protect the epoxy coating on the bars in the Epoxy Bridge.

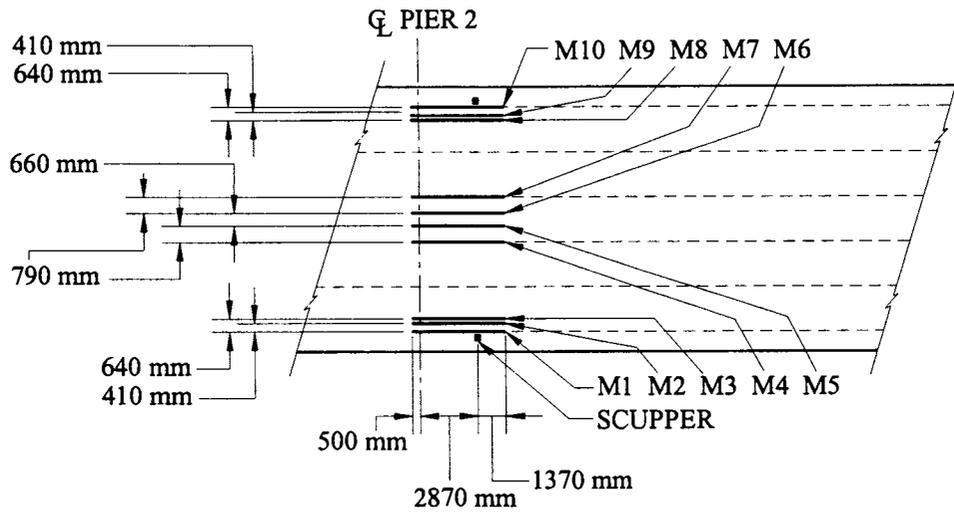
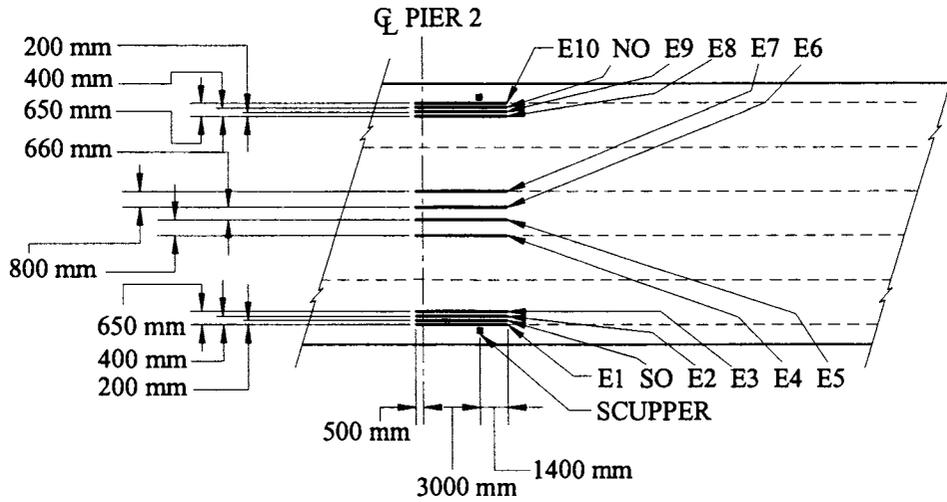
(a) – MMFX Bridge

(b) – Epoxy Bridge

Figure 2.7 – General locations of the V2000 electrode.

Twenty No. 25 top bars, 10 on each bridge (denoted M1 through M10 on the MMFX Bridge and E1 through E10 on the Epoxy Bridge) in the negative bending moment region near the eastern drainage points were instrumented. On the Epoxy Bridge, two additional short sections of MMFX reinforcement were each instrumented with an electrode and tied between other epoxy-coated reinforcement (one on the north side, denoted NO, and one on the south side, denoted SO) to compare with the epoxy-coated reinforcement within the same environment. The electrode locations within each bridge deck are shown in Figure 2.7.

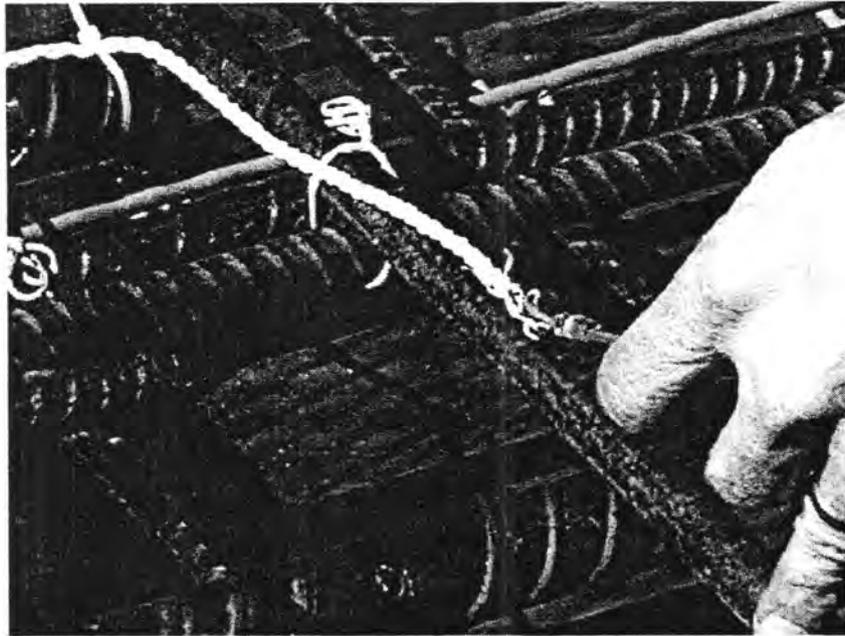
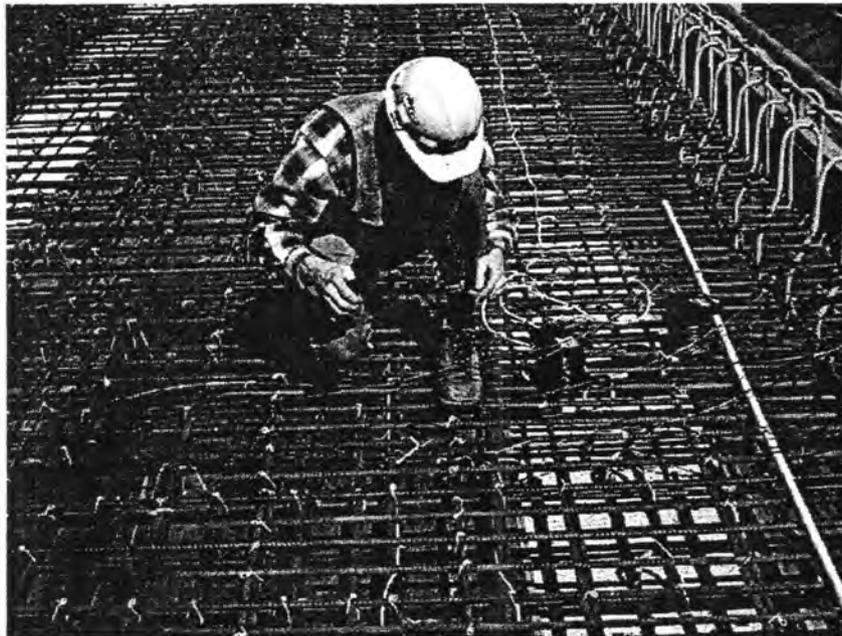
(a) – Connection of V2000 electrode to copper lead wire

(b) – Extending lead wires for future corrosion monitoring

Figure 2.8 – Typical photographs of the instrumentation installation.

The electrode sensors were wound around each bar for approximately a length of 4.6 m. Each electrode was connected to a red-sheathed copper lead wire with a protected butt splice, while a black-sheathed copper lead wire was attached directly to the bar using a stainless steel clamp. Both lead wires for each monitored bar were run out of the bridge deck and used to measure internal voltage and electrical current to assess corrosion development.

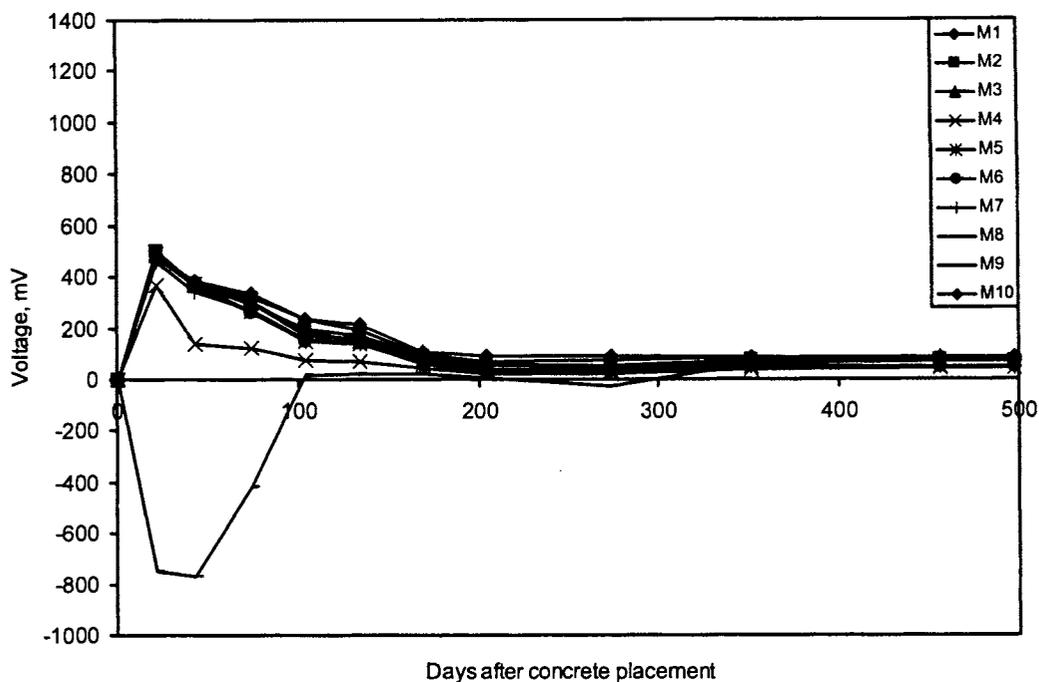
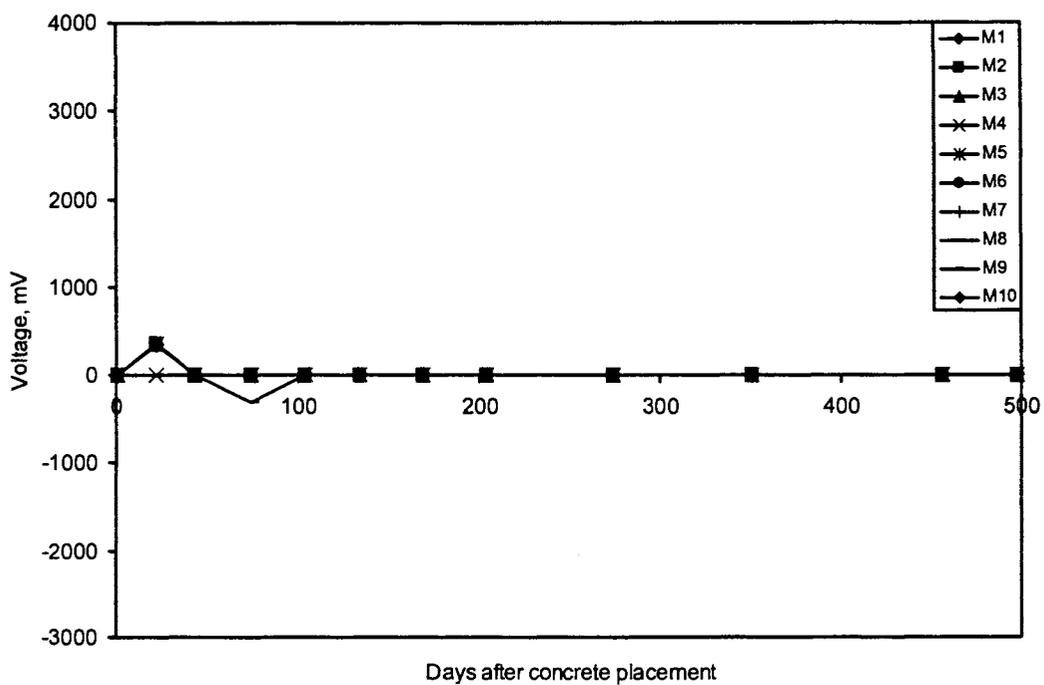
(a) Internal voltage

(b) Electrical current

Figure 2.9 – Measurements from V2000 electrode instrumented on the MMFX Bridge.

Figures 2.9 and 2.10 show the internal voltage and electrical current measurements, respectively, for all instrumented steel reinforcement in both bridge decks.

All of the MMFX Bridge measurements appear as expected. Although the voltage increased above 400 mV initially, normal levels were measured after the concrete cured. Even while the voltage increased above 400 mV, the current remained below 1000 μA (i.e., indication of weak site of corrosion). Approximately 84 days (12 weeks) after concrete placement, all voltage levels for the MMFX Bridge dropped steadily and remained less than 100 mV. After 490 days (70 weeks) of monitoring, there is no indication of corrosion activity.

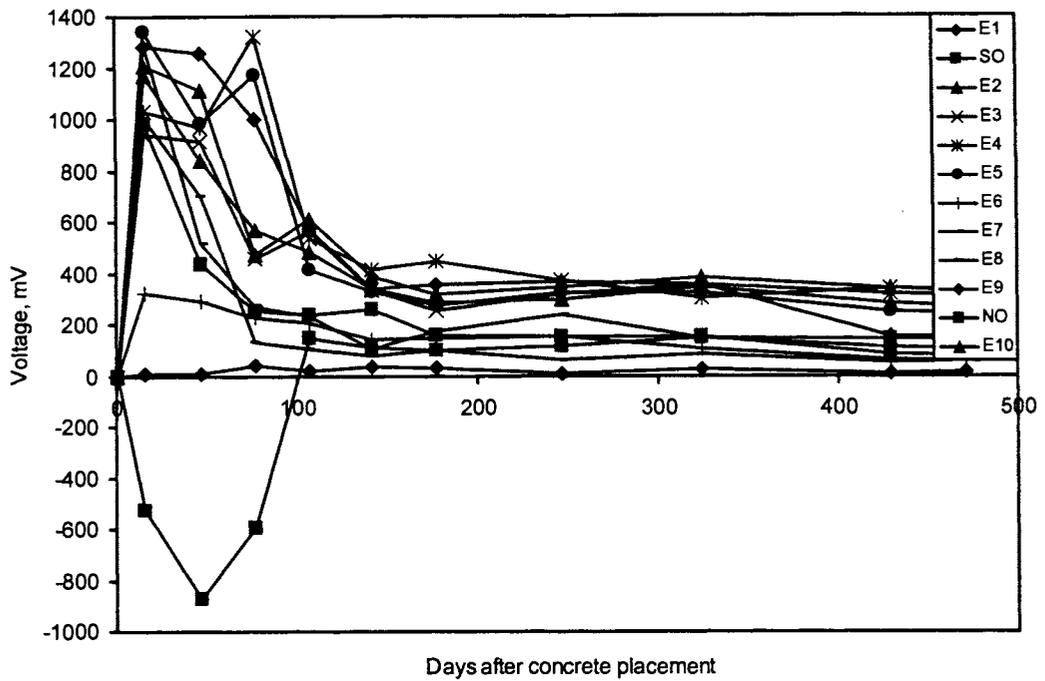
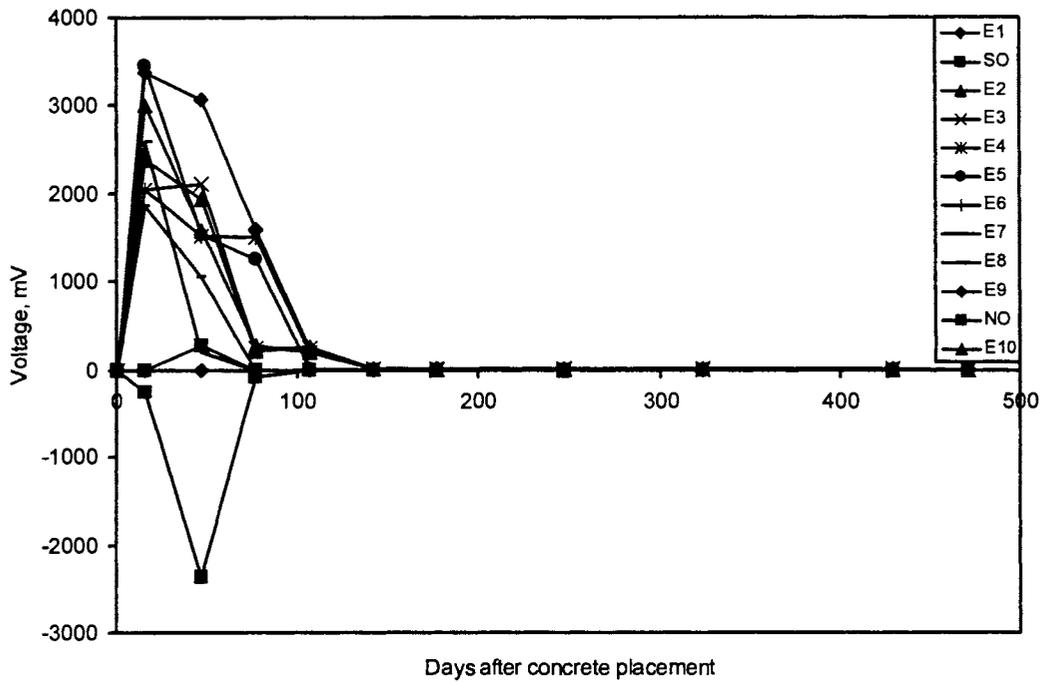
(a) – Internal voltage

(b) – Electrical current

Figure 2.10 – Measurements from V2000 electrode instrumented on the Epoxy Bridge.

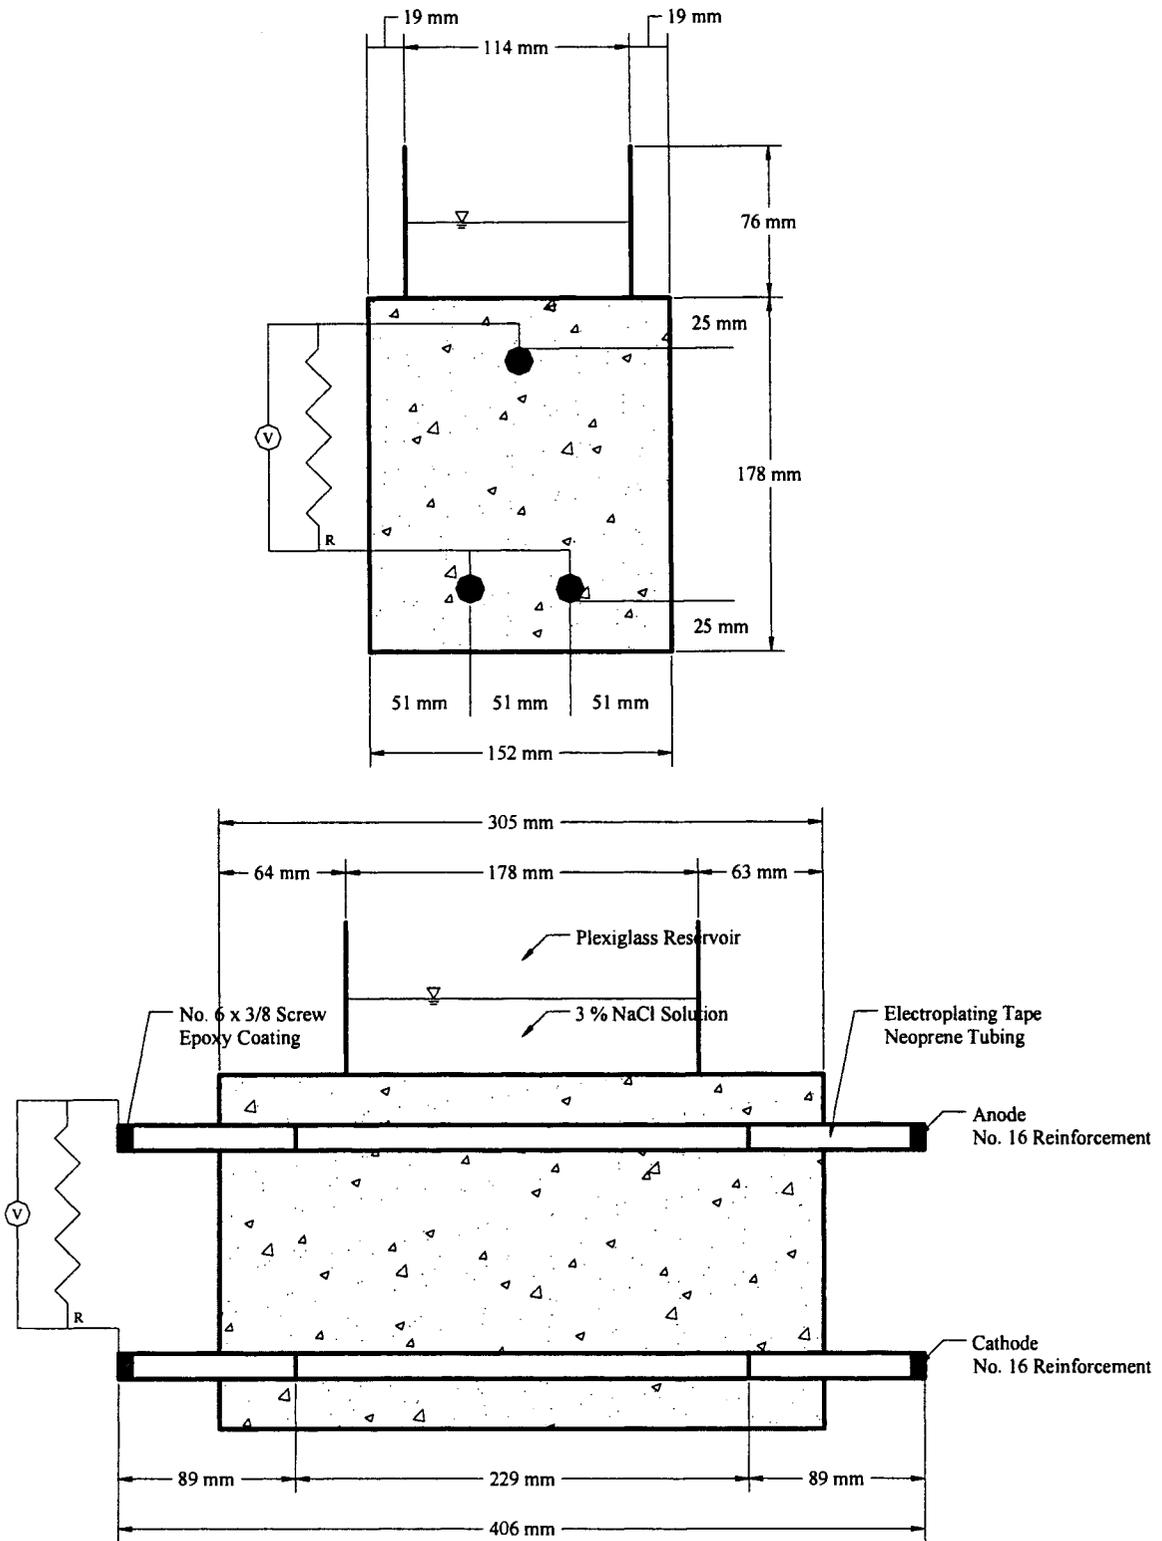
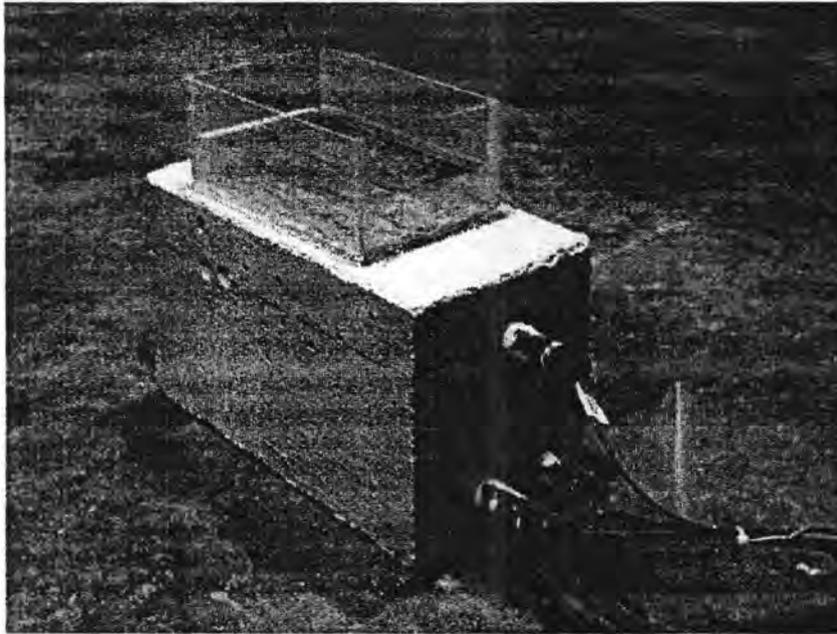
(a) – Schematic of ASTM G 109 ACT

Figure 3.1 – Schematic of ASTM G 109 accelerated corrosion test specimen.

(b) – Typical as-constructed ASTM G 109 ACT

The 22 ASTM ACT concrete beams were cast in a single set of formwork. As illustrated in Figure 3.1, the beams were cast 152 mm (6 in.) in width, 178 mm (7 in.) in height, and 305 mm (12 in.) in length. The forms were constructed with holes in the appropriate locations to position the No. 16 (No. 5) reinforcement to maintain exactly 25 mm (1 in.) of clear cover.

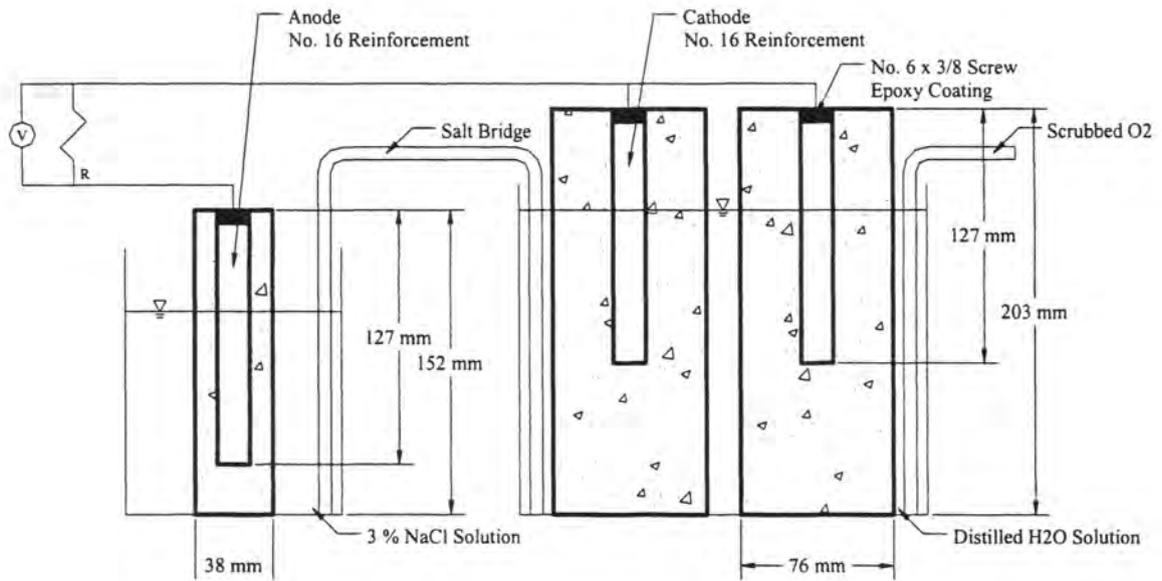
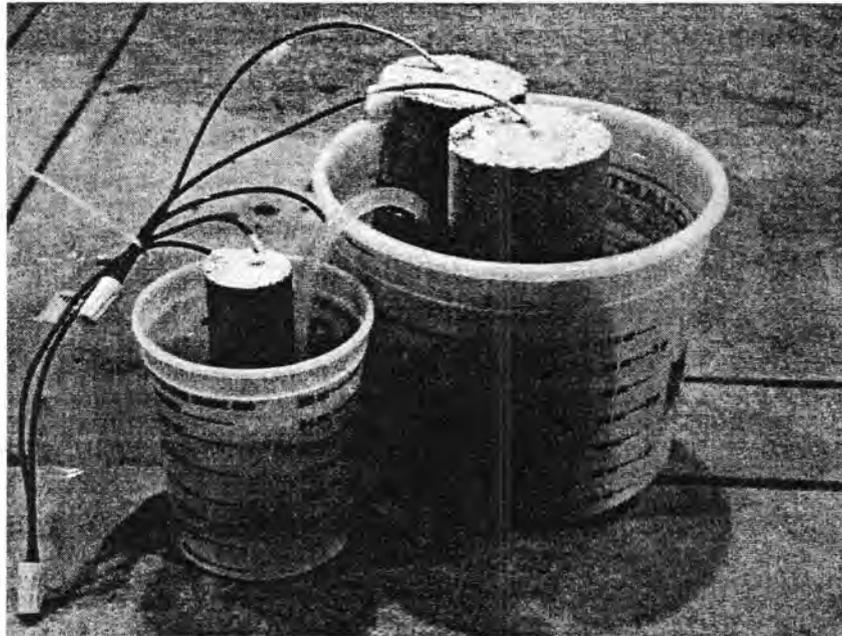
(a) – Schematic of Rapid Macrocell ACT

(b) – Typical as-constructed Rapid Macrocell ACT

Figure 3.2 – Schematic of Rapid Macrocell accelerated corrosion test specimen.

As illustrated in Figure 3.2, No. 16 (No. 5) reinforcement was cut to a length of 127 mm (5 in.) for the Rapid Macrocell ACT. One end of the reinforcement was then drilled to a depth of 13 mm (1/2 in.) to accommodate a self-tapping No. 6 x 3/8 stainless steel sheet metal screw and both ends were ground removing sharp edges. The bars were then soaked in hexane to remove grease, dirt, and hydraulic fluid from the surface, and dried at room temperature. The end of the epoxy-coated reinforcement that was to be submerged was protected using 3M Scotchkote 413/215 PC Patch Compound two-part epoxy.

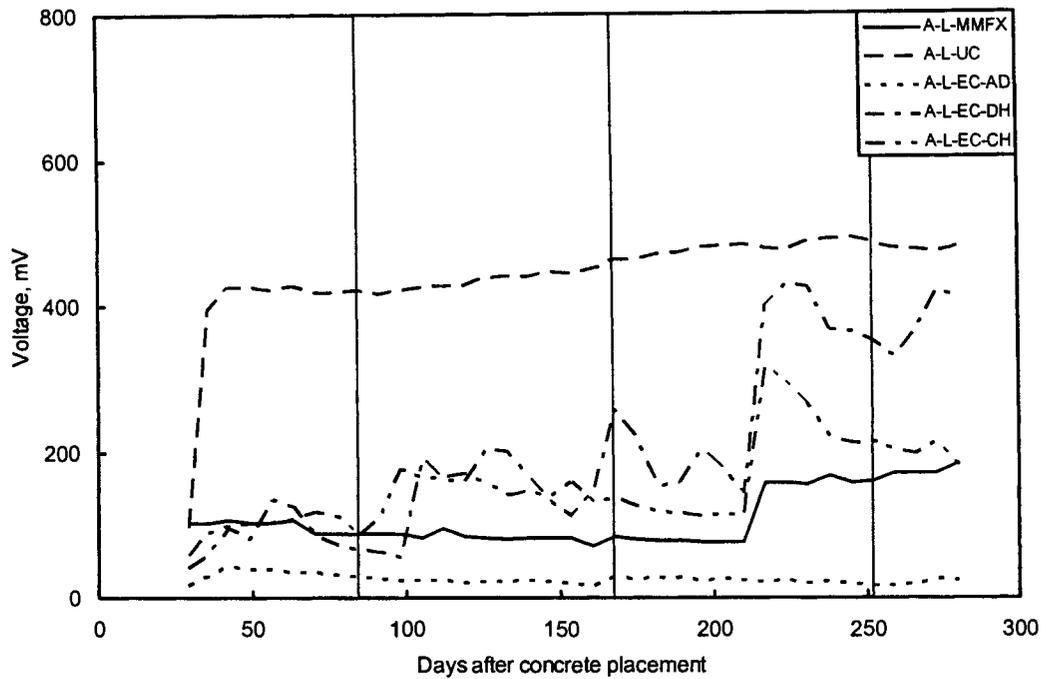
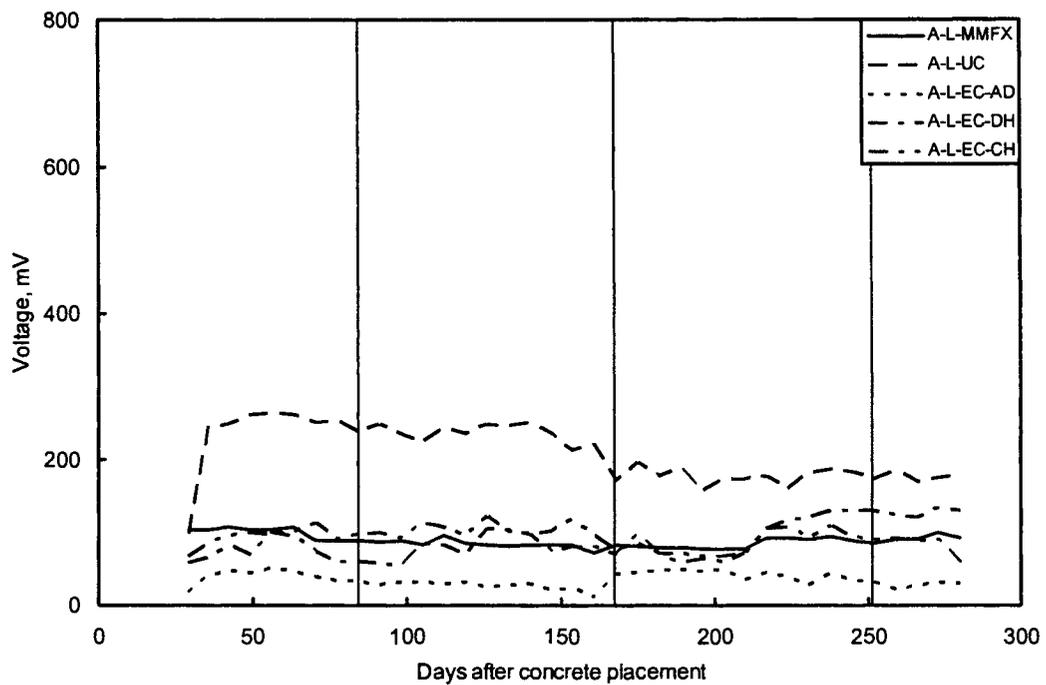
(a) – Corrosion risk of the top layer of steel reinforcement

(b) – Corrosion risk of the bottom layer of steel reinforcement

Figure 4.1 – ASTM G 109 ACT subjected to 3 % NaCl solution through longitudinal crack.

The corrosion potential for the top layer of reinforcement (anode) for the MMFX reinforcement with longitudinally cracked specimens remained at a relatively constant value of 100 mV through 217 days (31 weeks). At 217 days, a single MMFX specimen began corroding which caused the rapid increase and continued increase to 183 mV through 280 days (40 weeks).

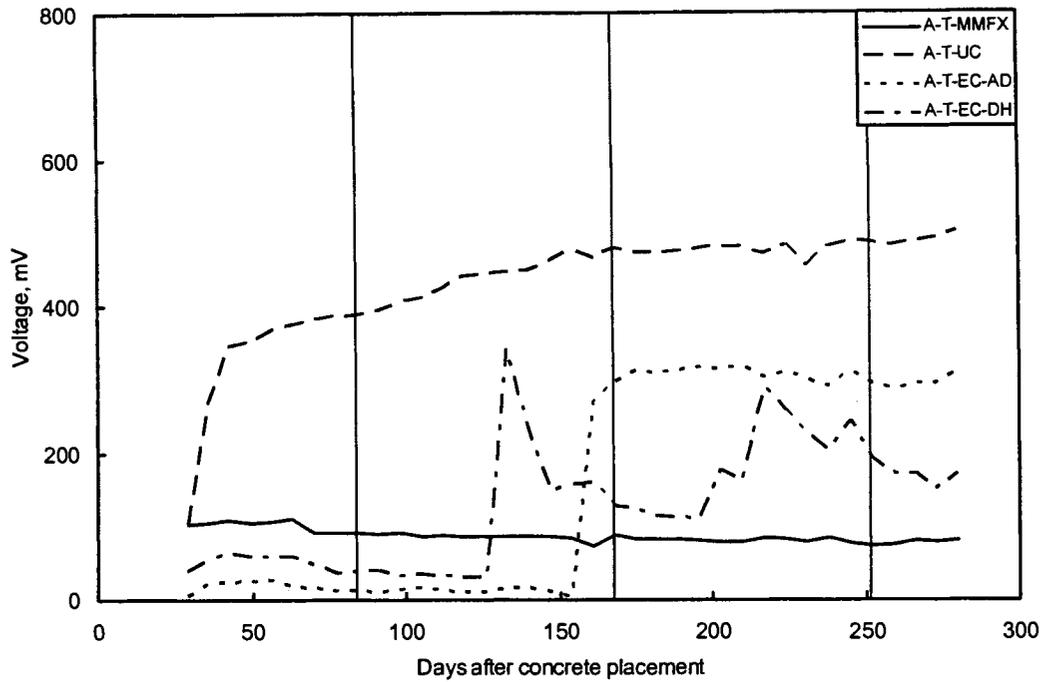
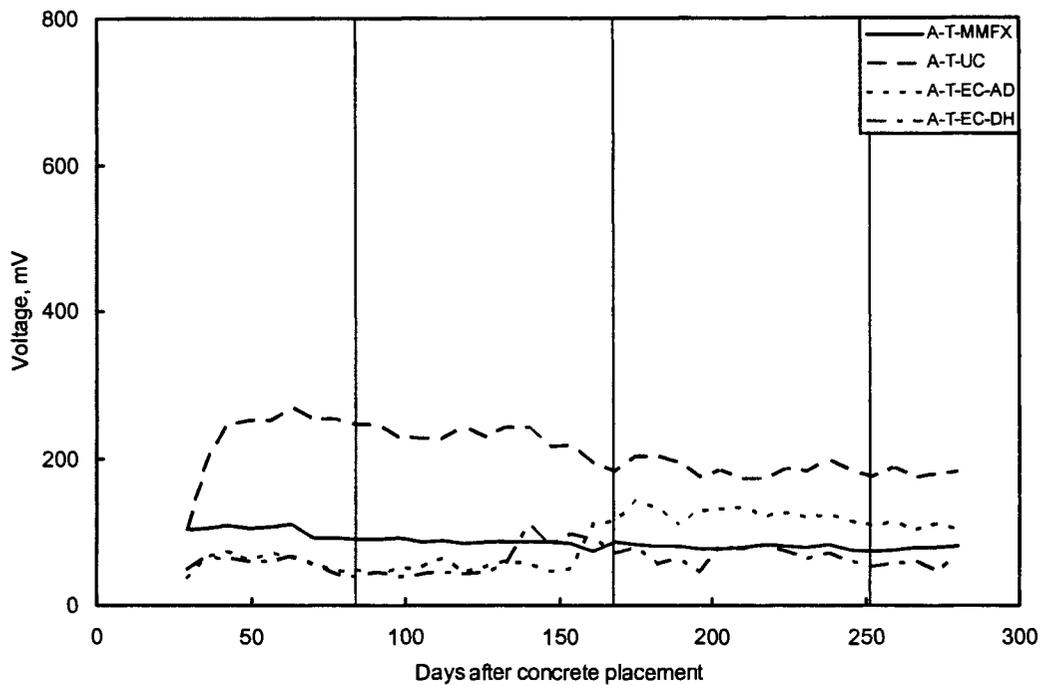
(a) – Corrosion risk of the top layer of steel reinforcement

(b) – Corrosion risk of the bottom layer of steel reinforcement

Figure 4.2 – ASTM G 109 ACT subjected to 3 % NaCl solution through transverse crack.

Similar to the longitudinally cracked specimens, the corrosion potentials for all the uncoated reinforcement specimens with transverse cracks increased beyond 276 mV by 35 days (5 weeks). By 98 days (14 weeks), the uncoated specimens experienced a corrosion potential value greater than 400 mV and continued to rise to 501 mV through 280 days (40 weeks), indicating a continued severe risk for corrosion.

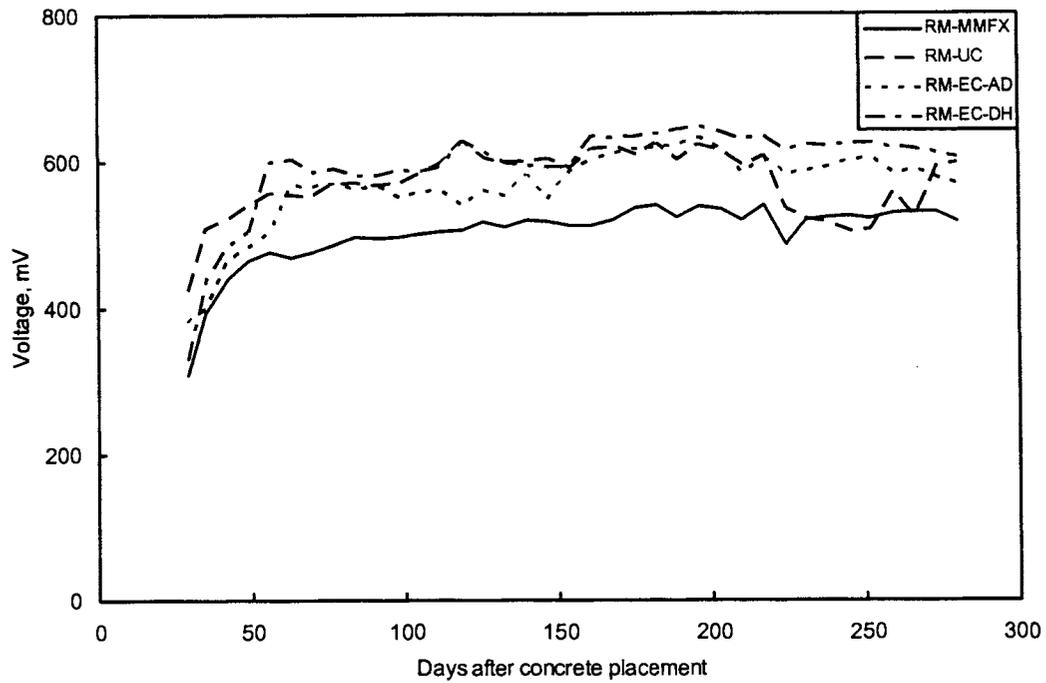
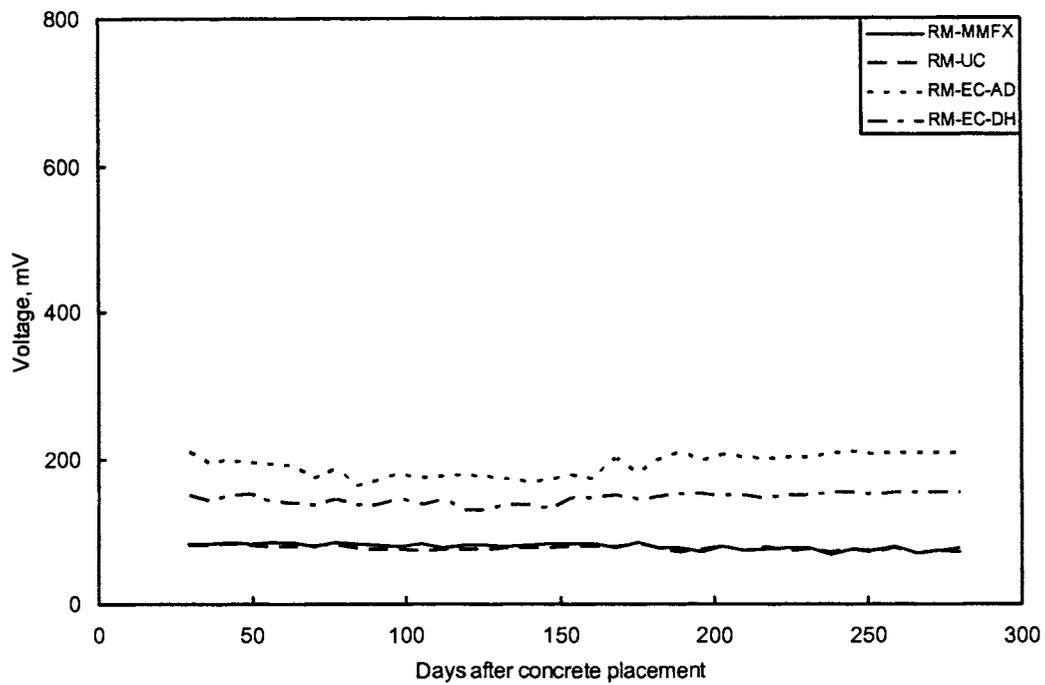
(a) – Corrosion risk of the top layer of steel reinforcement

(b) – Corrosion risk of the bottom layer of steel reinforcement

Figure 4.3 – Rapid Macrocell ACT subjected to 3 % NaCl solution.

The 280-day (40-week) average corrosion potentials for the anode (reinforcement in the container with sodium chloride solution) and cathode (reinforcement in the container with distilled water) steel reinforcement are shown in Figure 4.3.
