Investigation of steel stringer bridge superstructures

Major: Civil Engineering (Structural Engineering)

Iowa State University

2008

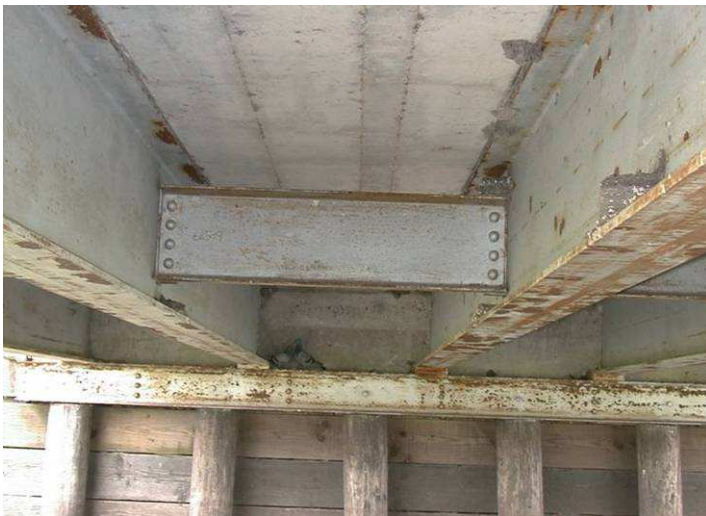
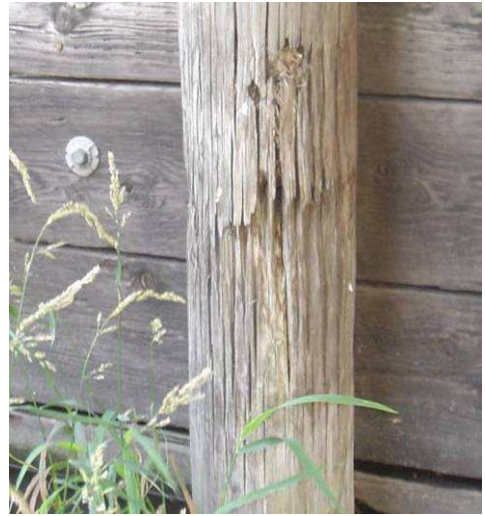
Figure 3.4. BCB Deterioration.

The superstructure appears to be in good condition with some minor rust in areas as shown in Figure 3.4(a). Typical decay that was found in some of the piles is shown in Figure 3.4(b). There were minor repairs made to the bridge in 1993 when the south bridge approach was washed away; the repairs consisted of the installation of a sheet pile wall behind the existing timber back wall and then filling the void with concrete. Shown in Figure 3.5(a) is the sheet pile wall while the concrete behind the top of the timber backwall is shown in Figure 3.5(b).

(a) Minor rust on girders

(b) Rotten pile

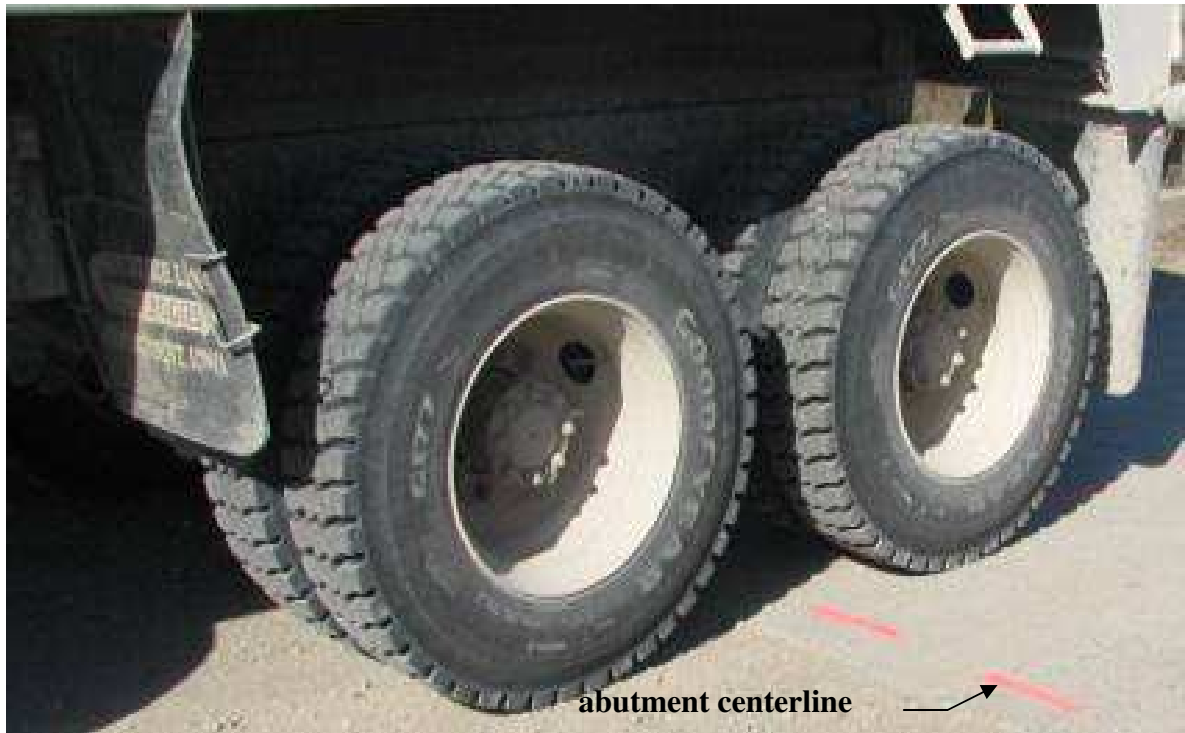
Figure 3.11. BCB Truck Tandem Centroid Centered Over Abutment.

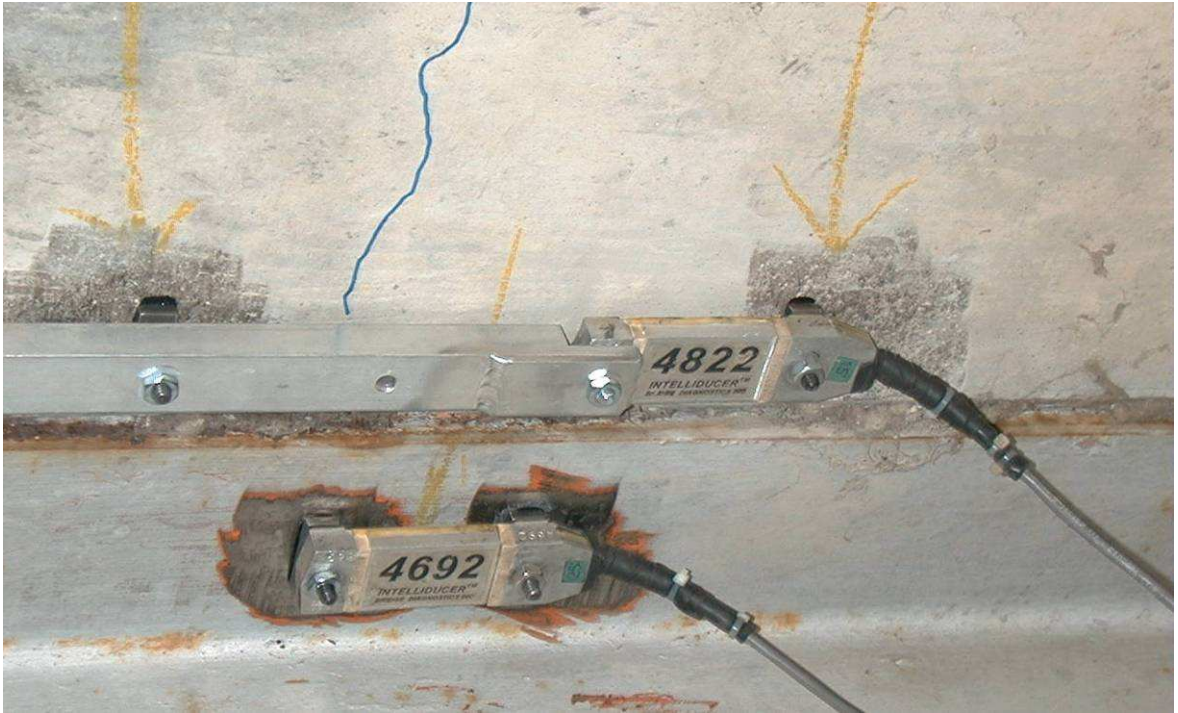
Figure 3.15. Concrete and Steel Mounted Transducers at Midspan of BCB.

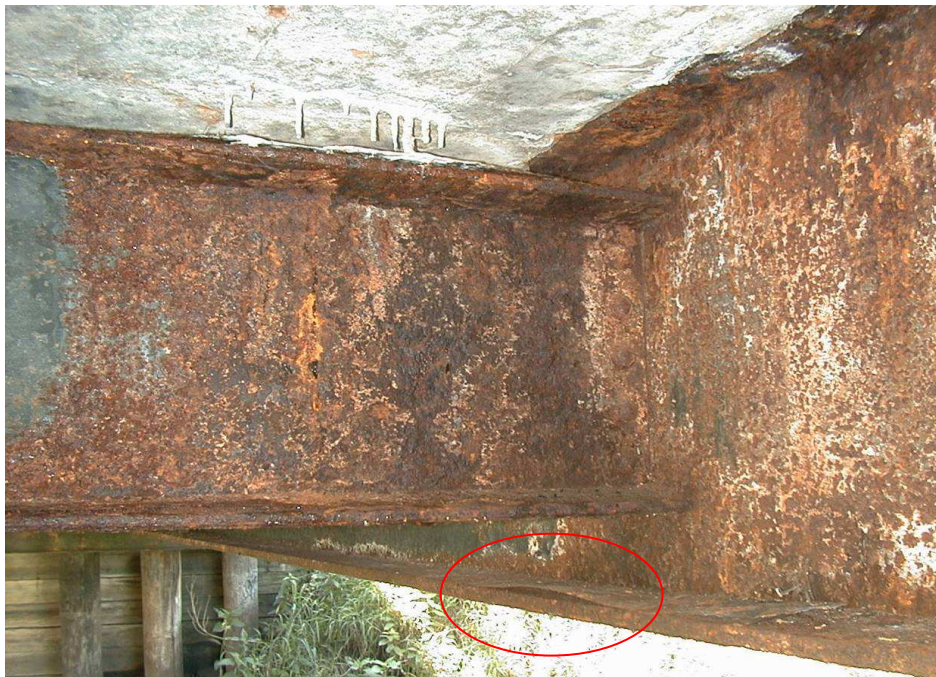
Figure 4.2. MCB Girder 2 Deterioration and Delamination.

The asphalt overlay, which was heavily cracked and trapped water between the concrete deck and the overlay, also caused some major deterioration in the concrete deck. On this bridge, with the average daily traffic around 940 (2001), the repeated loading and the trapped water caused about two inches of the concrete deck to completely deteriorate. During the bridge inspection, three coring holes shown in Figure 4.3, were noticed; only one of the cores continued all the way through the concrete deck.

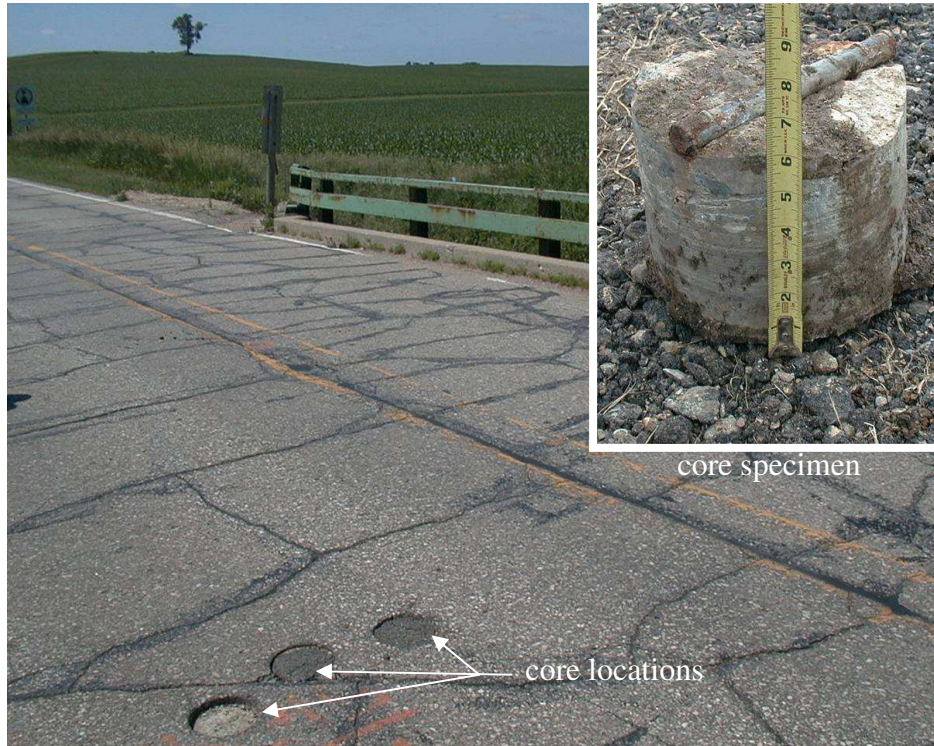
Figure 4.3. MCB Core Locations and Retrieved Core Specimen.

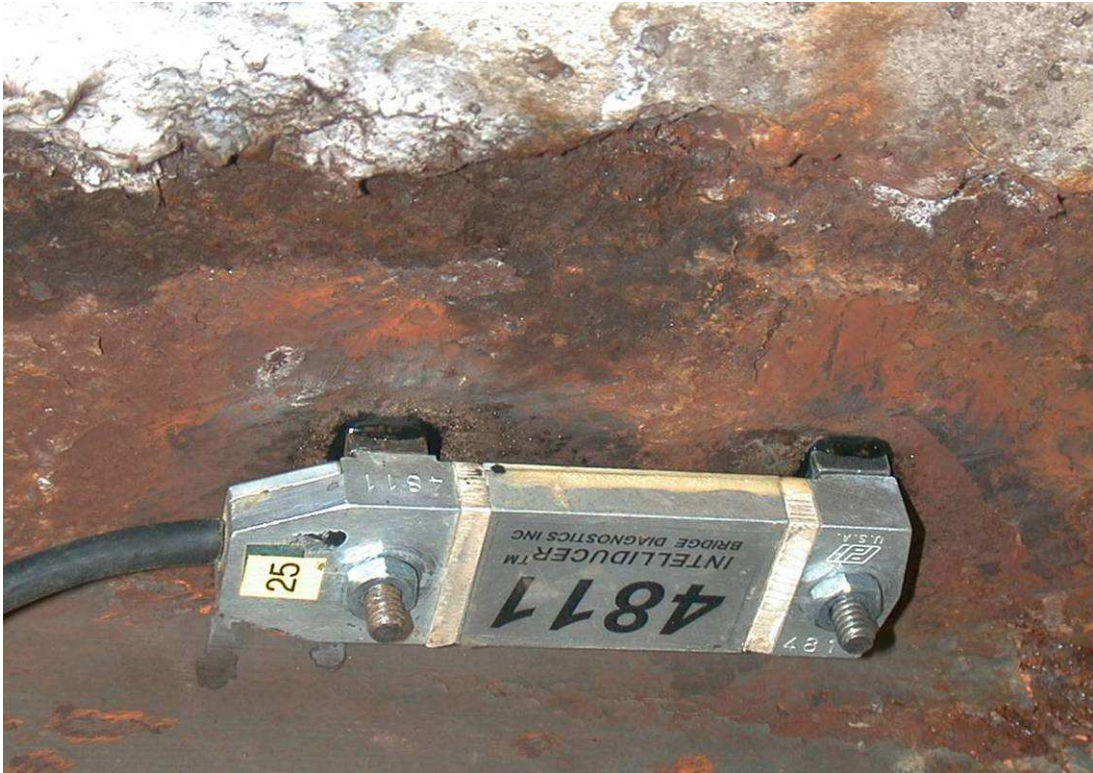
Figure 4.11. MCB Removal of Excess Corrosion for Transducer Application

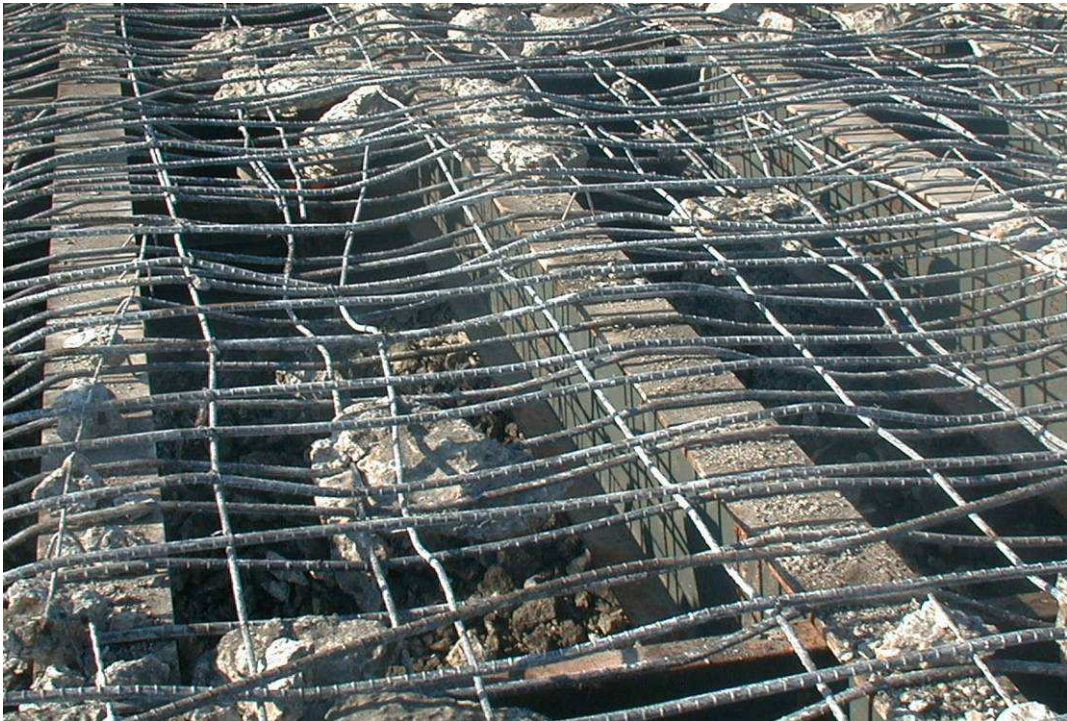
Figure 4.17. Exposed Top Flanges After MCB Deck Demolition.

creating the composite action even though no such a connection appeared on the plans provided. Approximately two weeks after testing this bridge it was removed and replaced with a new bridge. The bridge demolition provided little explanation as to why this composite action occurred as the top flanges were completely free of any kind of mechanical shear connector as shown in Figure 4.17.

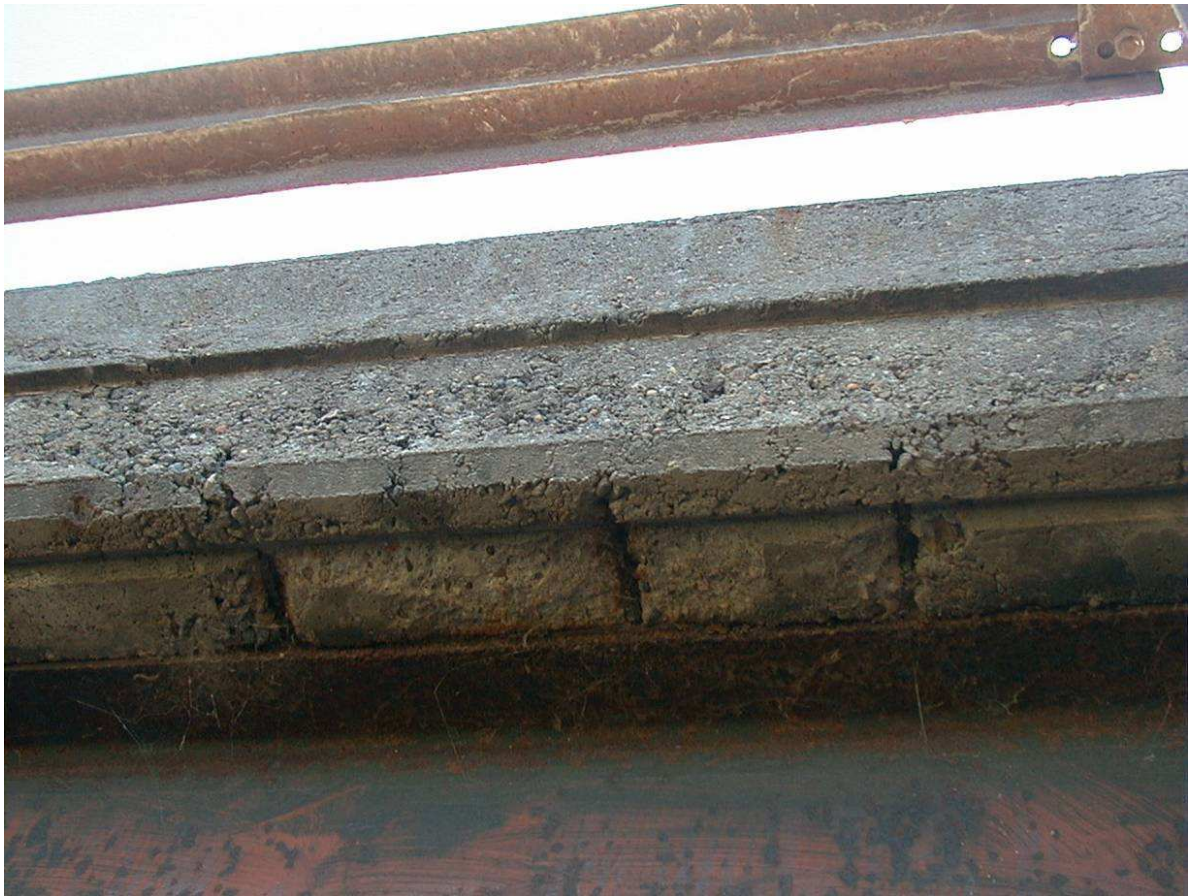
Figure 5.2. KCB1 Poor Concrete Consolidation.

The superstructure was in relatively good condition with only minor rust on the girders. Signs of poor concrete consolidation during the construction of the deck were observed on the underside of the deck where there were large voids near the midspan. The poor consolidation caused some of the reinforcing steel to be exposed as shown in Figure 5.2. There was also a large crack in the concrete deck located at the midspan of the bridge, a photograph of which is provided in Figure 5.3.

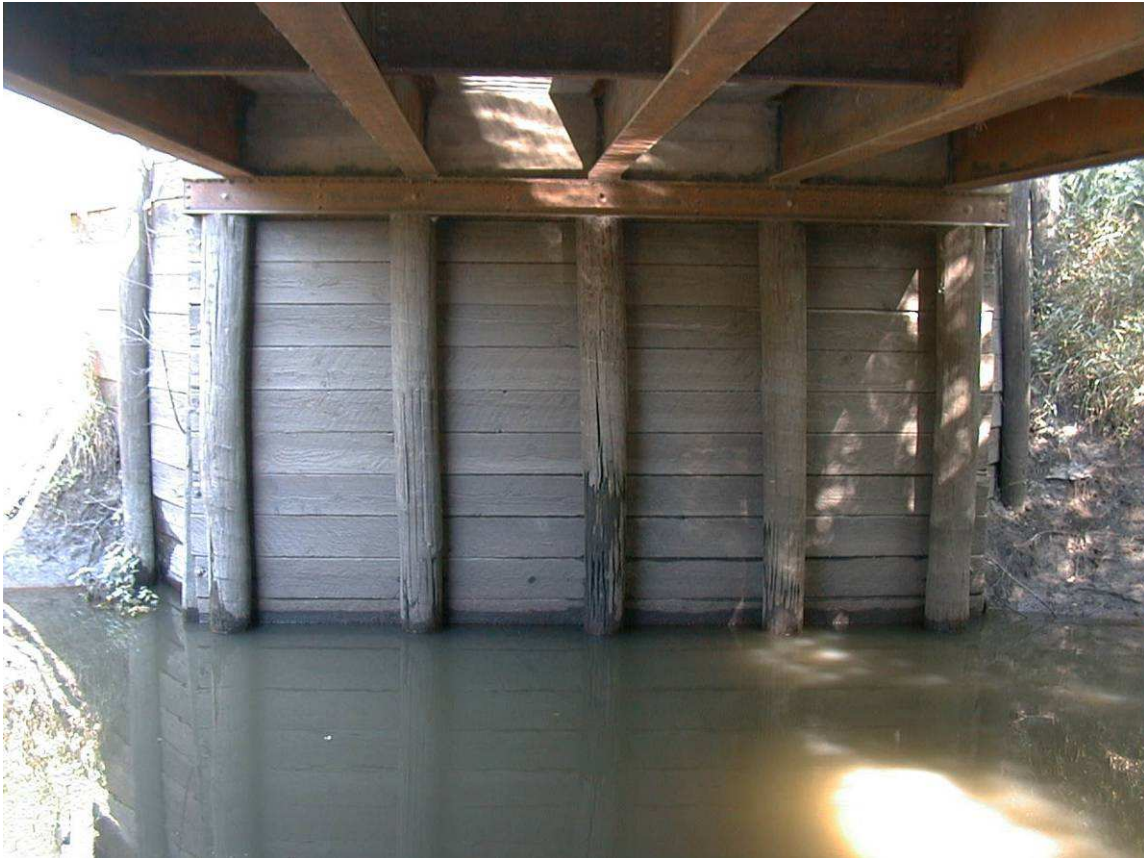
Figure 7.2. KCB2 Pile Deterioration.

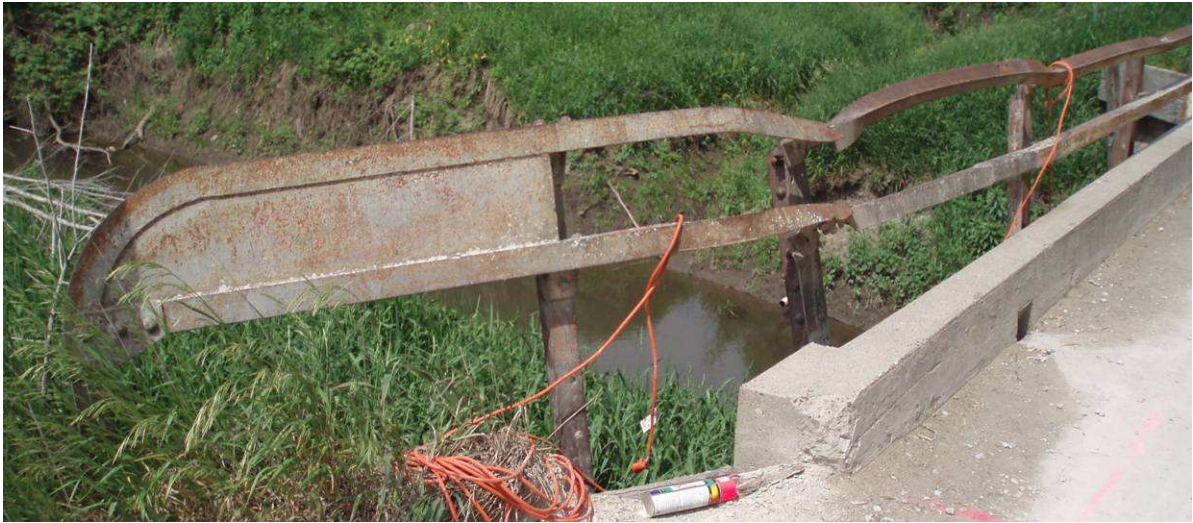
Figure 7.3. KCB2 Railing Damage.

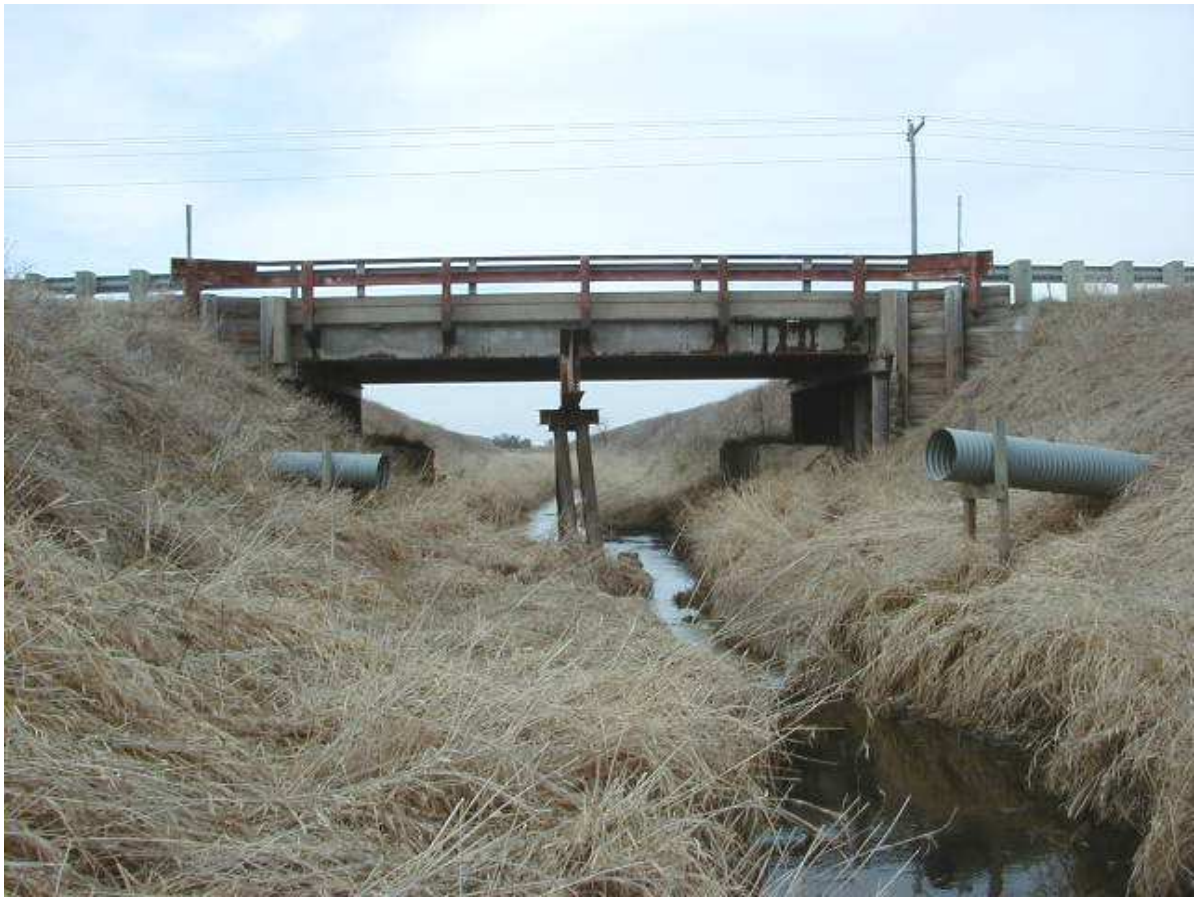
Figure 8.2. HCB Elevation View of Bridge Looking North.

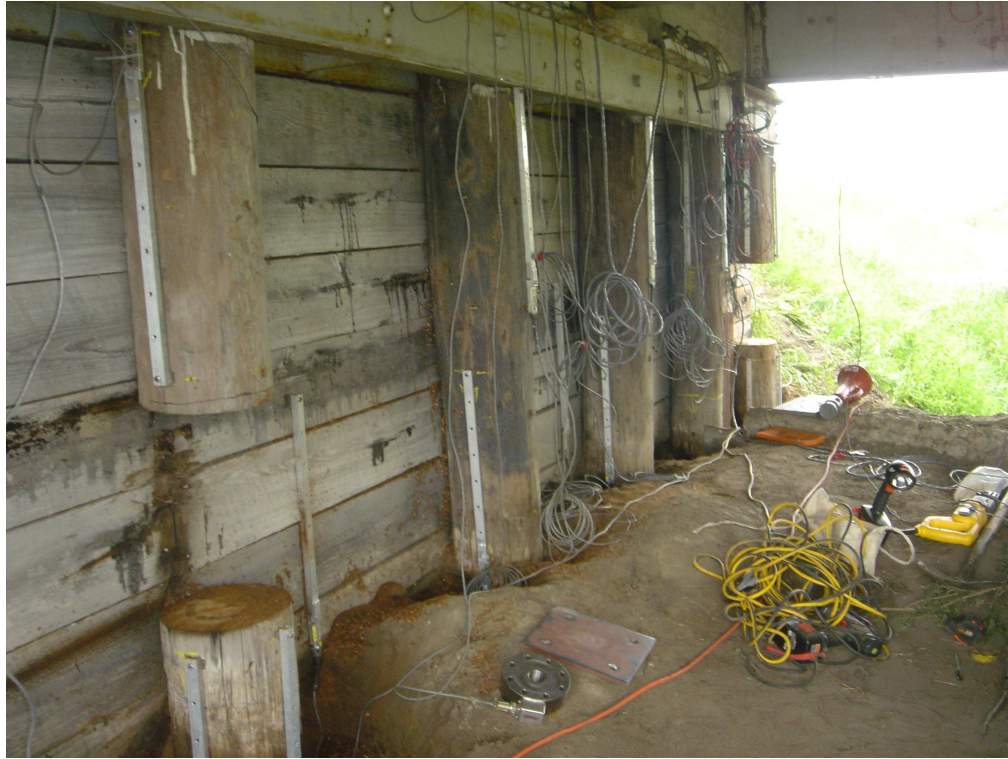
Figure 8.22. Photograph Showing Sections of Piles 3 and 7 Removed from HCB.

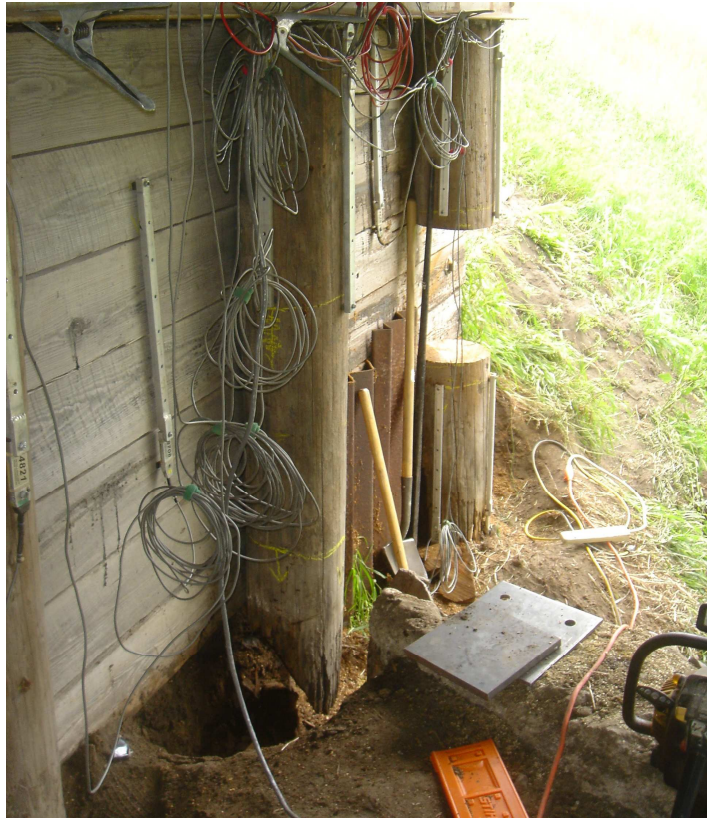
Figure 8.23. Photograph Showing Sections of Piles 6 and 7 Removed from HCB.
