R. H. Brockelman
 Army Materials and Mechanics Research Center
 Watertown, Massachusetts 02172

ABSTRACT

Fig. 1. Defect seeding plan for hot-pressed silicon nitride billets.

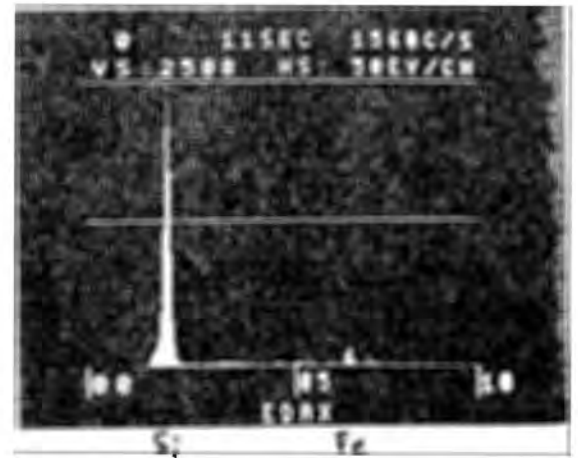
SiC No. 1 Billet, coarse size iron inclusion, defect number (DN) 1.

SiC No. 2 Billet, medium size carbon inclusion, defect number (DN) 1, test temperature 1371°C.

Fig. 11. C-scan (above), scanning electron microscope view of inclusion at fracture origin, 50X, (middle) and photograph of electron microprobe display (below) of silicon carbide bend bars.

Figures 10 and 11 contain examples of individual C-scans of rough-cut bend bars sectioned from the billets and the subsequent microscope analyses of defects contained within the corresponding bend bars. The latter includes photomicrographs of the fracture initiating defect and a photograph of the display of the energy dispersive microprobe. The photomicrographs are oriented such that the thickness direction of the bend bar corresponds to the vertical direction of the page. The C-scans were made from both the front and back sides of the bars. In addition to the two dimensional displays of the defect positions (in plane of paper), the depth (in direction perpendicular to plane of paper) of the defects are tabulated, as determined by the method of detection. Depths are measured relative to the back surface of the bar. The following abbreviations are used in the C-scans:
