An ASABE Meeting Presentation
Paper Number 096307

Daily Cleaning Options for Sloped Manure Pits in Swine Finishing

Abstract. Two technologies were evaluated for daily manure removal in shallow, sloped pits in swine finishing facilities. The criteria included cleaning ability, initial cost, and water usage.

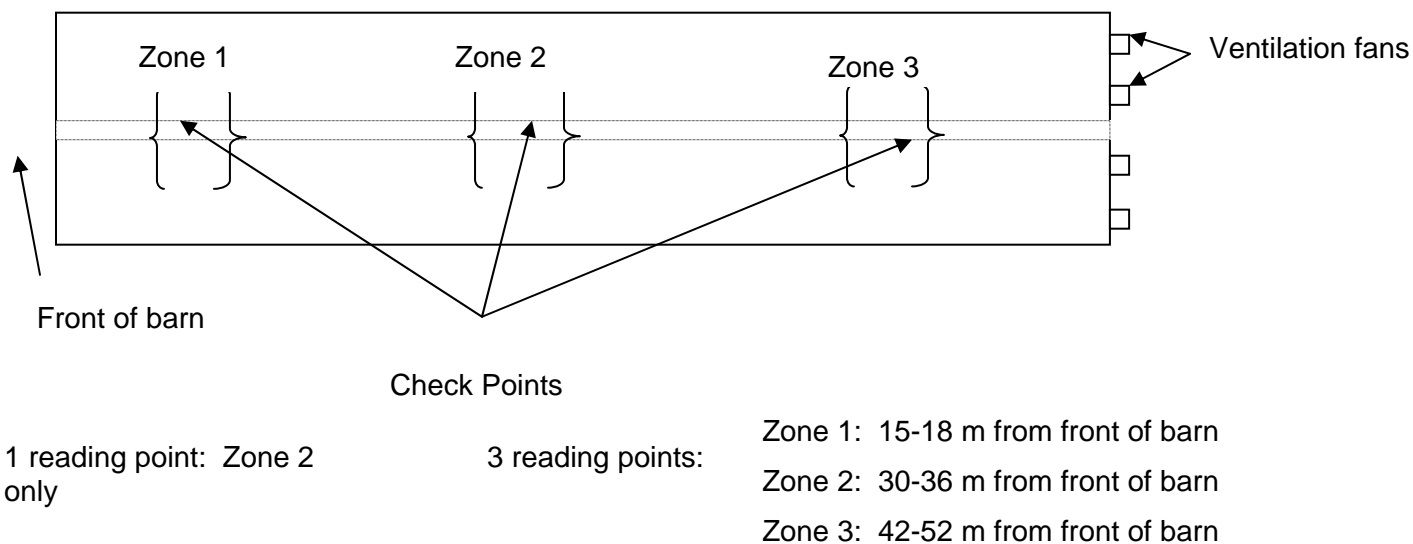
Figure 1. Layout of sampled finisher barns.

The facilities each were designed as a tunnel ventilated 1100 head finishing barn and measured 14.5 m by 60.6 m. They were previously flushed using automatic flush valves in 4 gutters running the length of the building. These barns were built on a 1.5% slope; therefore the pit was a uniform depth but built on a slope. The alternative manure systems were installed in a series of similar barns at Premium Standard Farms in the fall of 2008. Two 1100 head commercial grower-finisher rooms were used over two production cycles.

Table 3. Air quality measurements in sampled barns. The scraper system was in barn 6 and the flush tank barn in 7. From Figure 1, Front = Zone 1, Middle = Zone 2, and End = Zone 3 were averaged.

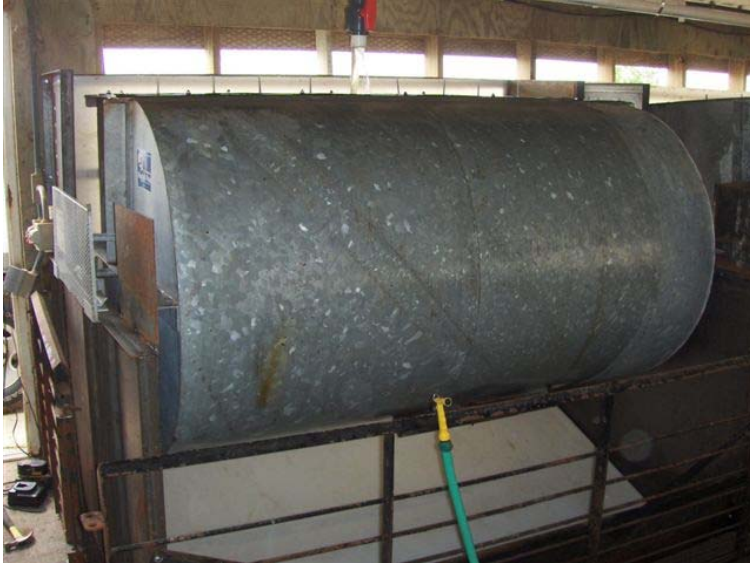
Photo 1. Tip tank shown in upright position.

Photo 1 shows an upright tipping or flush tank at the end of the barn. Each pit had a 900 gallon (1.2 m diameter) and 700 gallon tank (1.0 m diameter) side by side. The tanks were cylindrical and would rotate as they became full due to the change in center of gravity. The tank rotated towards the exterior of the building and a sloped piece (shown under the tank in Photo 1) ushered the flow in a straight shot into the gutter under the slats.

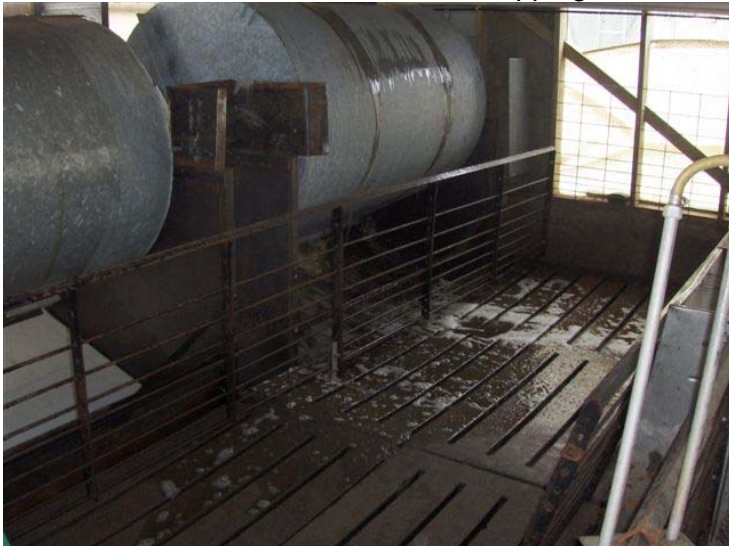
Photo 2. Flush tank has discharged its contents.

Photo 2 shows the tanks as it discharged. The water rushed through the shallow 20 cm (8") pit as a wall of force to remove manure solids in the channel. Notice the extra room needed at the end of the barn to accommodate the tank. Space immediately in front of the tank was needed also for the wall of water created after tipping.

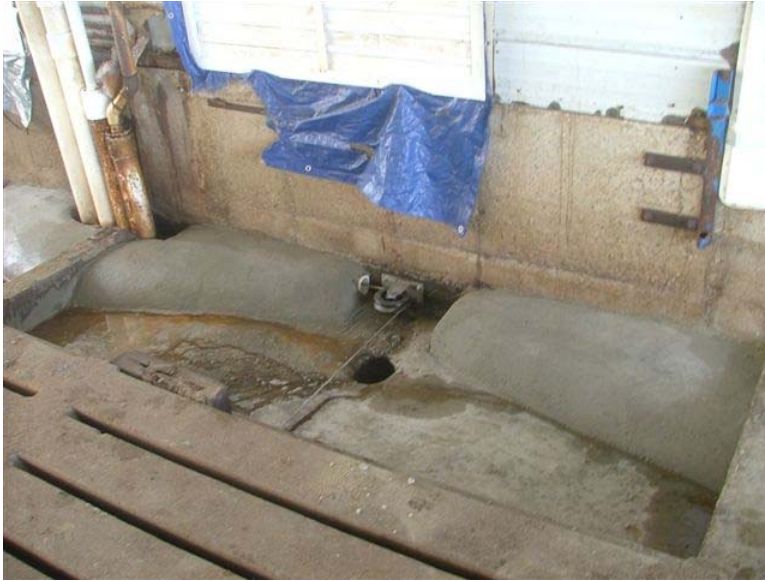
Photo 3. Concrete diverters used in the scraper system.

Photos 3 and 4 show the scraper installation at the test barns. Notice the concrete diverters at the end of the pit to lessen the need for fresh water to remove solids at the end of the channel. Electrical rate was \$0.08/kWh and cost per gallon of recycled water was \$0.01. One 7.5 hp

pump was used per tank and one $\frac{3}{4}$ hp motor per scraper. The size of the drain hole was 0.2 m (8").

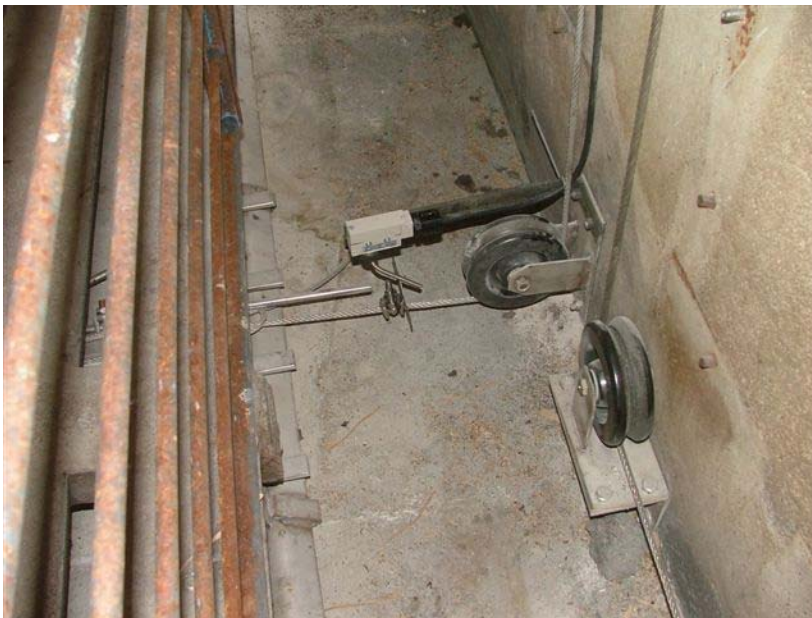
Photo 4. This scraper system showing pulleys with cable leading to the motor.

A limit switch is shown in Photo 4 to prevent the length of travel of the scraper to interfere with the pulley guide wheels. Guide wheels were plastic or cast. Notice the cable is stainless steel rather than galvanized to prevent corrosion due to constant exposure to pit gases. There were two drive units per barn. Scrapers were 2.6 m (8.5 ft) wide and barn was 12 m x 67.2 m (40'x220'). Each receiving pit was 5.5 m (18') wide. Each tip tank (4 per barn) was 2.4 m (8') wide. A galvanized tank is projected to last 15 years. The wear part is the cam.

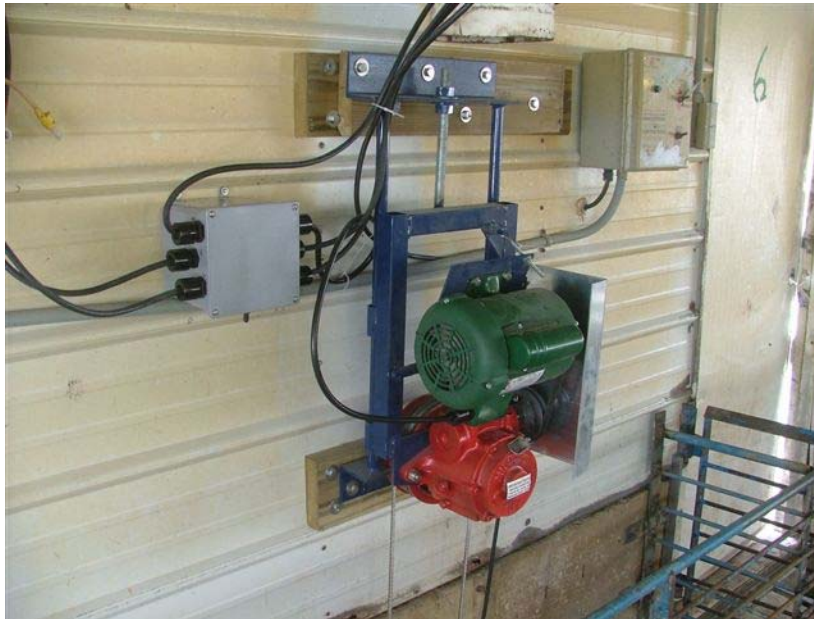
Photo 5. Safety features of the scraper system above the floor.

With the scraper system that was installed, there was a shield in-place over the drive unit facing the aisle and mounted on the wall. See Photo 5. A metal sleeve in the pens prevents access to the cable from the floor to the motor. Notice that all wiring was in rubberized cord. The limit switch prevents the scraper blade from passing a certain point under the slats (Photo 4) and the guide wheels were below the slats. The drive wheel was above the slats and parallel to the room wall and protected by the drive motor. No changeable or out-of-route locations of any moving parts were noted above the slats. Only the cable moves above the slats and is parallel to the wall in the end pens.
