The archaeology and architecture of Fort Atkinson, Iowa 1840-1849

Co-majors: Anthropology and Architectural Studies

Iowa State University

1998

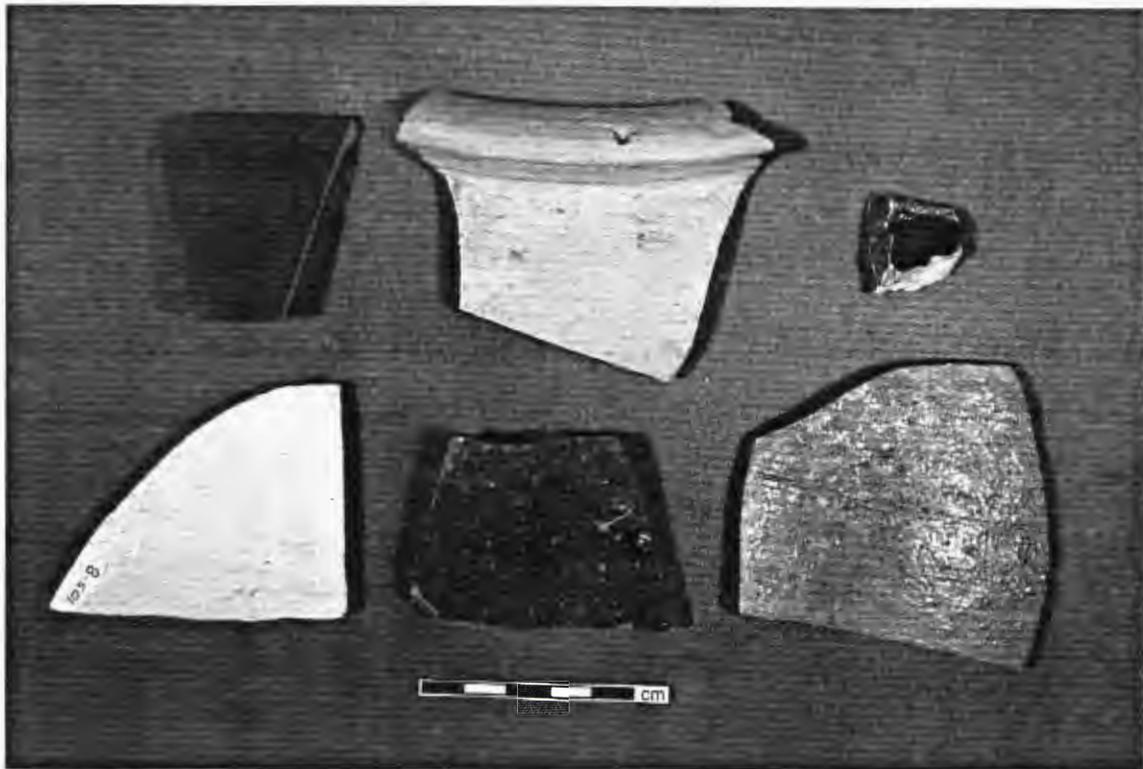
Figure 66. Luster decorated ceramics.

Finally, lusterware refers to ceramics that are characterized by a metallic sheen or shiny surface (Figure 66). The sheen is produced by adding metallic oxides to the glaze.

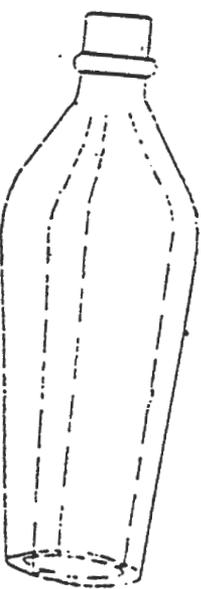
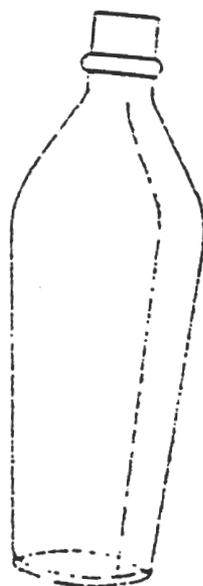
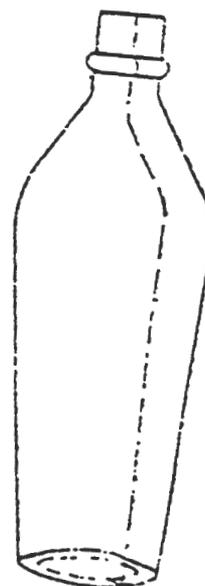
Figure 69. Mold seams characteristic of historic glass (from IMACS 1992).

Containers were blown into molds made of iron, wood, copper, brass, or ceramic. Mold-blown containers are symmetrical and usually have surface texturing as a result of contact between the hot glass and cooler mold. Mold seams indicate the type of mold used to manufacture a particular vessel (Figure 69). Although the mold seams on fine tableware

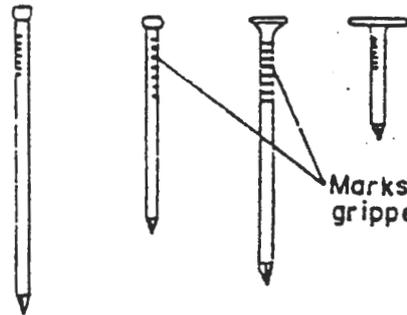
Figure 70. Historic nails (from IMACS 1992).

MODERN WIRE NAILS
Ca. 1850 - present

Flooring brads Finish Common Roofing

Marks of
gripper die

Usually have a 4-facet point
caused by cutter die

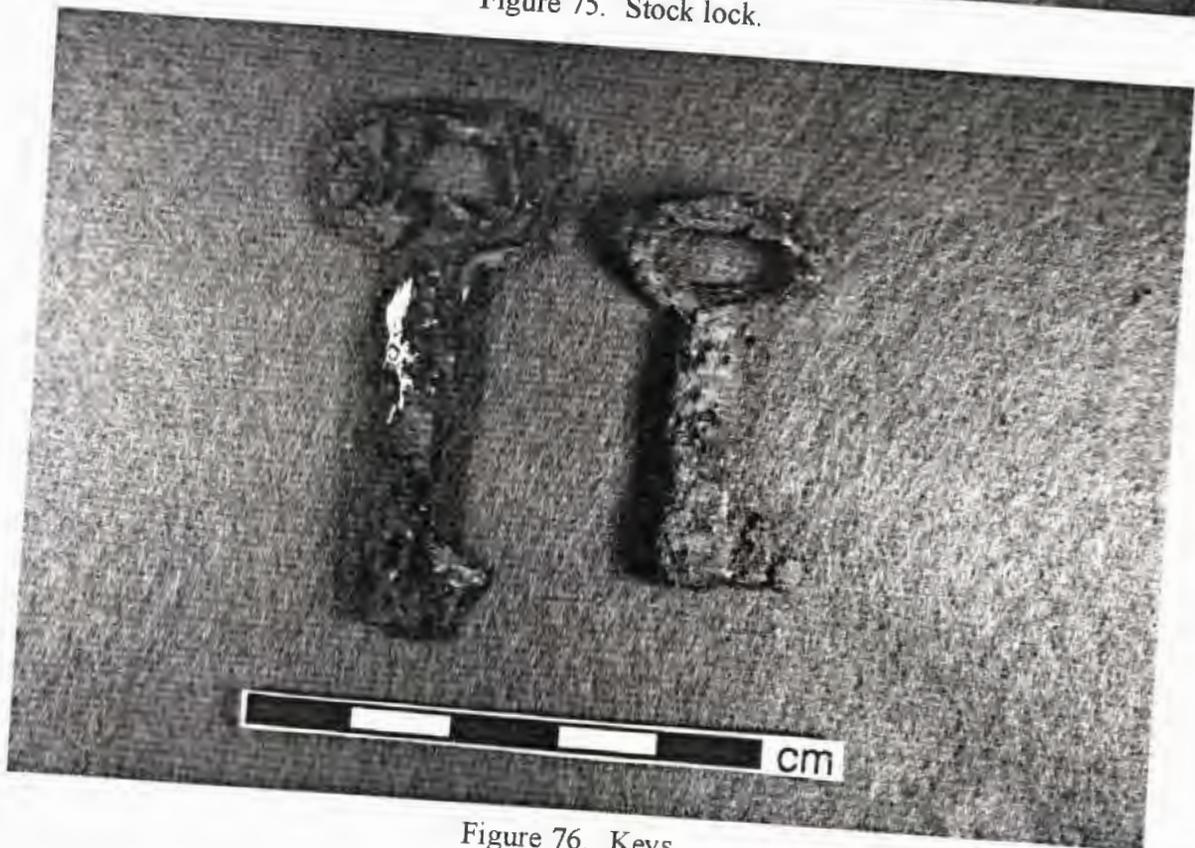
Figure 75. Stock lock.

Recovered from Privy 1 was a plate stock-lock, made of iron and consisting of a locking mechanism attached to a flat sheet-iron plate (Figure 75). These locks were set into a block of wood and attached to the face of a door (Carlson 1979:103; Streeter 1970:251-55). On specimens recovered from other sites the sheet-iron plate is bent over the top or over on one end to receive one end of the bolt. The stock-lock is trapezoidal in outline and

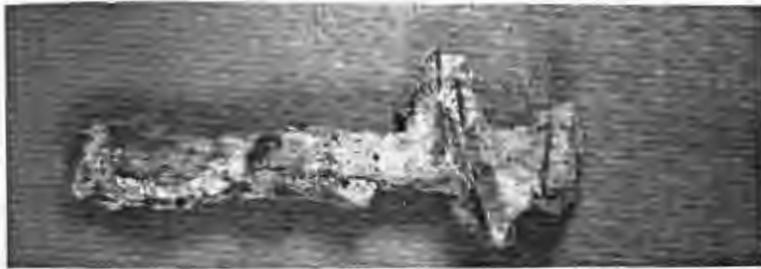
Figure 76. Keys.

Also recovered from Privy 1 were two keys probably associated with rimlocks or mortise locks (Figure 76). The specimens were of the skeleton type, commonly used with door rimlocks and mortise locks in the nineteenth century (Reynolds 1983:267). They are iron and measure 3.9 cm and 5.4 cm in length.
