Dan Church, Tyler Hamann, Troy Harding, Tyler Hoch

Silicone Applicator Cleaning Improvement

Client: Cardinal Glass, Greenfield, Iowa

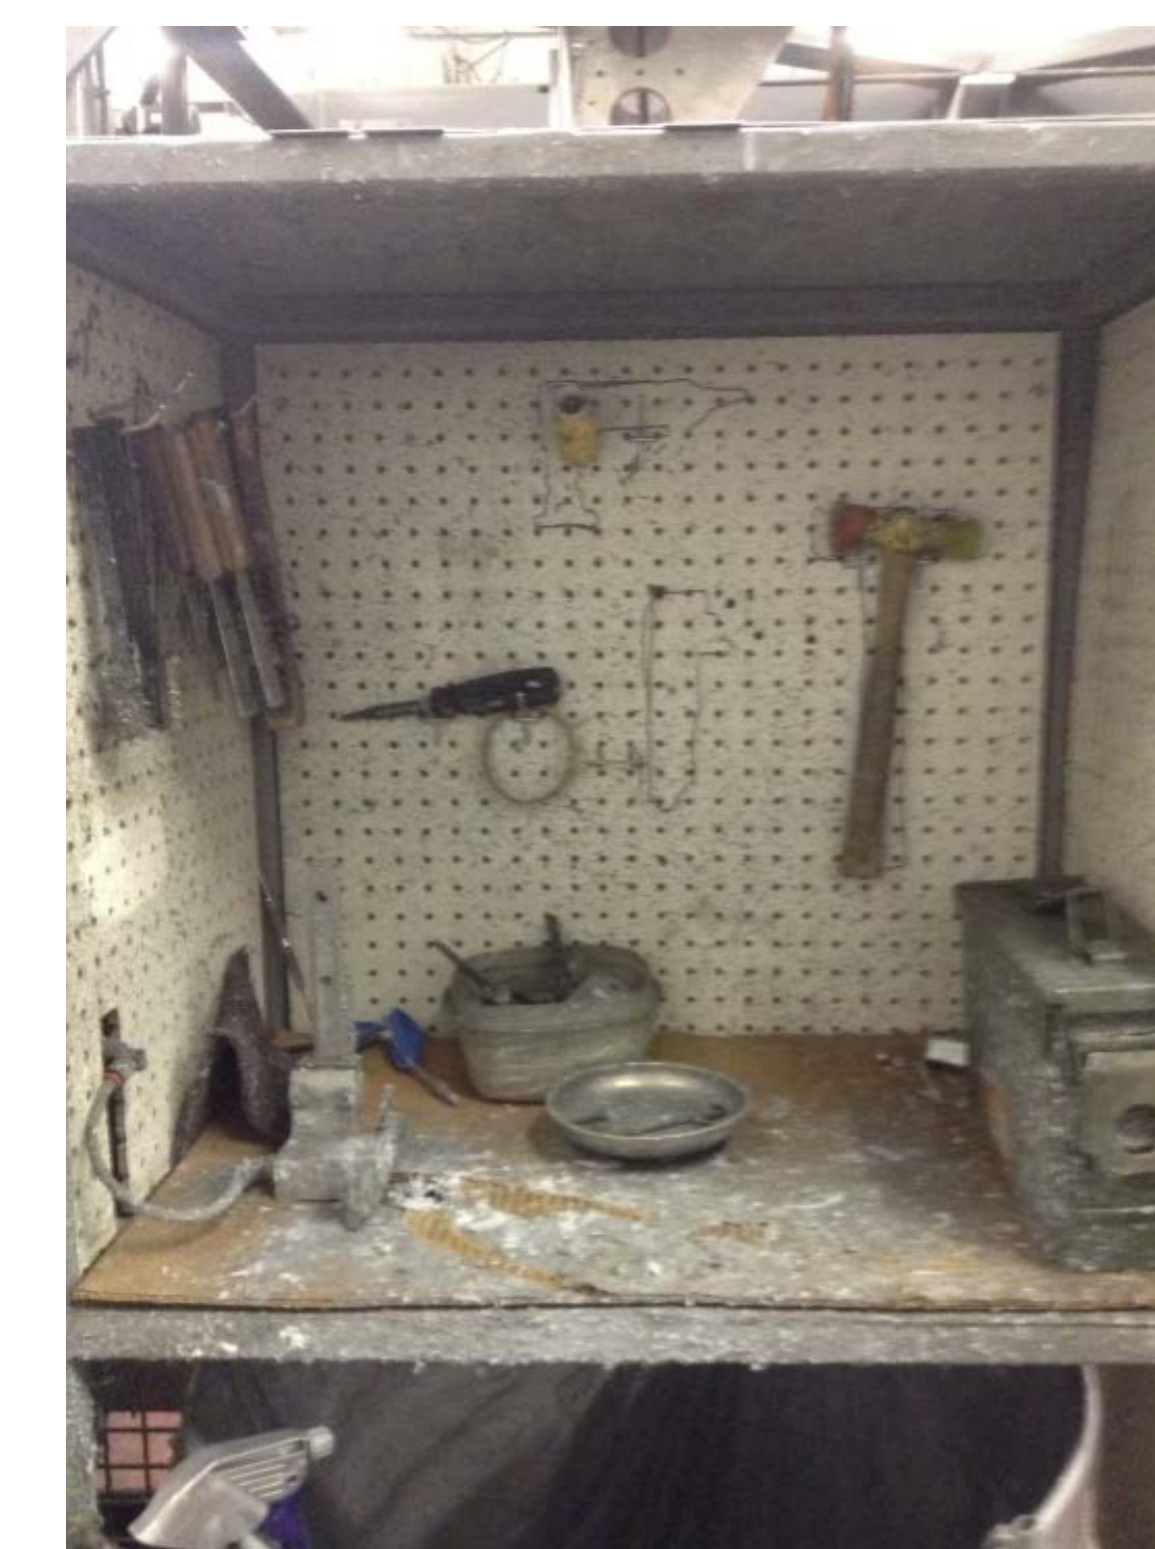
Current Workstation Layout

- Update the SOP to improve tip cleaning time by 5%
- Replace solvent to decrease tank cycle time by 5%
- Make workstation 5S compliant to improve organization and efficiency
