Feasibility Study for Detection and Quantification of Corrosion in Bridge Barrier Rails

Final Report
April 2013

Sponsored by
Federal Highway Administration
Iowa Department of Transportation
(InTrans Project 11-413)

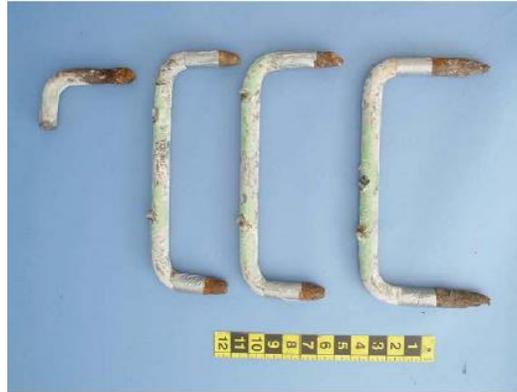
Figure 1. Corroded conditions of several U-bolt anchors that were extricated from concrete bridge barrier rail (NTSB 2010)

Figure 1 shows the corroded condition of U-bolt anchors from the NTSB recommendations to the FHWA. For this particular bridge construction, it was possible to detect the condition of a fully-fractured anchor using ultrasound techniques; however, the NTSB identified the need to detect intact but degraded anchors as a high priority need.

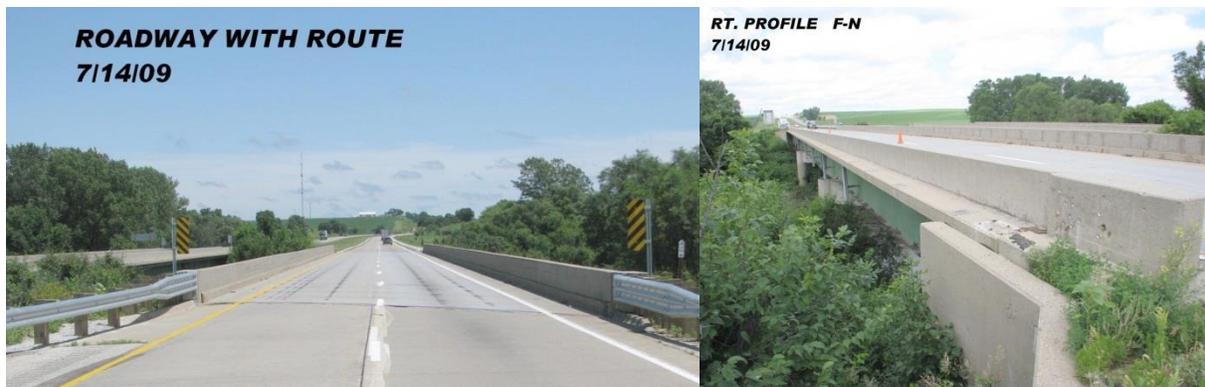
Figure 2. Typical bridge barrier rail construction

Concrete bridge barrier rails provide protection of passing vehicles and are critical to public safety. A cold joint exists between the barrier rail and the bridge deck, either with or without an overlay. At issue is the corrosion of the reinforcing steel within the barrier rail, particularly at the joint of the barrier rail with the bridge deck.

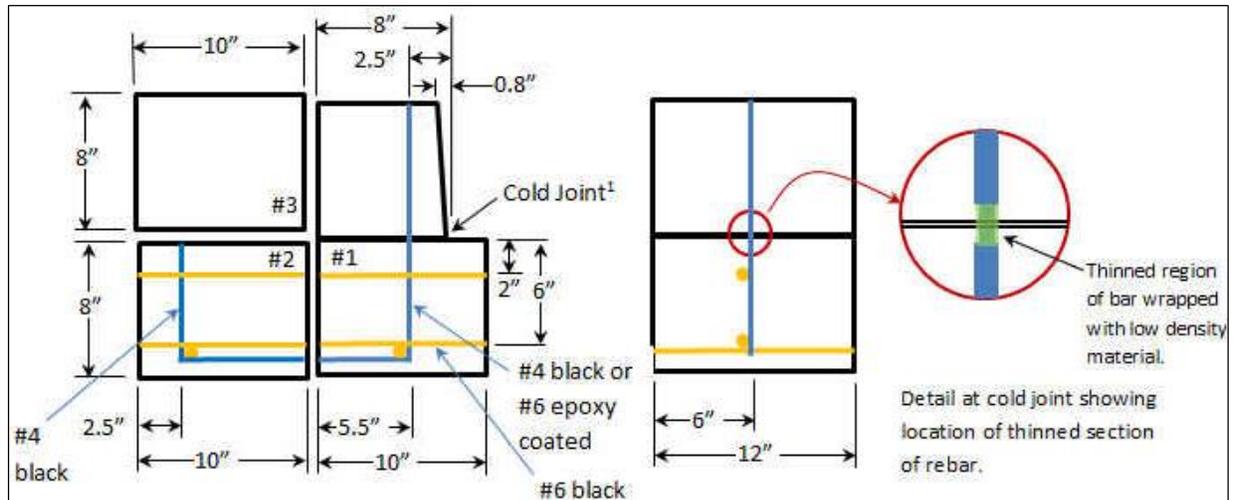
Figure 3. Configuration of test specimens

Concrete test specimens were fabricated as shown in Figure 3 to represent typical concrete construction thicknesses and materials.

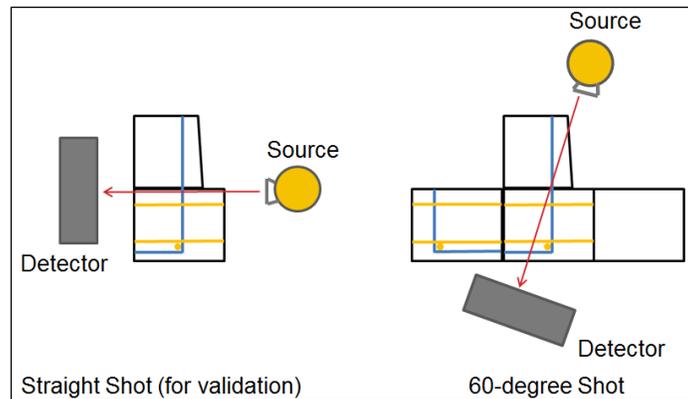
Figure 4. X-ray configuration of reference test and realistic test

For evaluation of radiography techniques, the concrete barrier specimens, x-ray source, and detector were configured as shown in Figure 4. The straight shot (for validation) shown on the left is called the reference angle or orientation later in this report. The 60 degree shot is called the realistic angle or orientation.

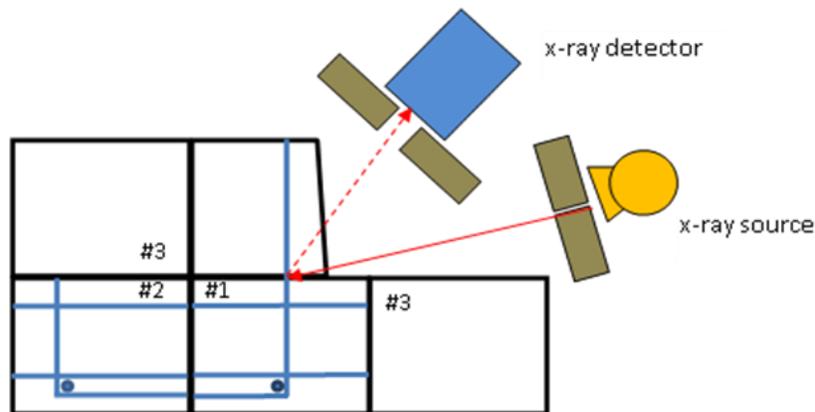
Figure 5. Configuration for back-scatter inspections

A single-sided x-ray inspection would greatly simplify the evaluation of bridge barrier rails. X-ray backscatter imaging, as shown in Figure 5, is an approach that can, in principle, achieve this.

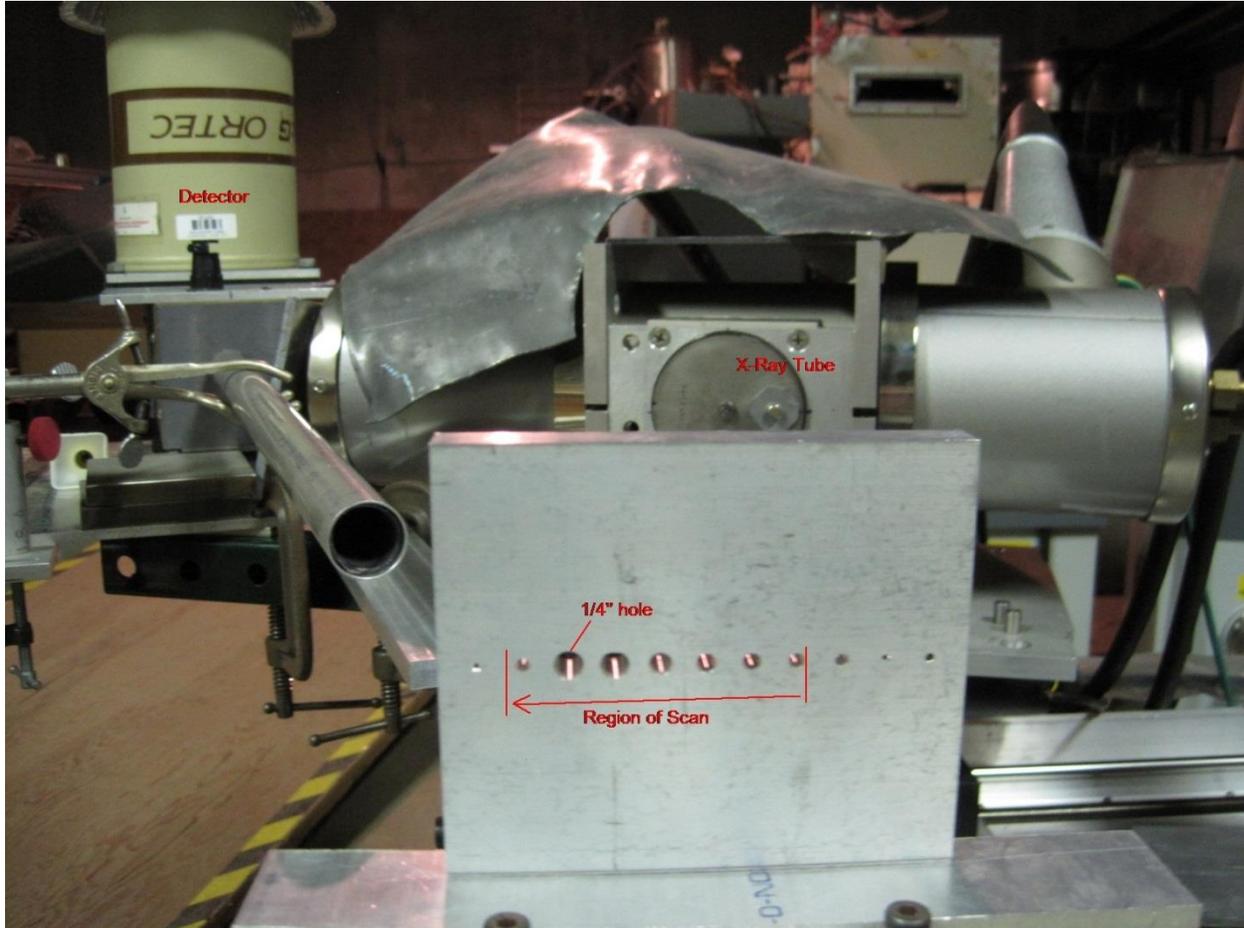
Figure 6. Setup used for x-ray backscatter studies

The method is used routinely, for example, in screening cargo at border crossings (Callera 2006) and has been used by the National Aeronautics and Space Administration (NASA) to inspect the space shuttle external rocket (Dugan et al.). To evaluate this method, we set up a tightly-collimated x-ray source and detector as indicated in Figure 6.

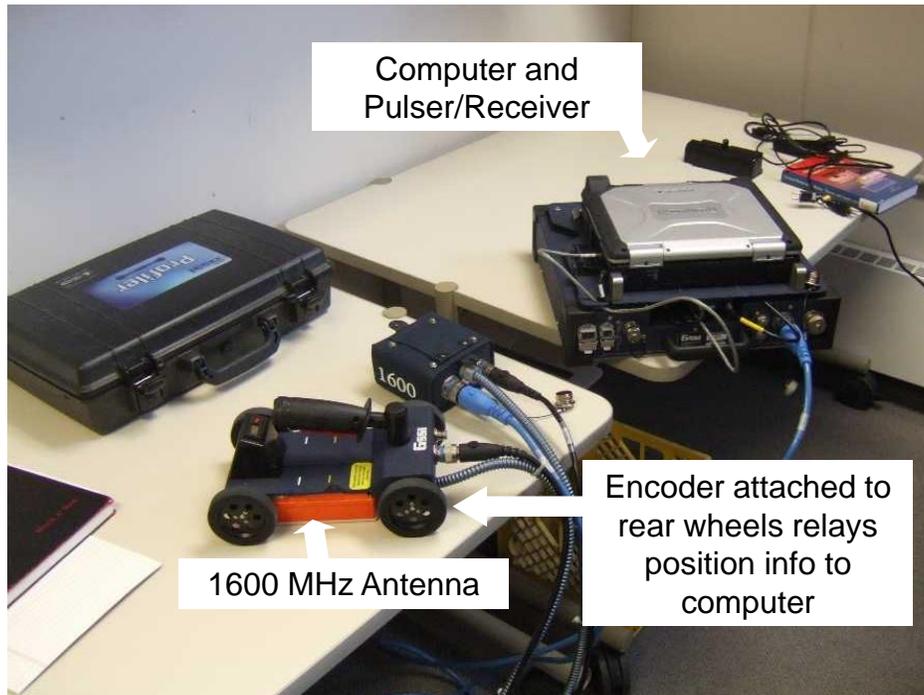
Figure 7. Portable GPR equipment used

GPR is routinely used to locate and map reinforcing steel in concrete structures. Detecting damage to embedded reinforcing steel is a much more difficult challenge. The equipment used for our measurements is shown in Figure 7.

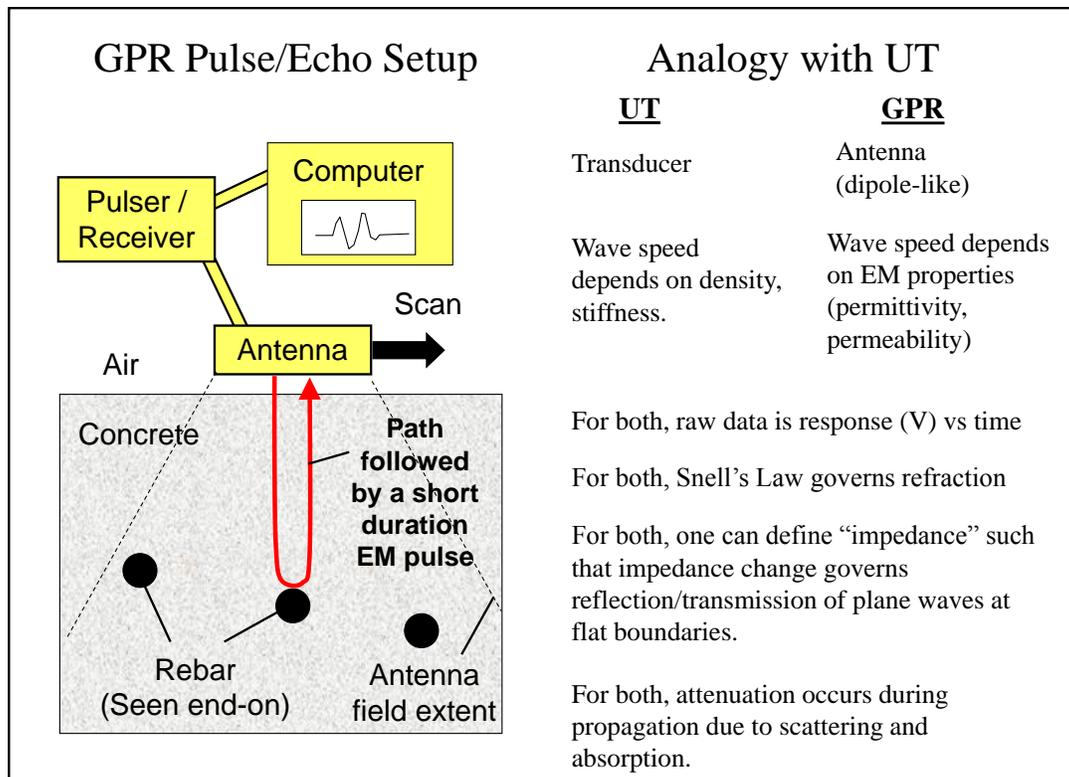
Figure 8. GPR pulse/echo inspection of reinforcing steel and analogy with ultrasonic inspection

As indicated in Figure 8, the GPR inspection process is analogous to that used in pulse/echo ultrasonic inspection, and tools developed on the ultrasonic side for analyzing data and modeling inspections can be adapted readily to GPR.

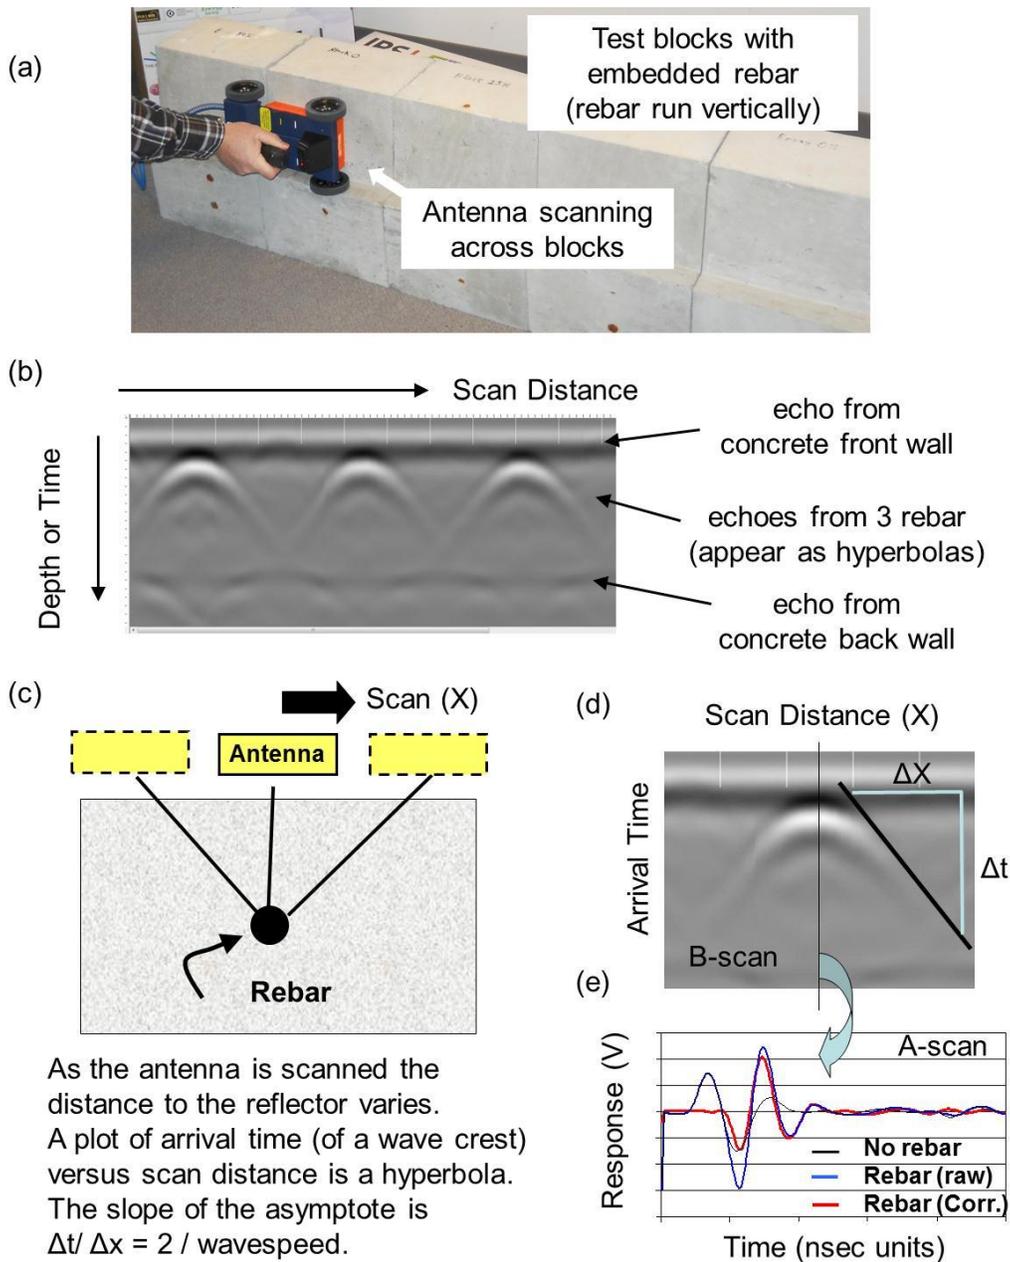
Figure 9. Scan of the GPR antenna, the resulting B-scan image, why B-scan responses have a hyperbola shape, and A-scan plot of output voltage versus time for the antenna position

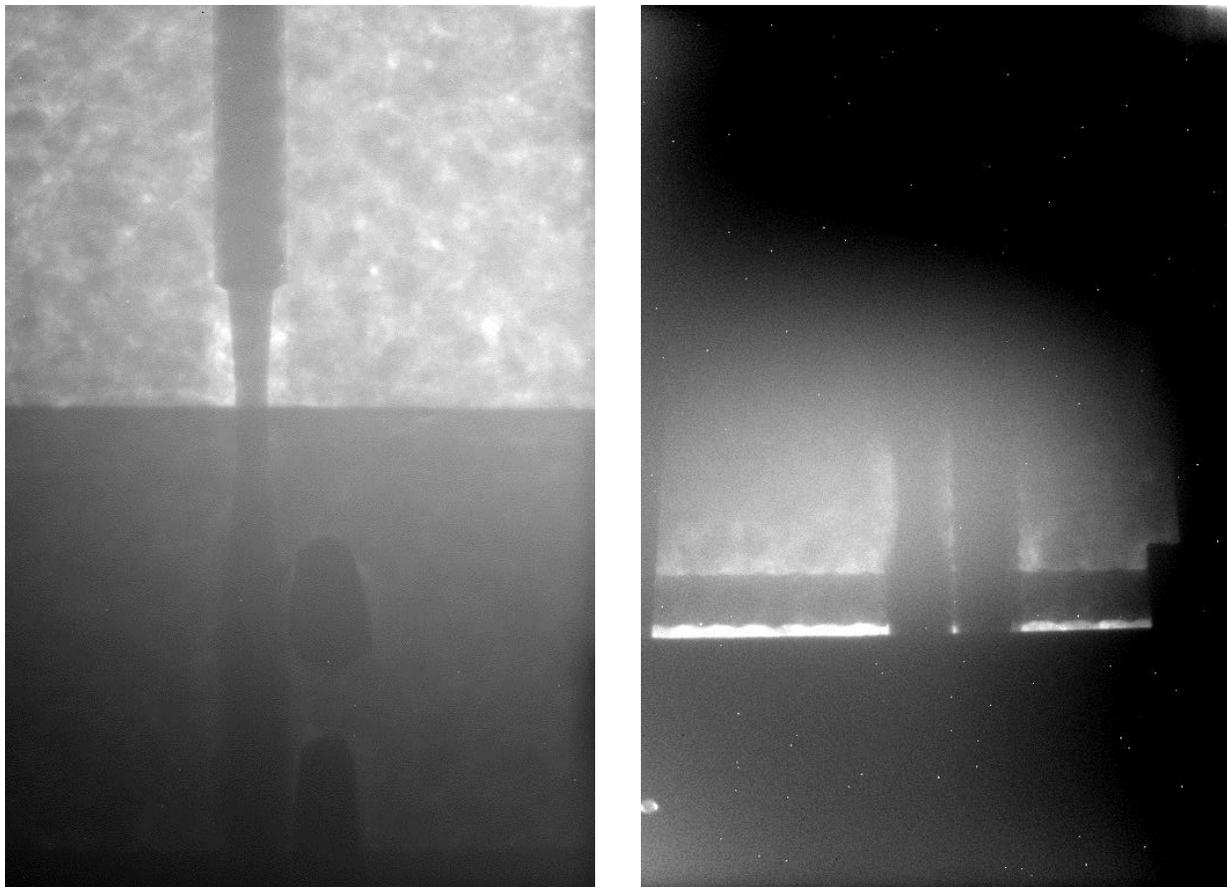
Figure 10. #6 Epoxy-coated reinforcing steel with simulated 50 percent corrosion loss at reference (left) and realistic (right) angles

Only a limited range of the realistic images on the right (x-ray settings of 290 kV, 30 sec, 5 mA) appear to have good contrast. This is because the x-ray path length varies considerably from top to bottom of the image. The display has been optimized to emphasize the region where the corrosion is located. If desired, we could adjust the display settings to emphasize a different region. Still, the contrast is more limited than in the examples for the reference orientation on the left. We also found it was necessary to use lead to block some of the thinner regions of concrete to prevent a very high intensity signal from washing out an adjacent darker region.

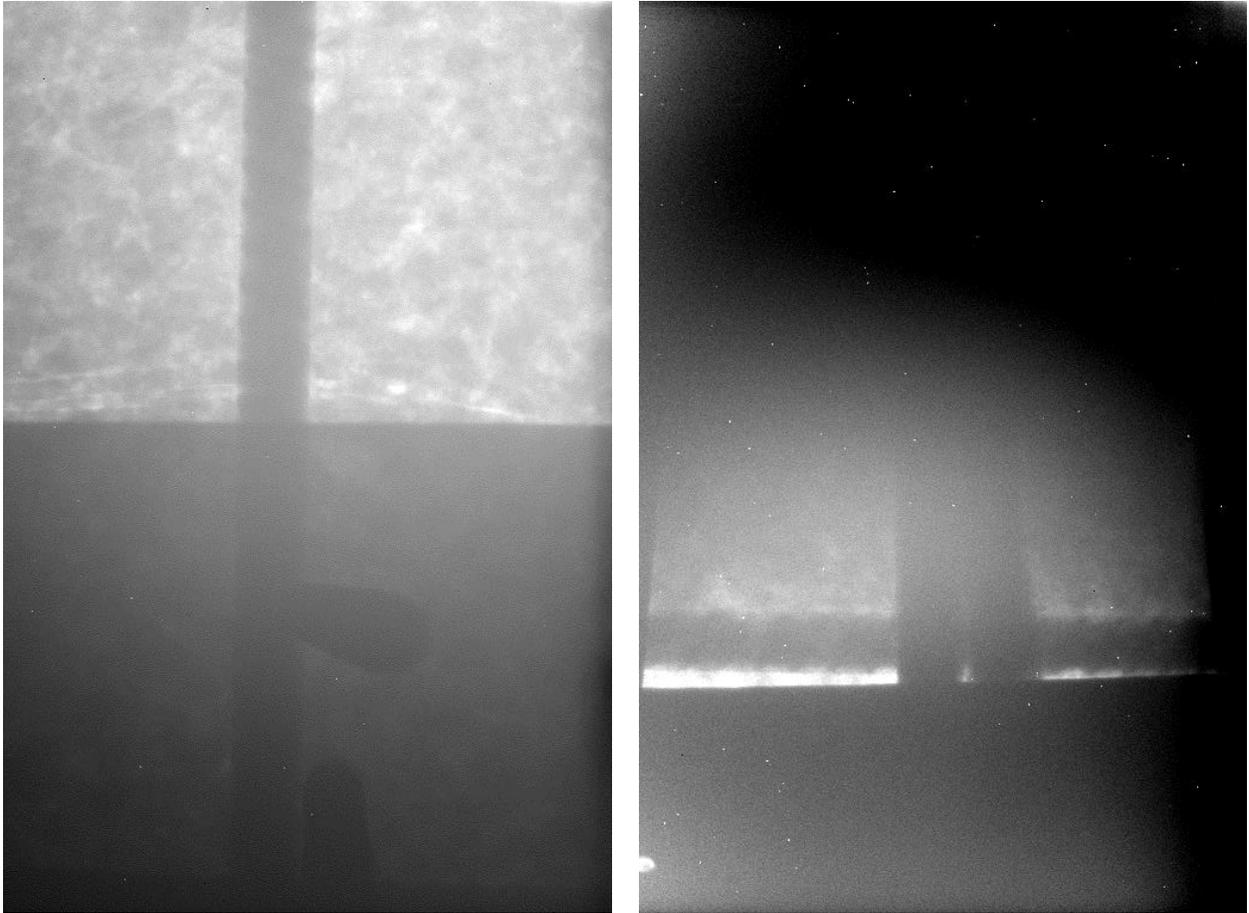
Figure 11. #6 Epoxy-coated reinforcing steel with 0 percent corrosion loss at reference (left) and realistic (right) angles

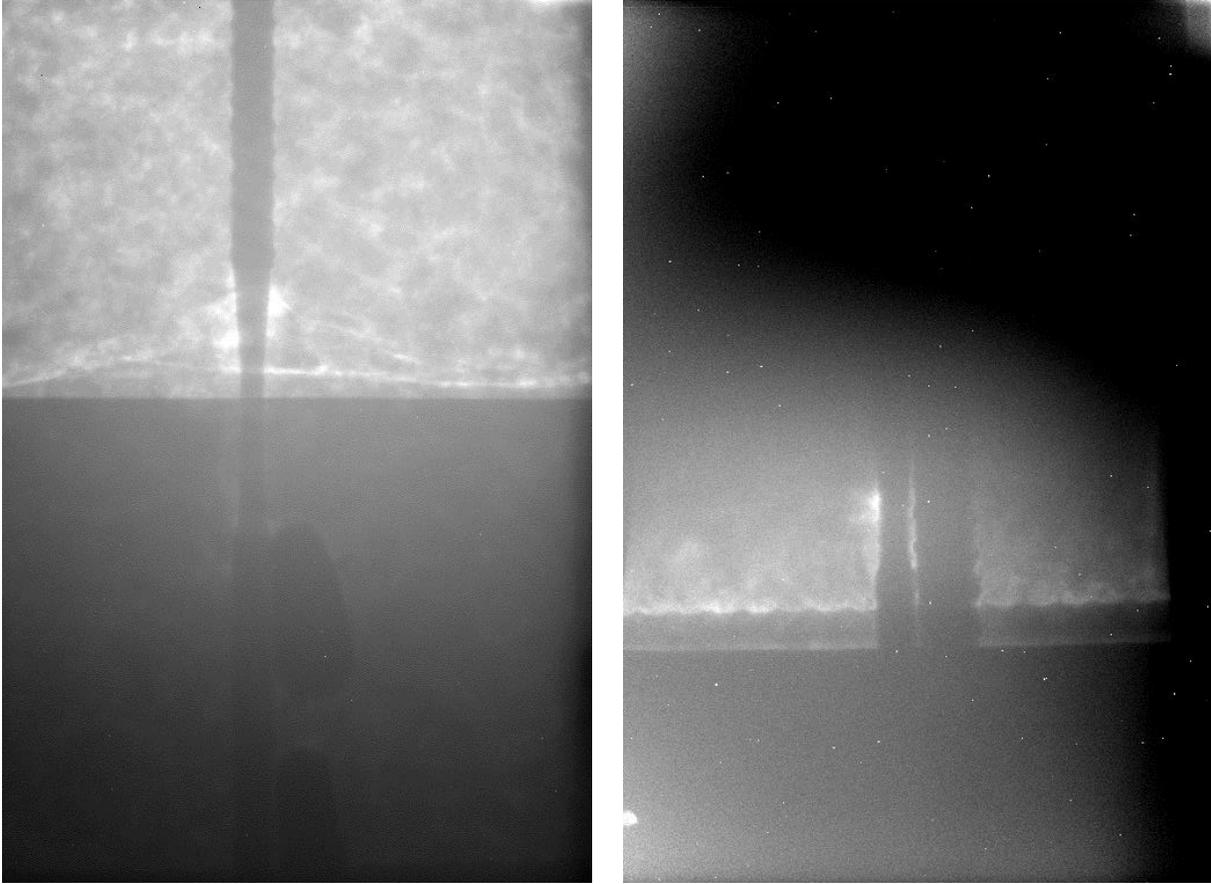
Figure 12. #4 Reinforcing steel with simulated 50 percent corrosion loss at reference (left) and realistic (right) angles

Comparing the image in Figure 15 to the corresponding reference image on the left in Figure 12, it can be seen that the two methods produce comparable results. Because the CR system was on loan for a demonstration, there was not sufficient time to set up the more realistic geometry (60 degree shot) and varying conditions.

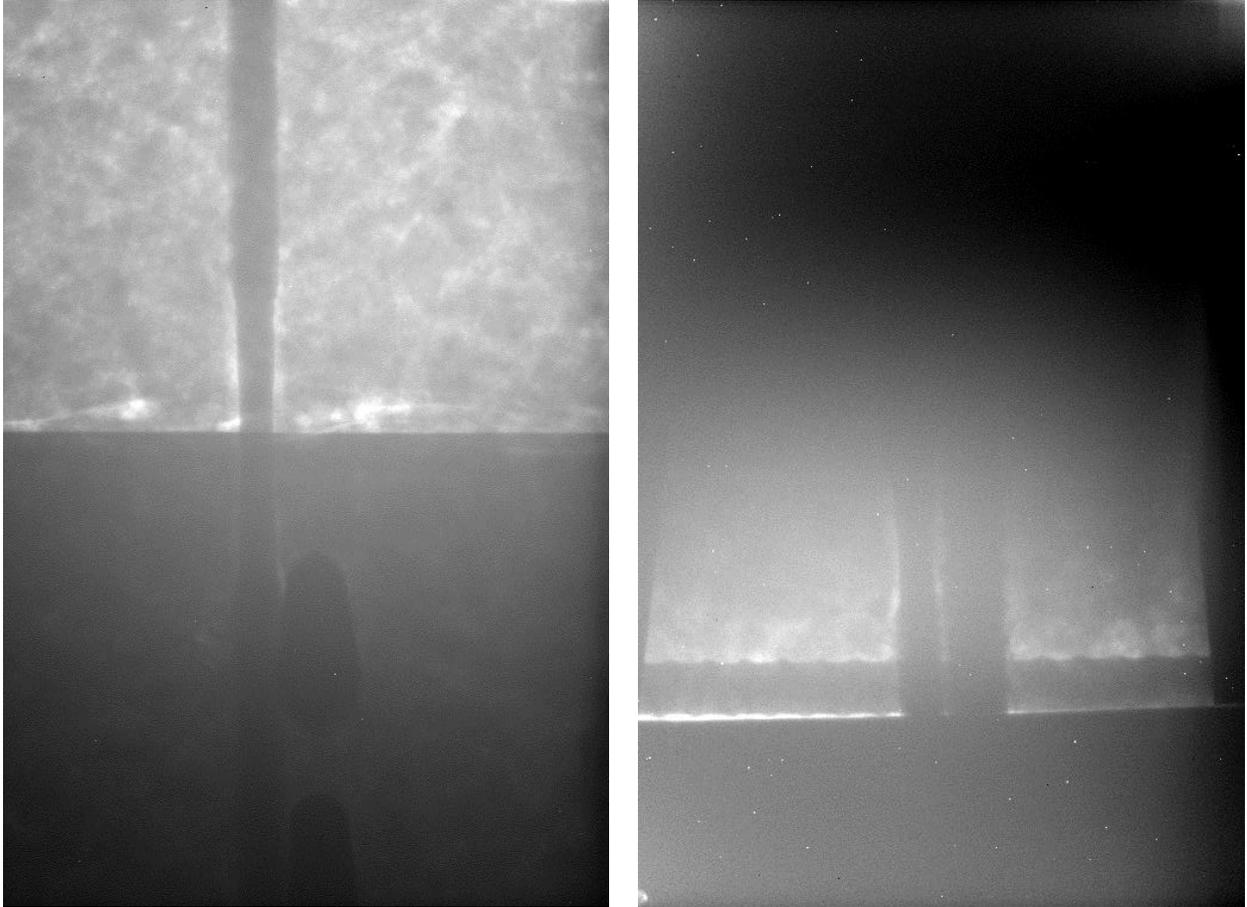
Figure 13. #4 Reinforcing steel with simulated 25 percent corrosion loss at reference (left) and realistic (right) angles

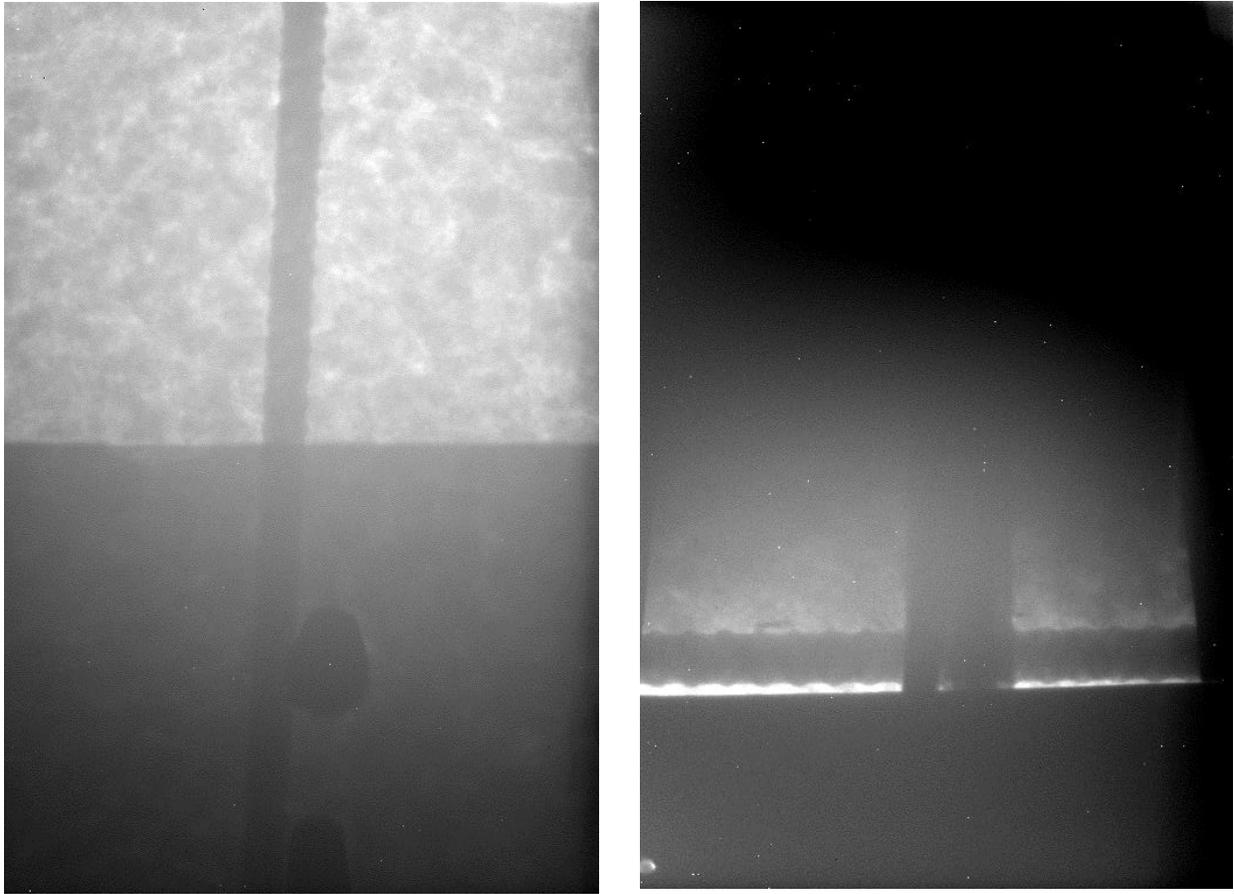
Figure 14. #4 Reinforcing steel with 0 percent corrosion loss at reference (left) and realistic (right) angles

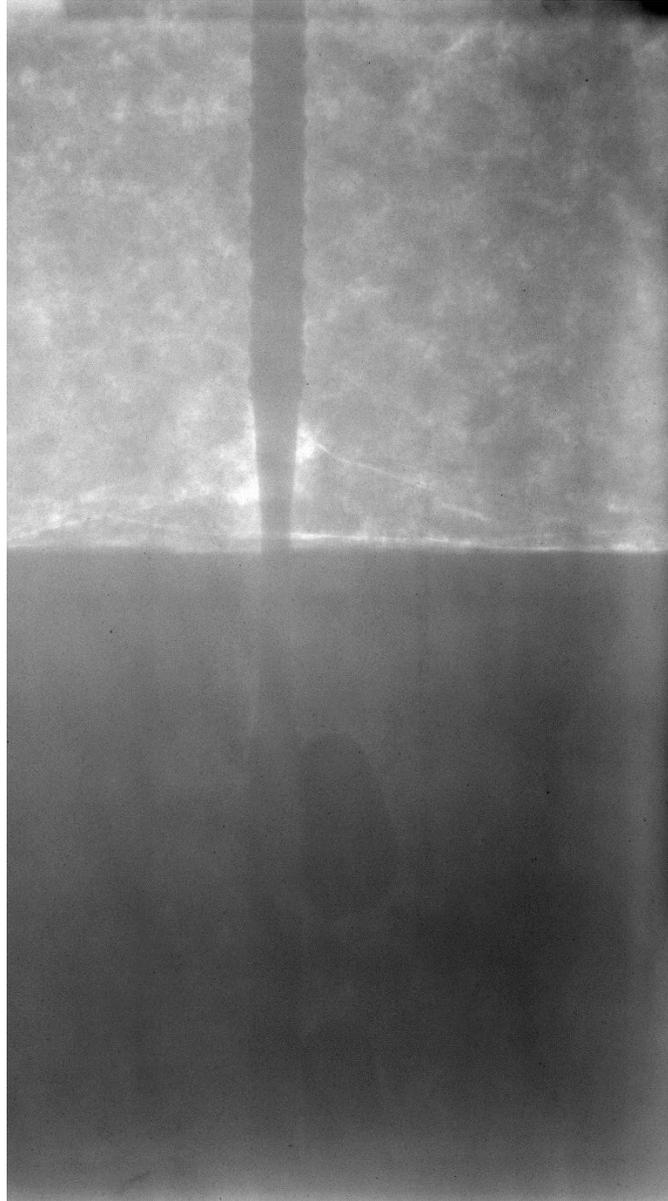
Figure 15. #4 Reinforcing steel with 50 percent corrosion loss at reference angle

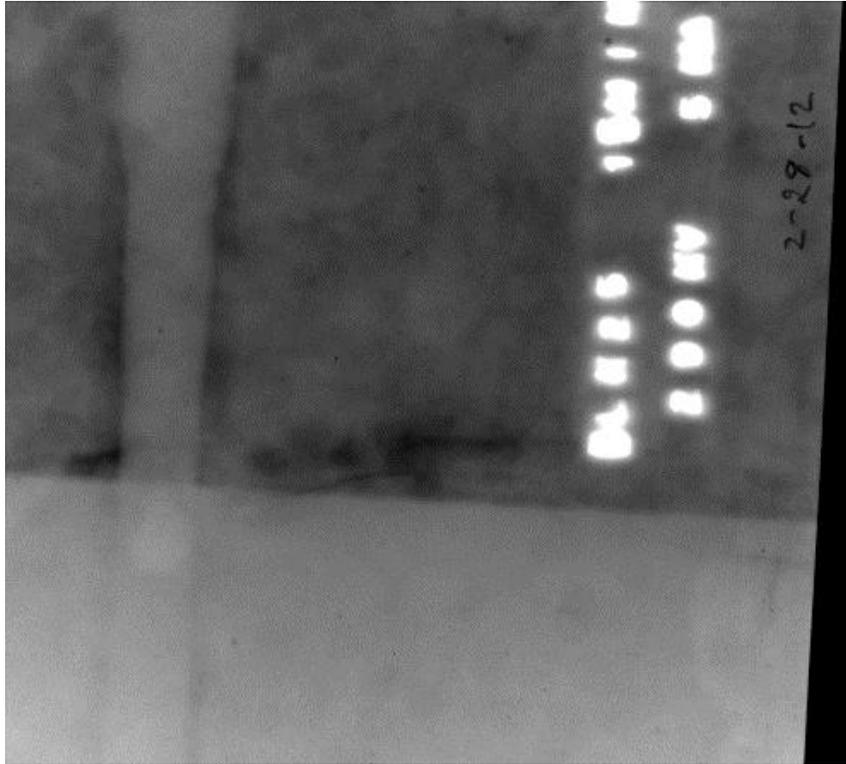
Figure 16. #4 Reinforcing steel with simulated 25 percent corrosion loss at reference angle

For comparison with traditional film radiography methods, we imaged the specimen with #4 reinforcing steel with 25 percent corrosion. The resulting image (digitized with x-ray settings of 290 kV, Agfa D7 film, 15 minutes, and 5 mA) in Figure 16, compares favorably with the corresponding reference image on the left in Figure 13. Note that in the film exposure, lighter areas represent thicker concrete or denser reinforcing steel. The total time for exposure and development was about 30 minutes.

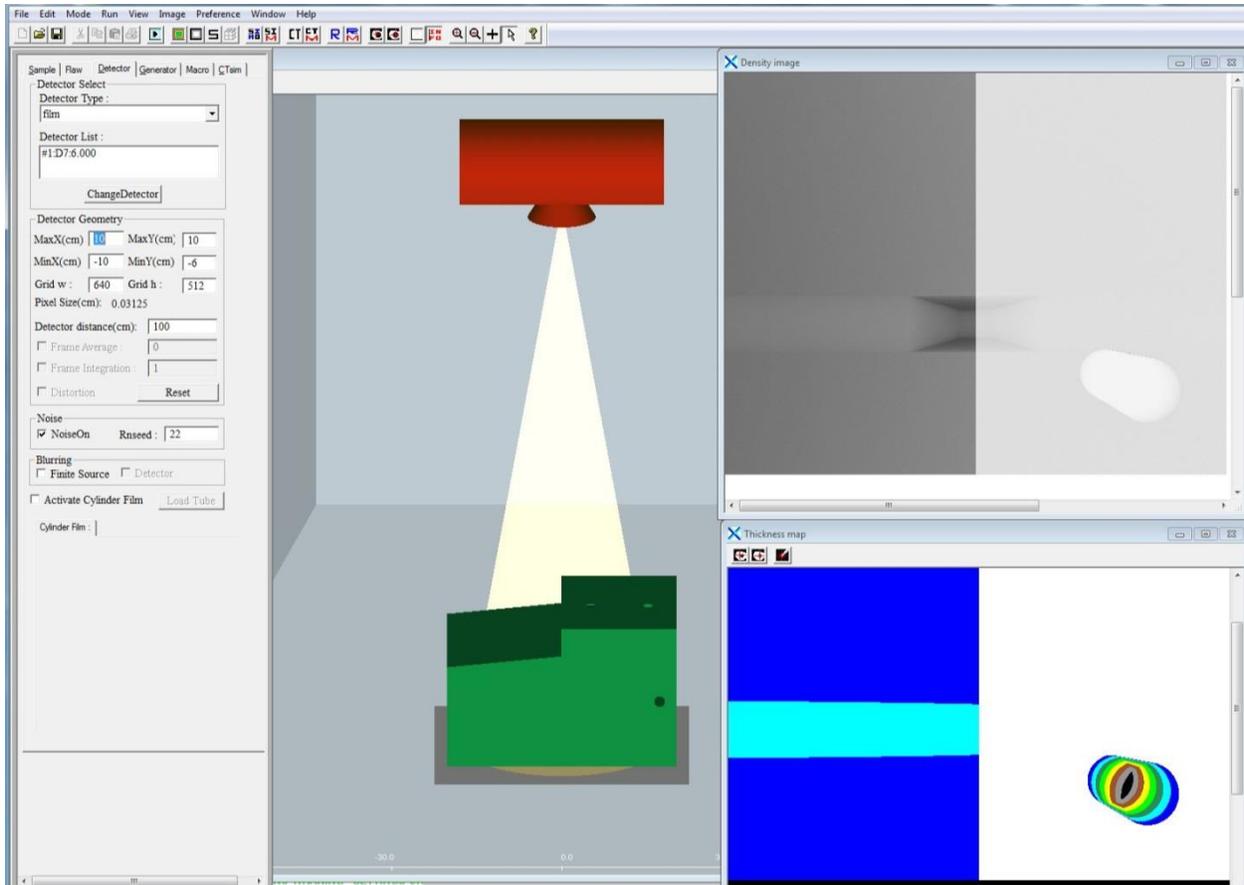
Figure 17. #4 Reinforcing steel with 50 percent corrosion loss at reference angle

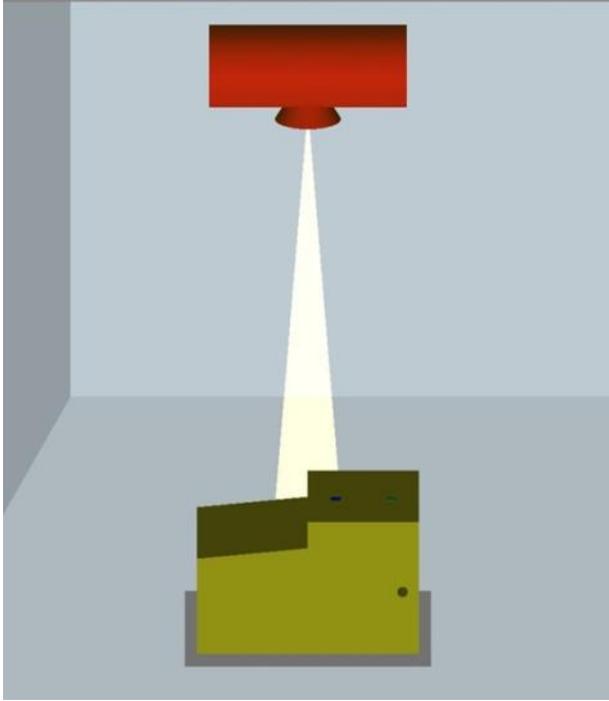
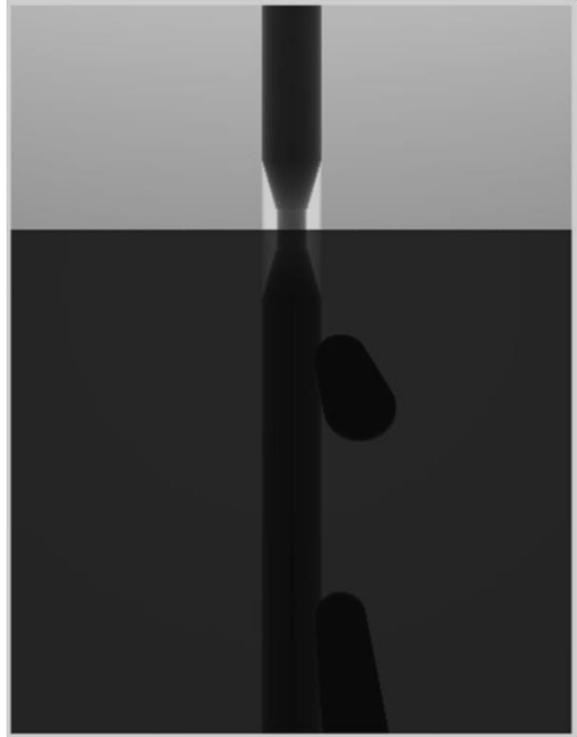
Figure 18. #6 reinforcing steel with 50 percent corrosion loss at reference angle

Figures 18 and 19 show simulations of the reference and realistic angles, respectively. For these images, the CsI screen and camera detector system (with x-ray setting of 290 kV) was modeled. Note that the contrast in the region of the reduced diameter is greater in the simulations because there is no material filling the void, whereas the specimens contained a low-density filler material around the simulated corrosion. The simulated reinforcing steel does not include any ribbing. In addition, the simulated images do not have a mottled appearance because the concrete is modeled using the average density for concrete and the aggregate is not included.

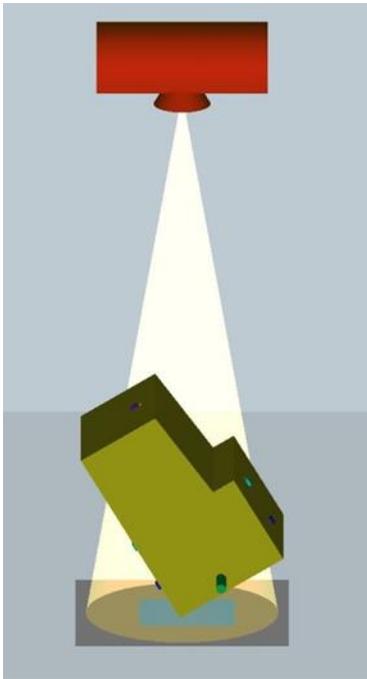
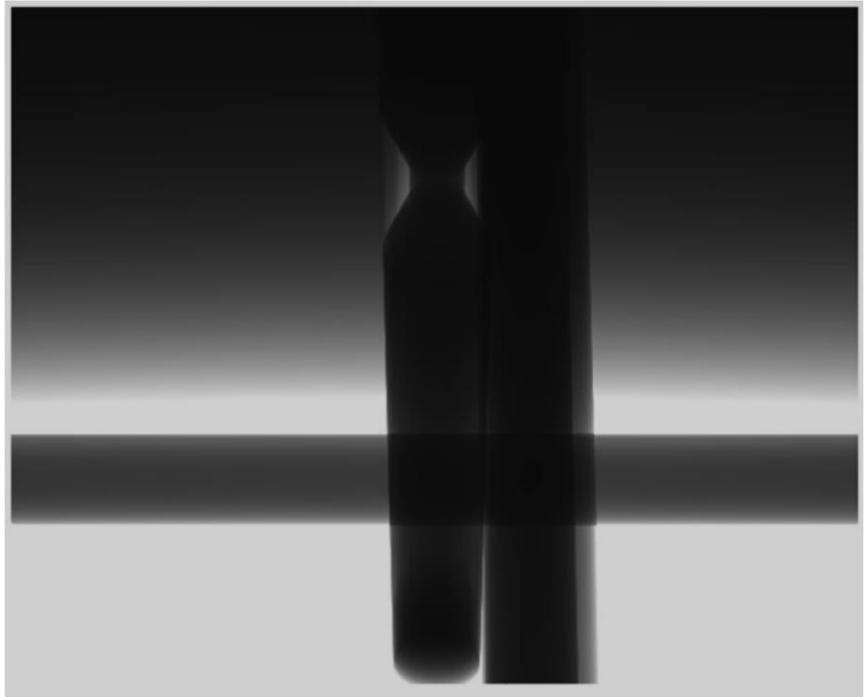
Figure 19. #4 Reinforcing steel with 50 percent corrosion loss at realistic angle

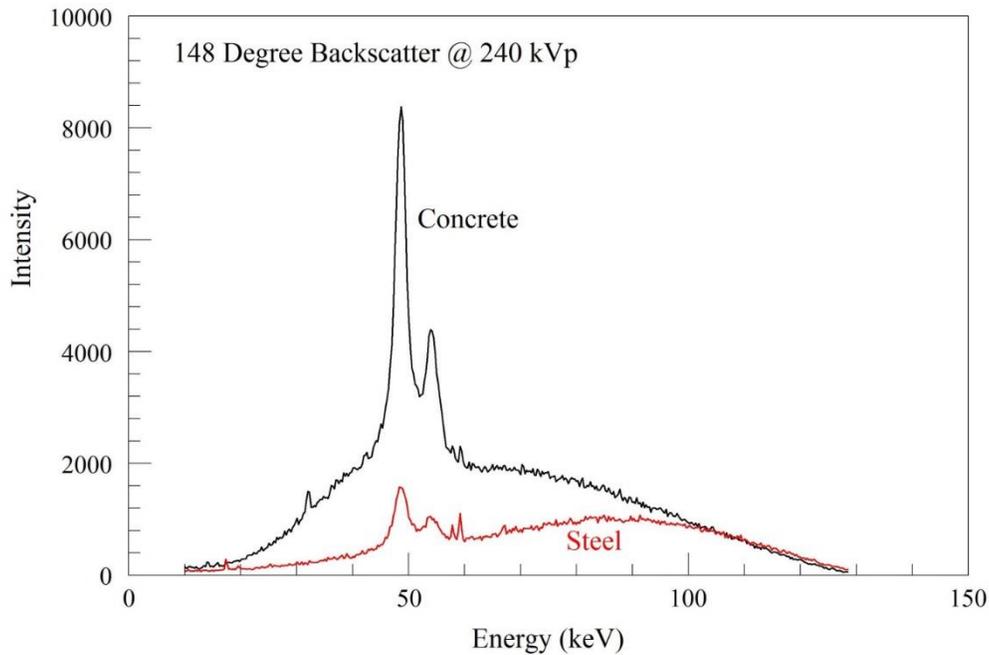
Figure 20. Backscatter spectra observed for concrete and steel samples

Some very preliminary studies of x-ray backscatter were carried out using the configuration shown earlier in Figure 5. Comparison of the x-ray spectra observed for scattering from concrete and steel is shown in Figure 20.

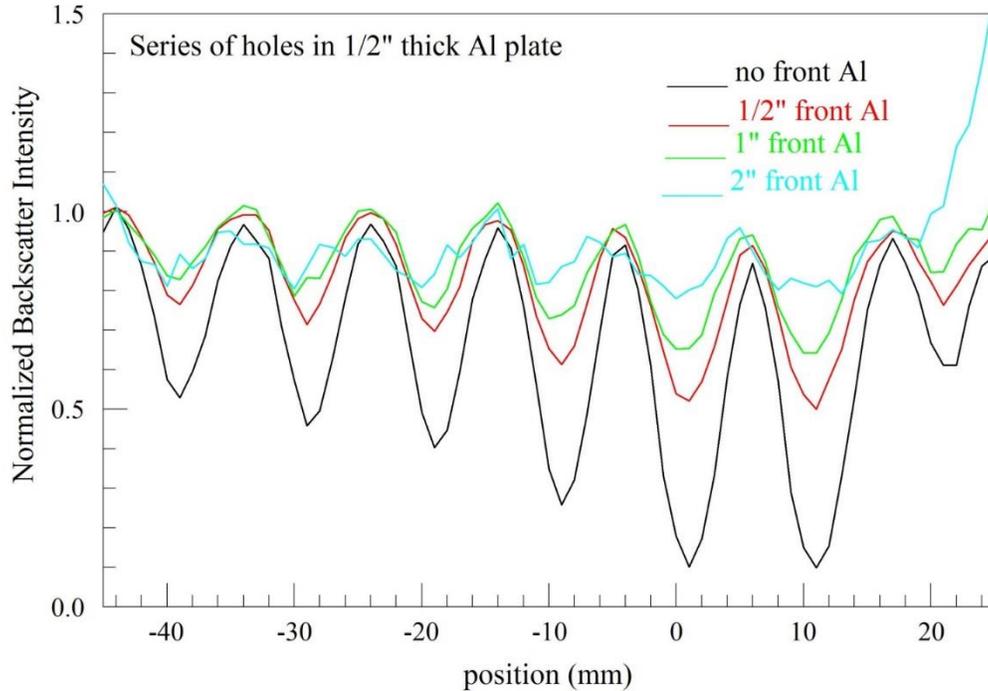
Figure 21. X-ray backscatter contrast at detector as a function of material thickness

However, the above spectra were obtained at relatively small depths in the samples. As the inspection point moves deeper into the sample, most low-energy x-rays are absorbed, regardless of material. At the higher energies, the contrast between materials is not as great. To test the effect of material thickness on contrast, we used a sample consisting of a 1/2 in. thick aluminum plate with a series of holes drilled in it (as shown earlier in Figure 6). We then placed different amounts of aluminum in front of this plate as we scanned the beam across the holes. The results are shown in Figure 21. With 2 in. of aluminum in front of the plate, the contrast is greatly reduced.

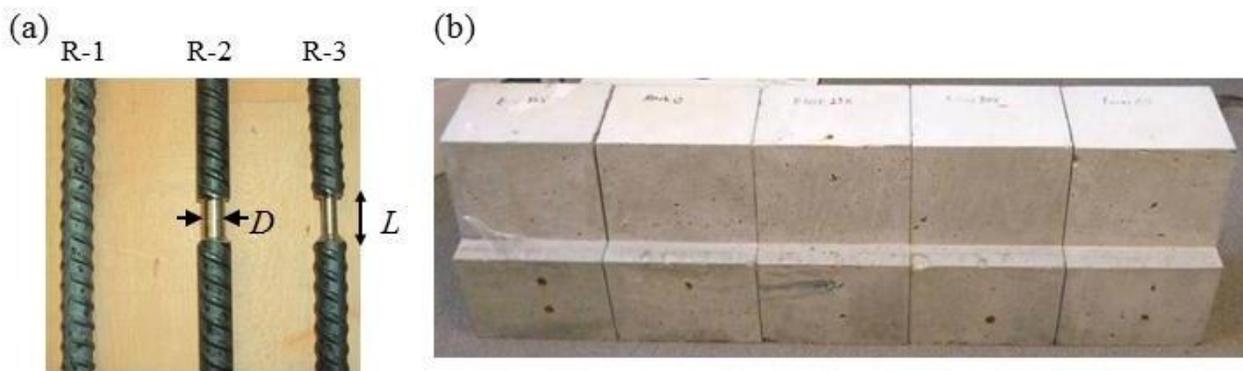
Figure 22. (a) Bare #4 reinforcing steel specimens and (b) concrete test specimens consisting of either #4 or epoxy-coated #6 reinforcing steel

Commercial MFL systems are almost exclusively designed for specific NDE applications (e.g., pipeline inspections), with sensor probe designs and instrumentation optimized for the given inspection geometries and sensitivity needs (e.g., minimum detectable defect size). In view of this, an MFL sensor probe was designed and fabricated specifically for detecting reinforcing steel damage near the cold joint according to the inspection geometry shown in Figure 22.

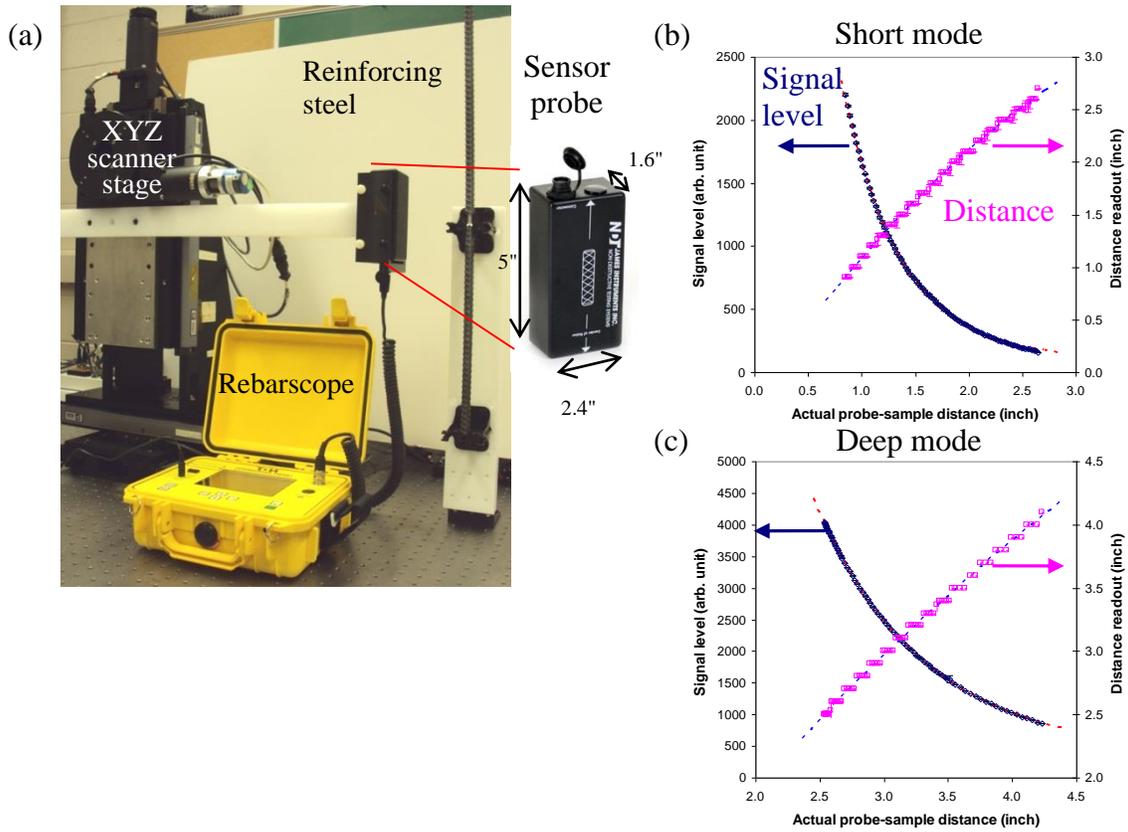
Figure 23. (a) Setup for EC scans on bare #4 reinforcing steel specimens and (b) and (c) signal level and distance readings versus actual probe distance

scanner stage (Figure 23a) that was under computer control for performing line or raster scans over the bare reinforcing steel or concrete test specimens.

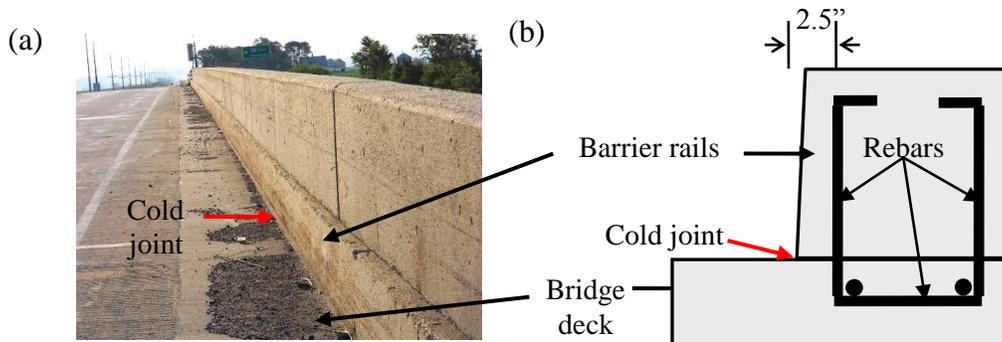
Figure 24. Bridge barrier rail showing the presence of a cold joint between the deck and the rail and locations of reinforcing steel that anchor the barrier rail to the bridge deck

An MFL sensor probe was designed and fabricated using GMR sensors specifically for inspecting reinforcing steel near the cold joints of concrete structures as shown in Figure 24. The concept of the probe design is illustrated in Figure 25.

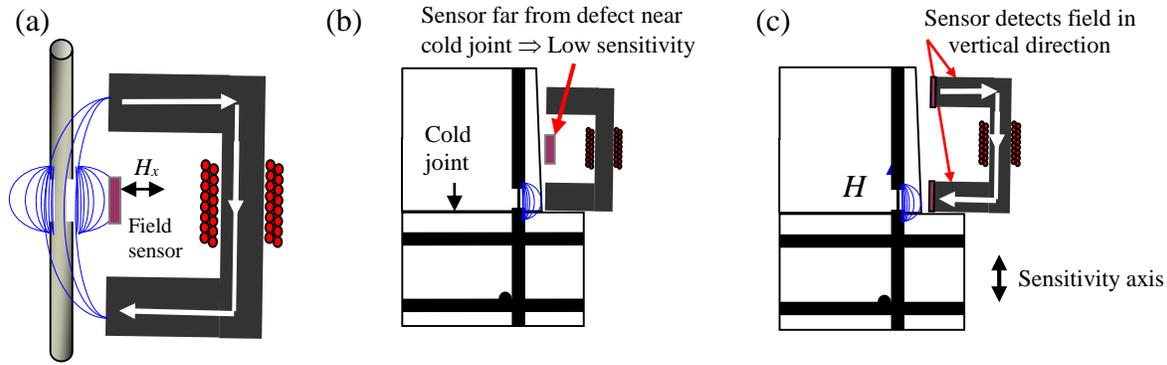
Figure 25. Conventional and alternative MFL probe design

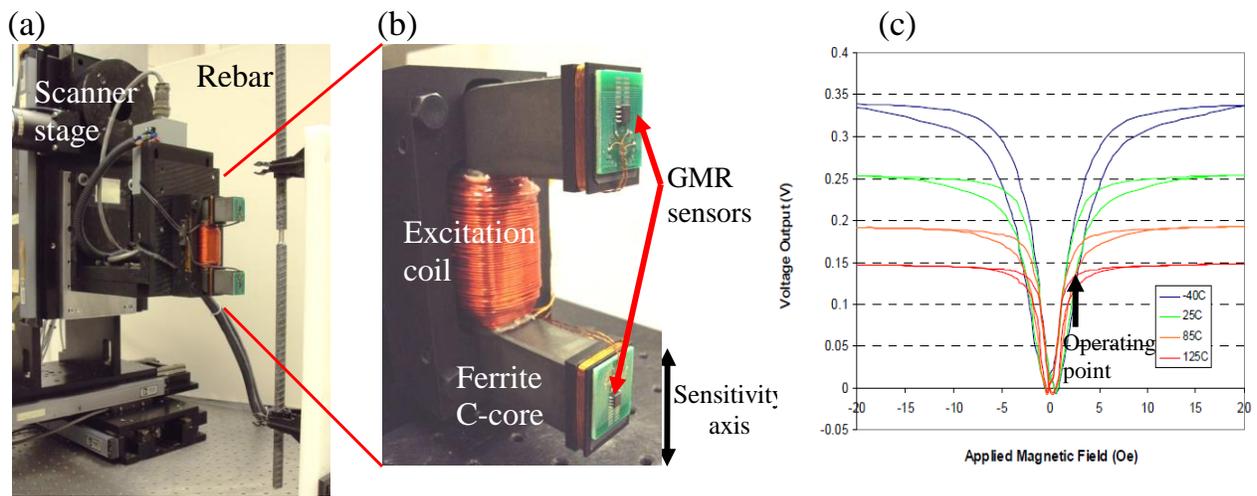
Figure 26. (a) Experimental setup for performing MFL scans, (b) close-up of the MFL sensor probe and (c) nominal output of the GMR sensors versus magnetic field (Bligh et al. 1994)

The experimental setup for performing MFL scans on bare reinforcing steel and concrete test specimens in the laboratory is shown in Figure 26a. Figure 26b shows a close-up of the MFL sensor probe that consists of an electromagnet to apply the magnetizing field and two GMR sensors to detect the vertical component of leakage field at the pole-piece of the electromagnet.
