Feasibility Study for Detection and Quantification of Corrosion in Bridge Barrier Rails

Final Report
April 2013

Sponsored by
Federal Highway Administration
Iowa Department of Transportation
(InTrans Project 11-413)

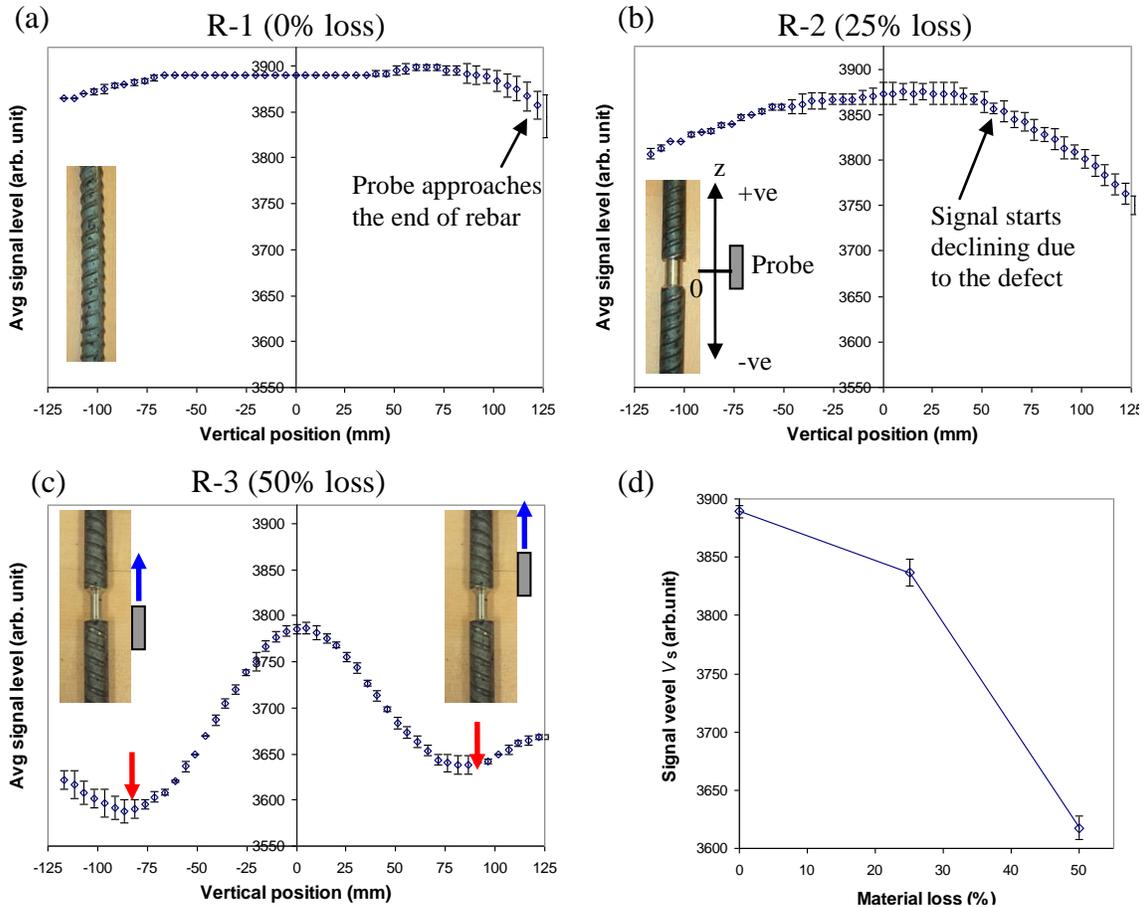
Figure 27. (a-c) EC signal levels (in arbitrary unit) versus vertical position of the sensor probe and (d) dependence of the averaged EC signal level detected at 3 in. from the defect on the amount of material loss

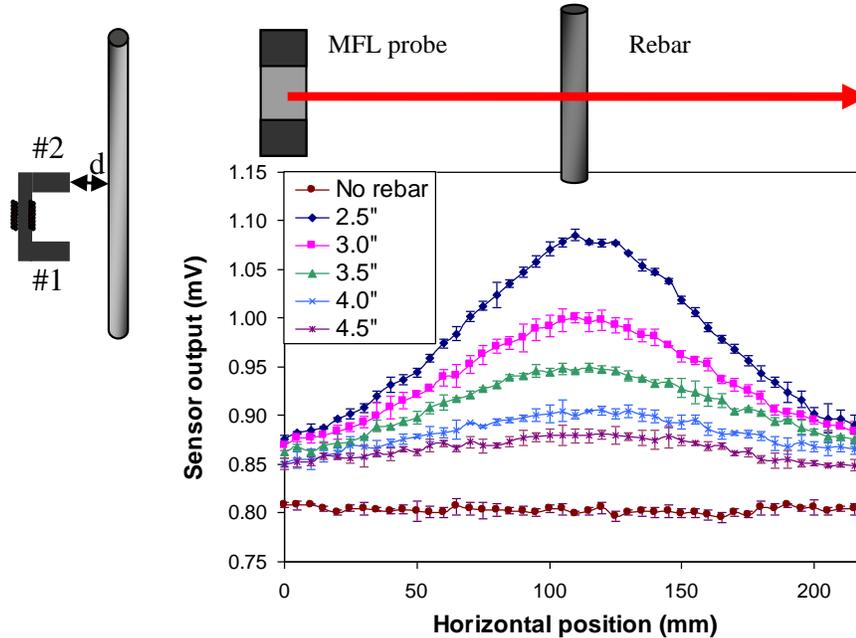
Figure 28. GMR sensor output versus the horizontal position of the MFL sensor probe at various perpendicular distances from the reinforcing steel

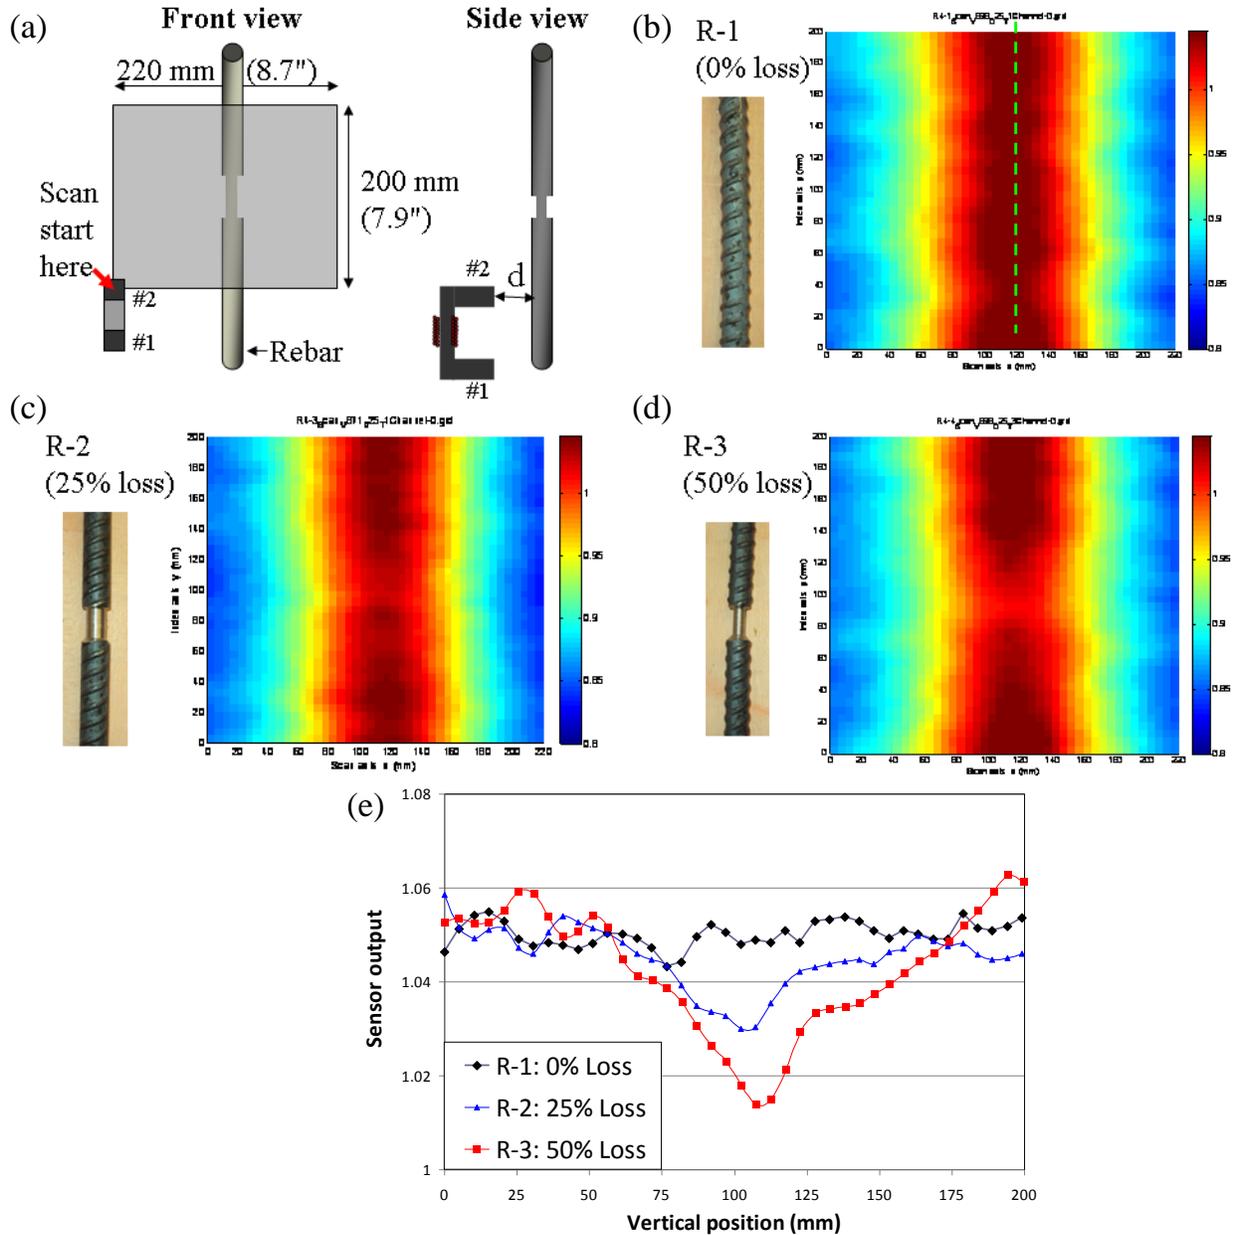
Figure 29. (a) Size and coverage of raster scans over bare #4 reinforcing steel, (b-d) C-scan images, and (e) profile of sensor outputs

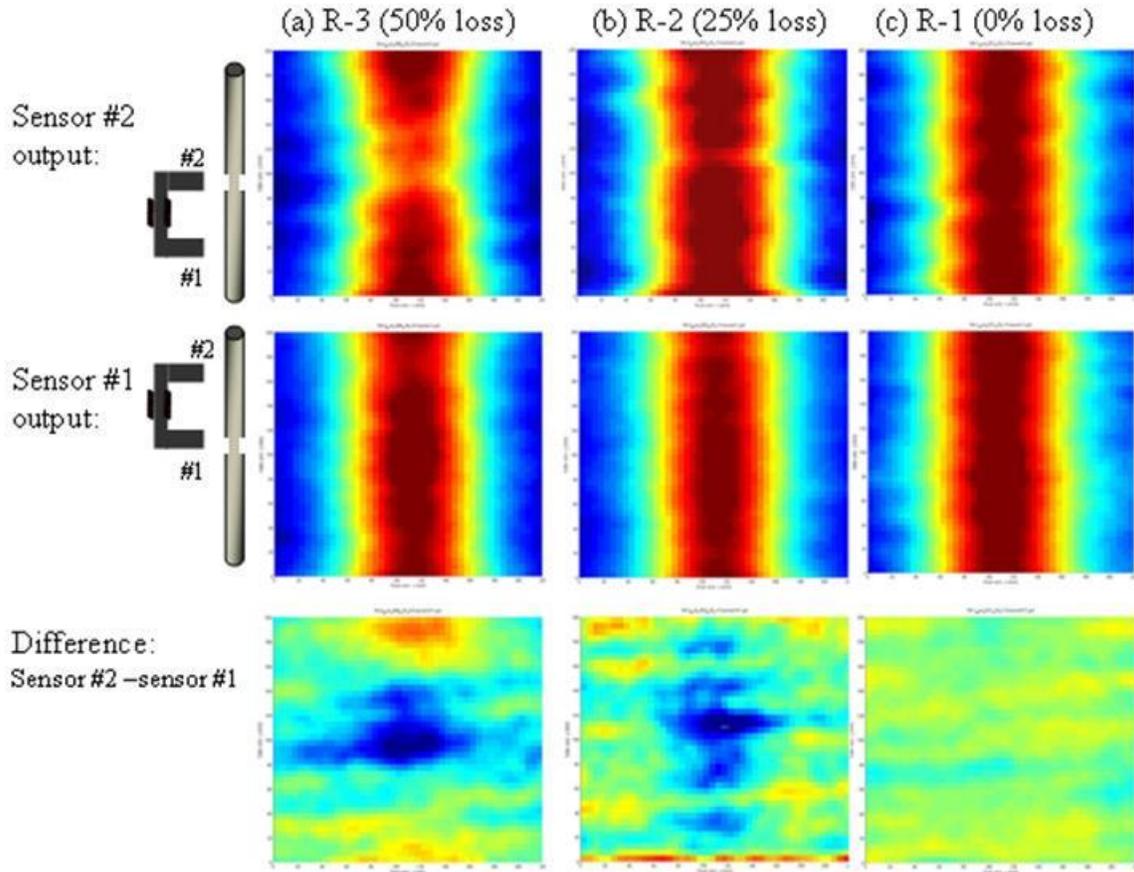
Figure 30. C-scan MFL images for bare reinforcing steel specimens

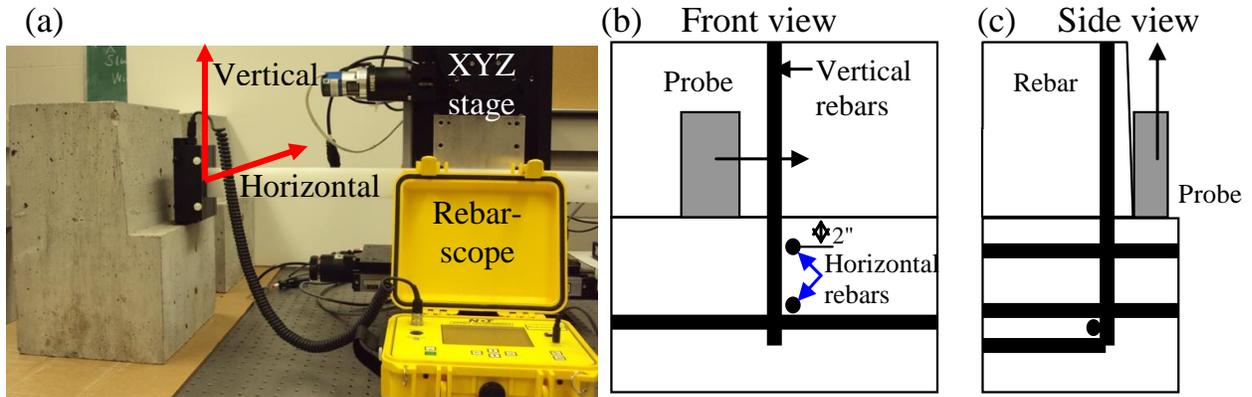
Figure 31. Experimental setup for performing EC line scans on the concrete test specimens

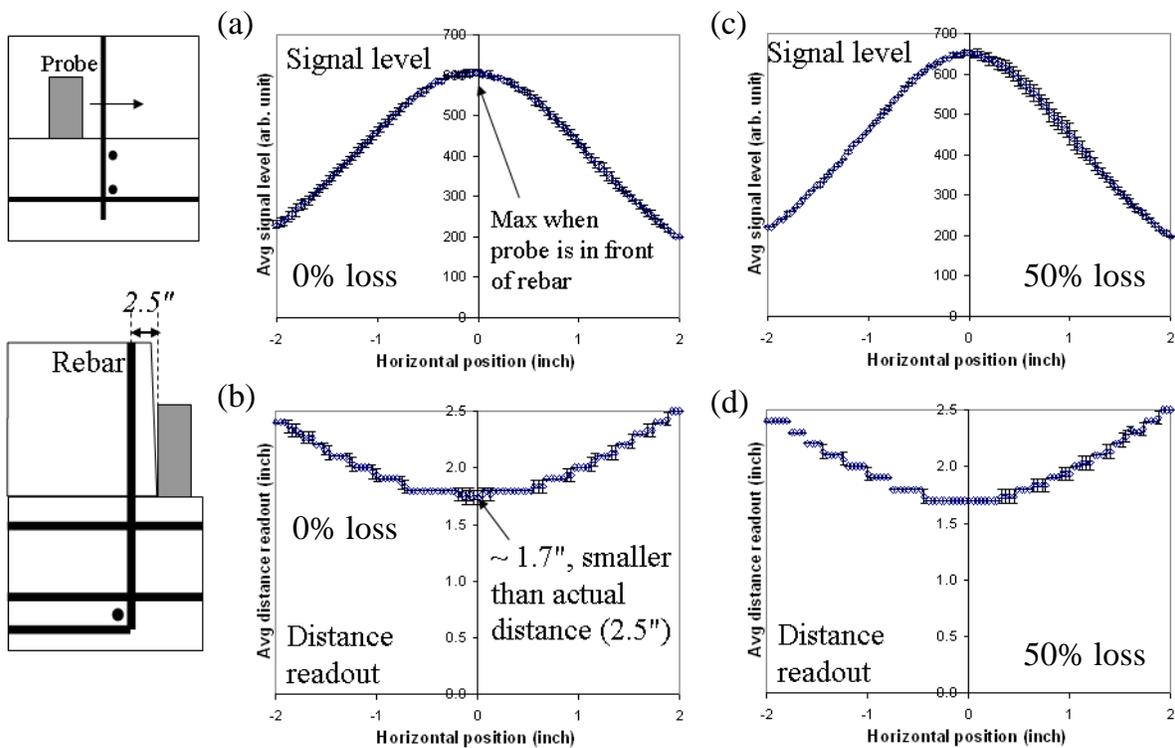
Figure 32. (a and c) EC signal levels and (b and d) distance reading obtained from horizontal line scans over the concrete test specimens

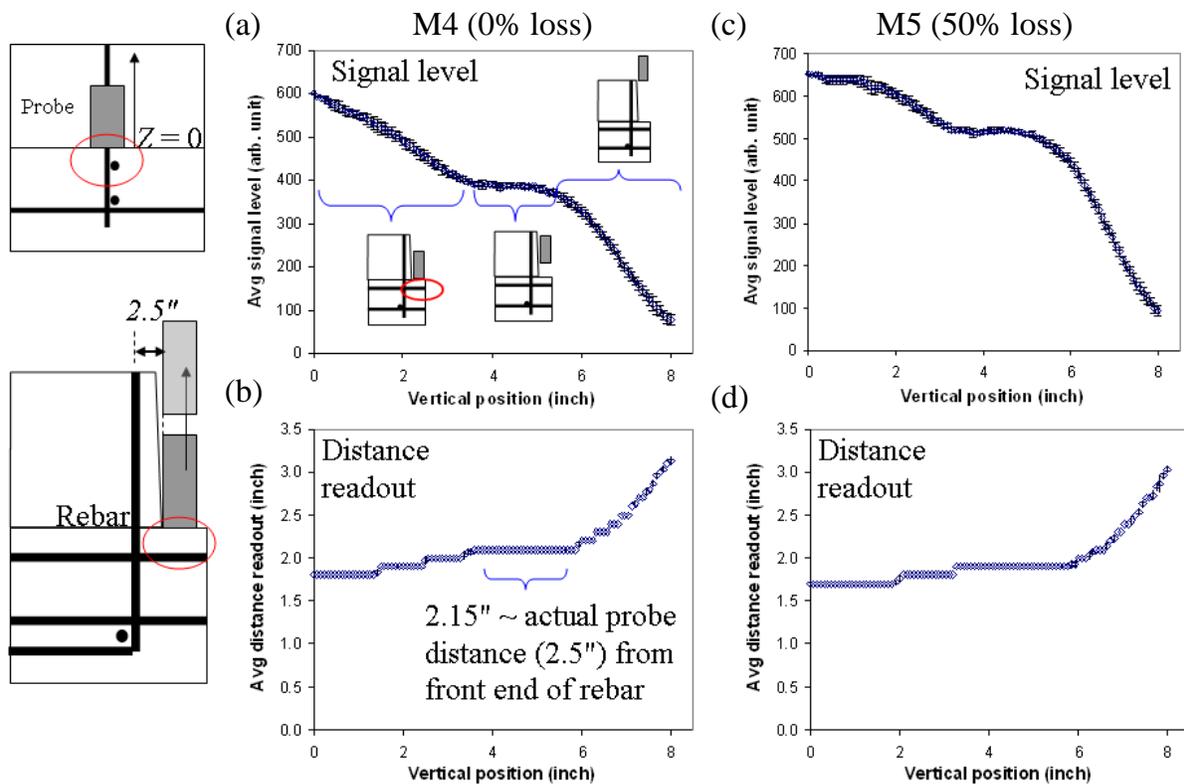
Figure 33. (a and c) EC signal levels and (b and d) distance reading obtained from vertical line scans over the test specimens

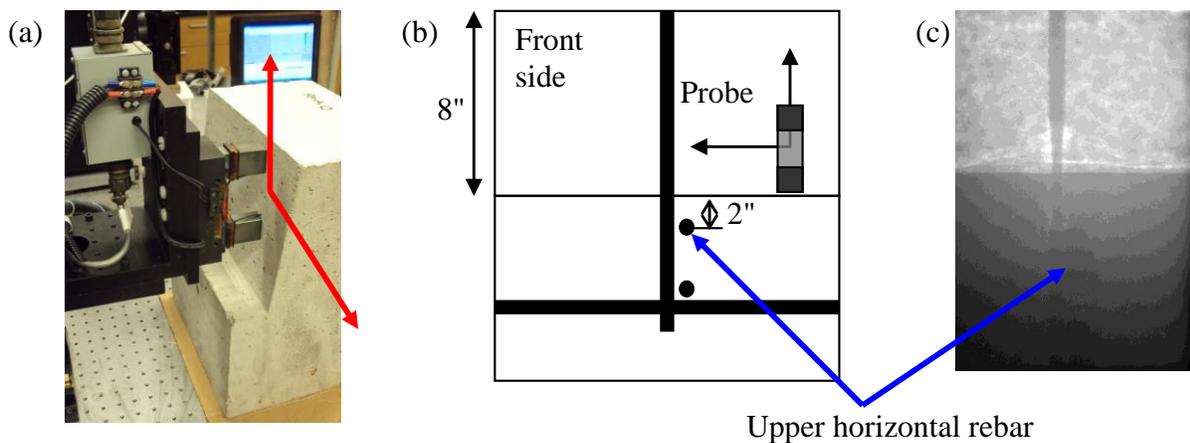
Figure 34. Experimental setup for raster MFL scans and x-ray image of test specimens

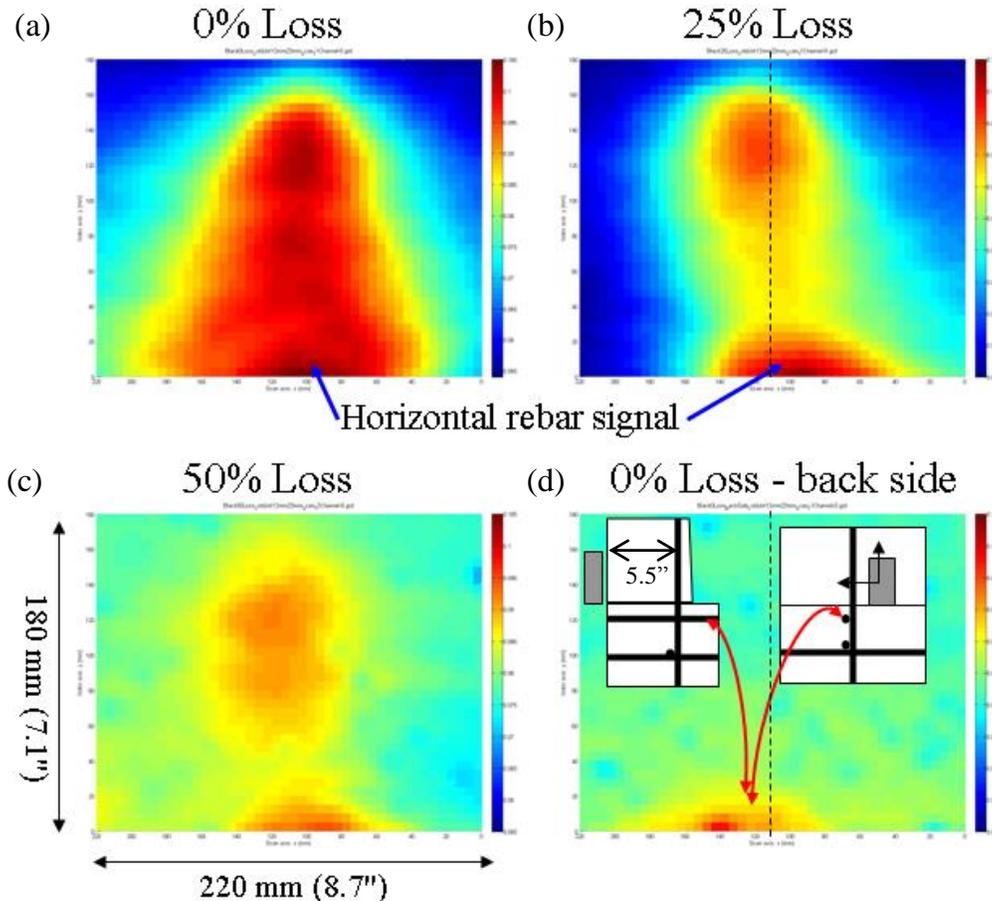
Figure 35. C-scan images of test specimens and the regions of strong signal levels caused by the horizontal reinforcing steel

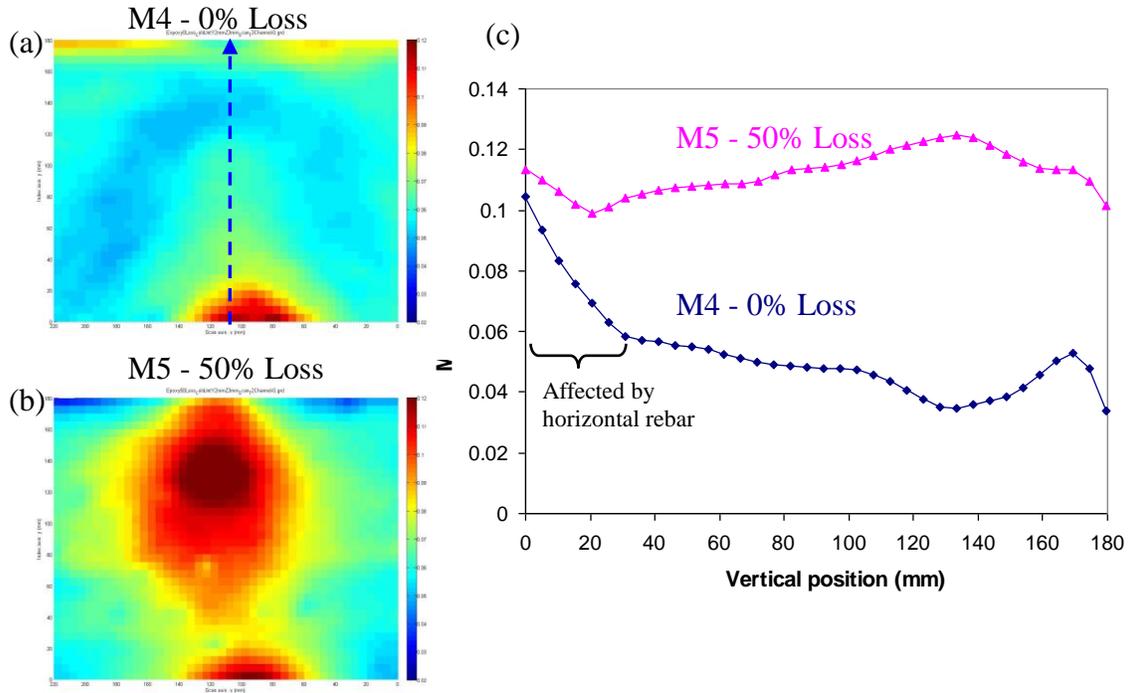
Figure 36. C-scan images of the test specimens and comparison of signal levels

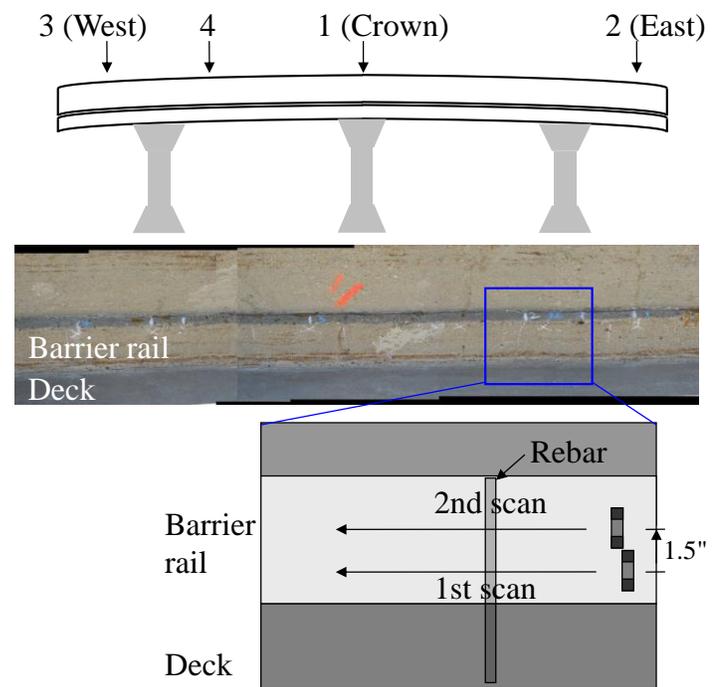
Figure 37. Iowa Highway 210 Bridge MFL field testing

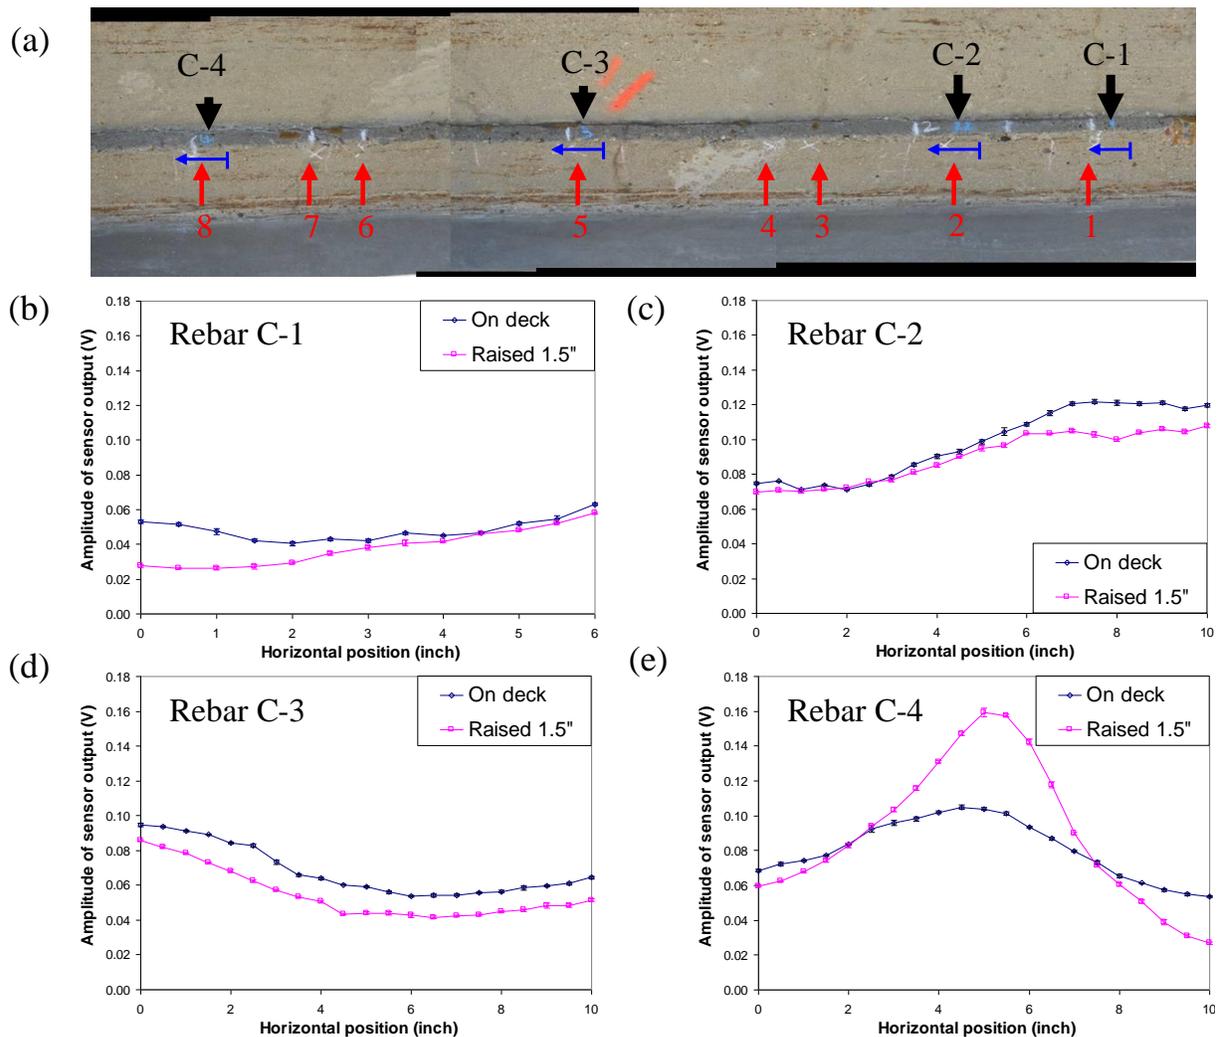
Figure 38. Crown section of the Highway 210 Bridge barrier rail

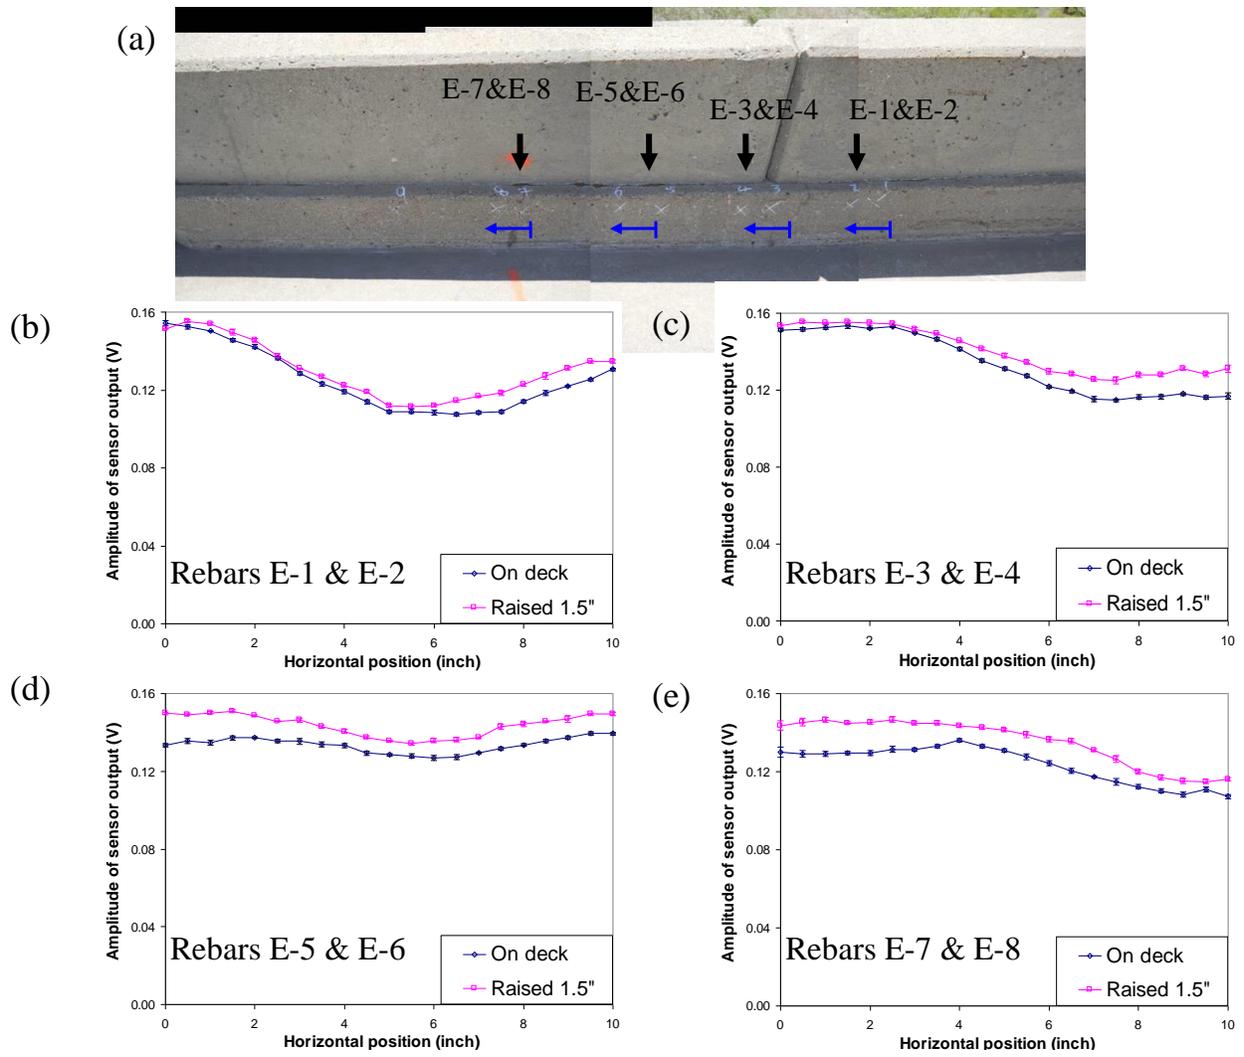
Figure 39. East-end section of barrier rail

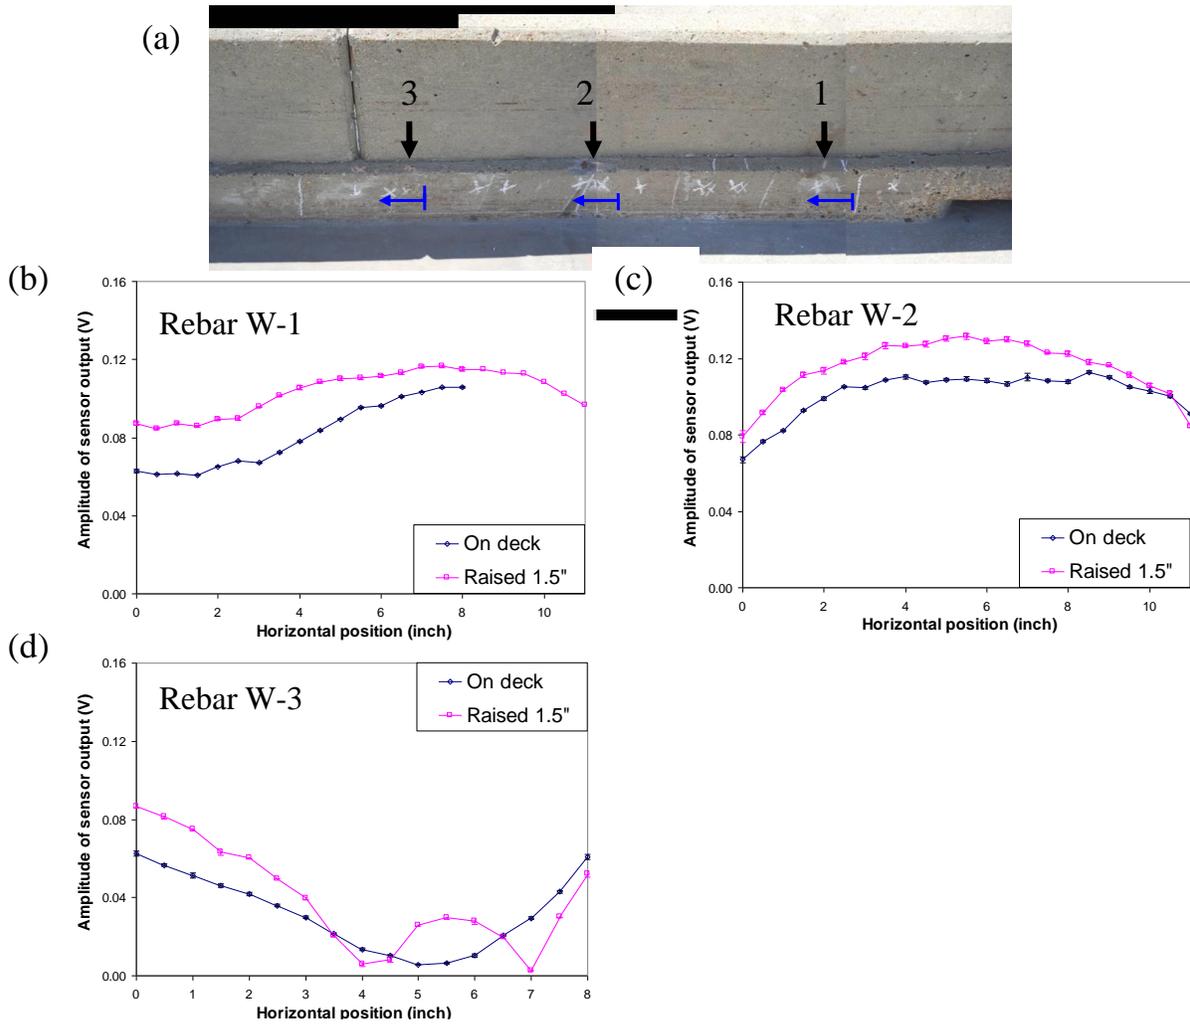
Figure 40. West-end section of barrier rail

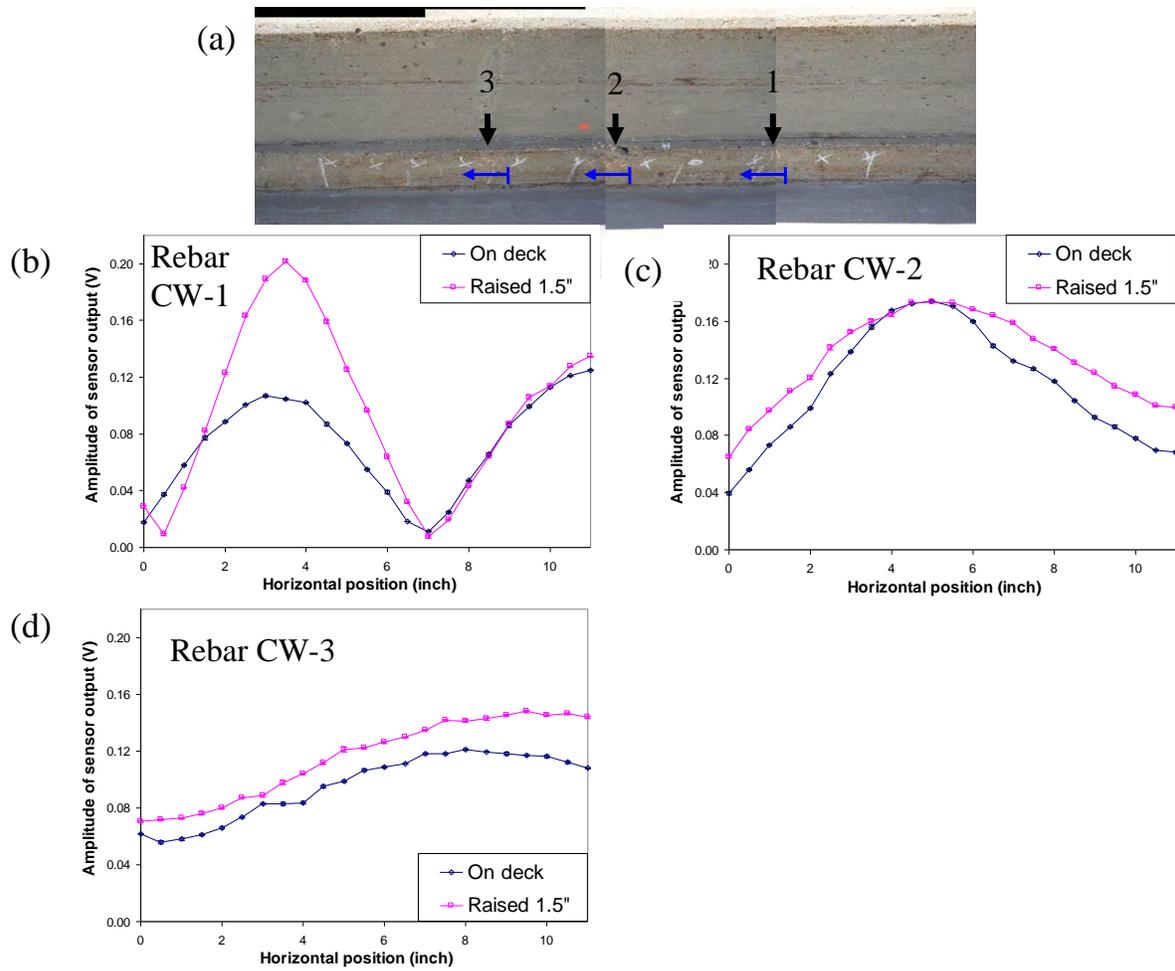
Figure 41. Section 4 of barrier rail

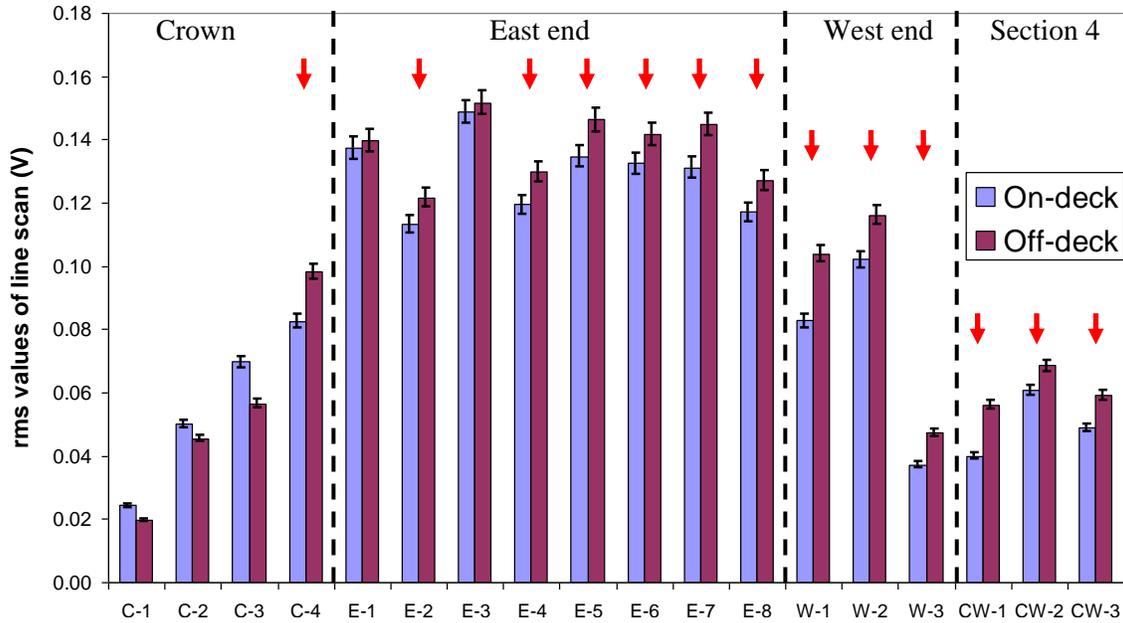
Figure 42. rms values of the on-deck and off-deck MFL line scan data from the selected reinforcing steel in the field test

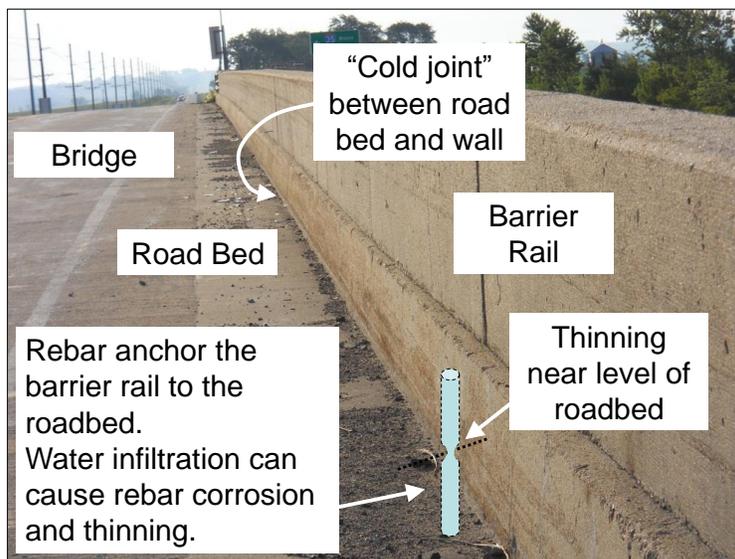
Figure 43. Bridge inspection problem

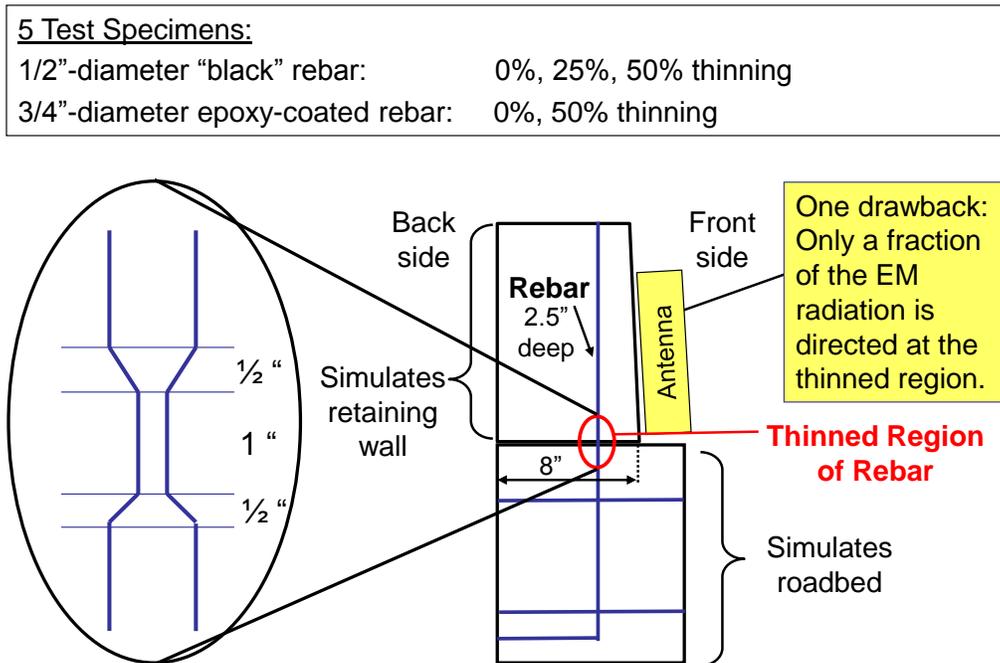
Figure 44. Relative positions of the GPR antenna and thinned reinforcing steel in laboratory test specimens

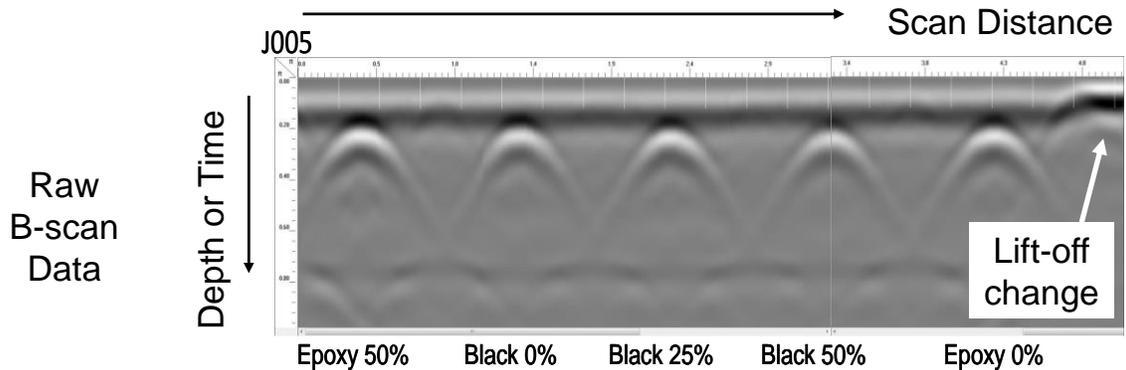
Figure 45. B-scan (bottom) obtained by scanning the GPR antenna across the five aligned test specimens (top)

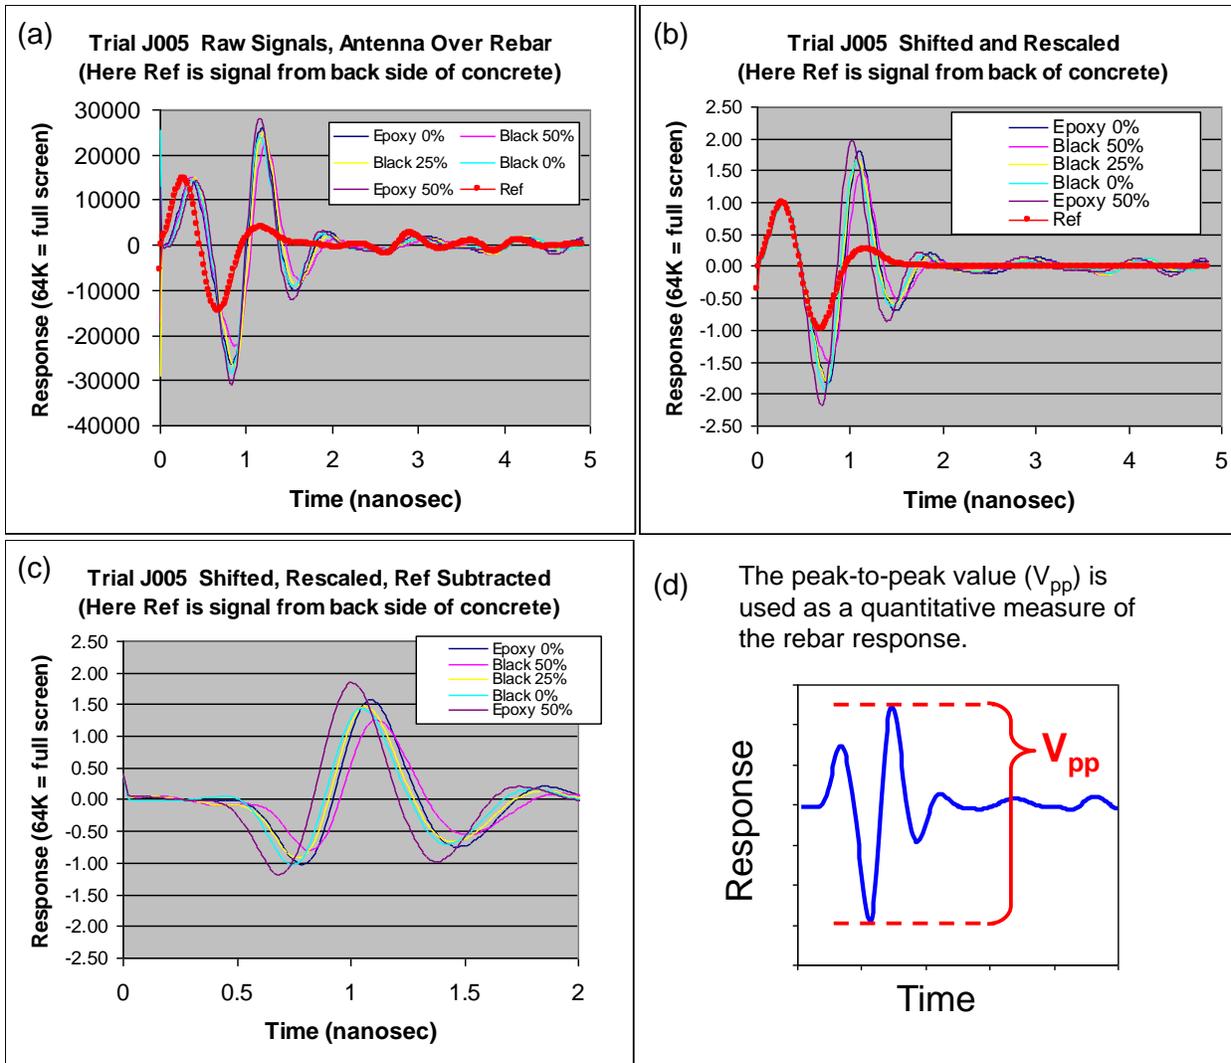
Figure 46. Processing of GPR waveform (A-scan) data from test specimens

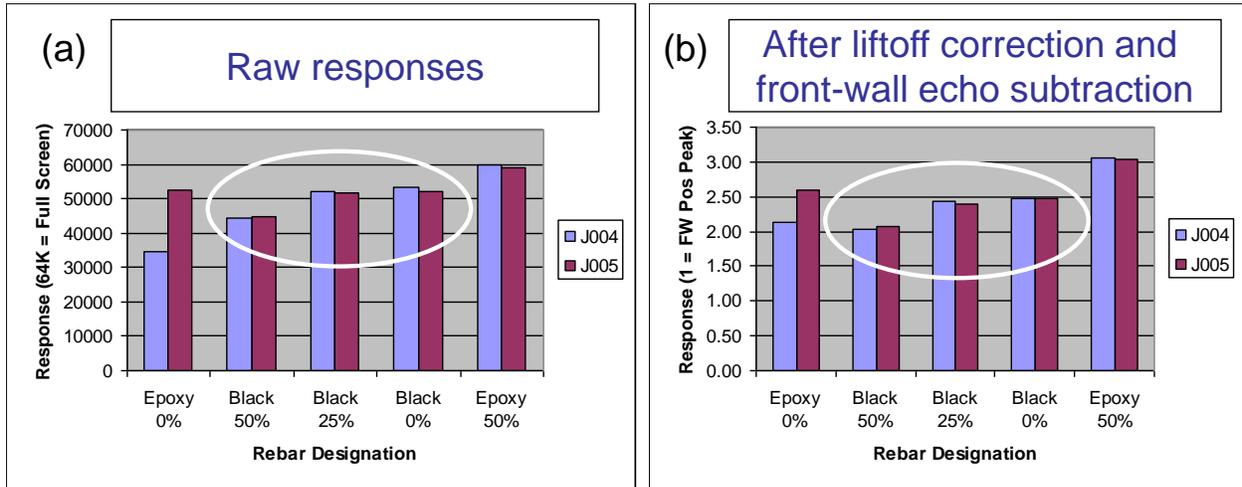
Figure 47. As-measured (a) and corrected (b) peak-to-peak responses for the vertical reinforcing steel in the five test specimens for right-to-left (J004) and left-to-right (J005) measurements

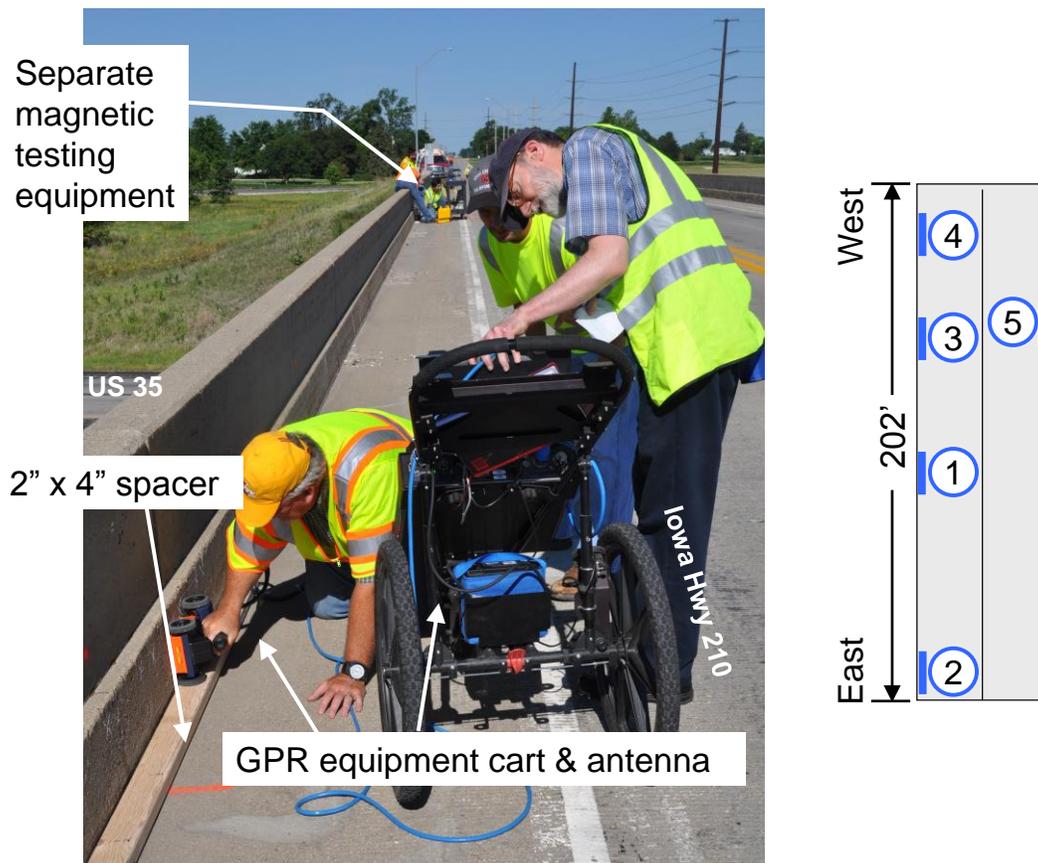
Figure 48. GPR scan showing 2 by 4 being used to elevate antenna above the bridge deck

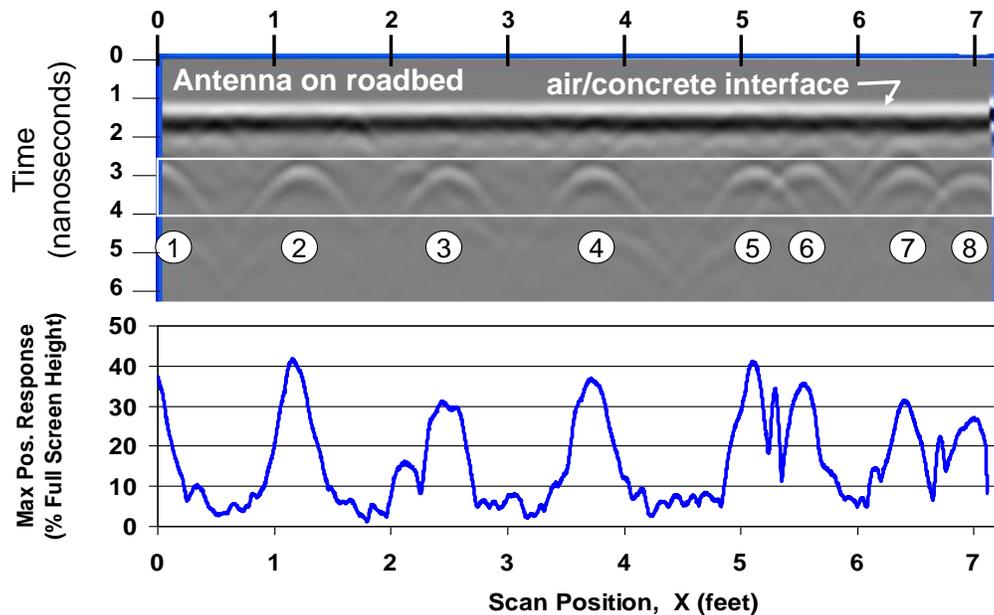
Figure 49. Sample GPR data from field test

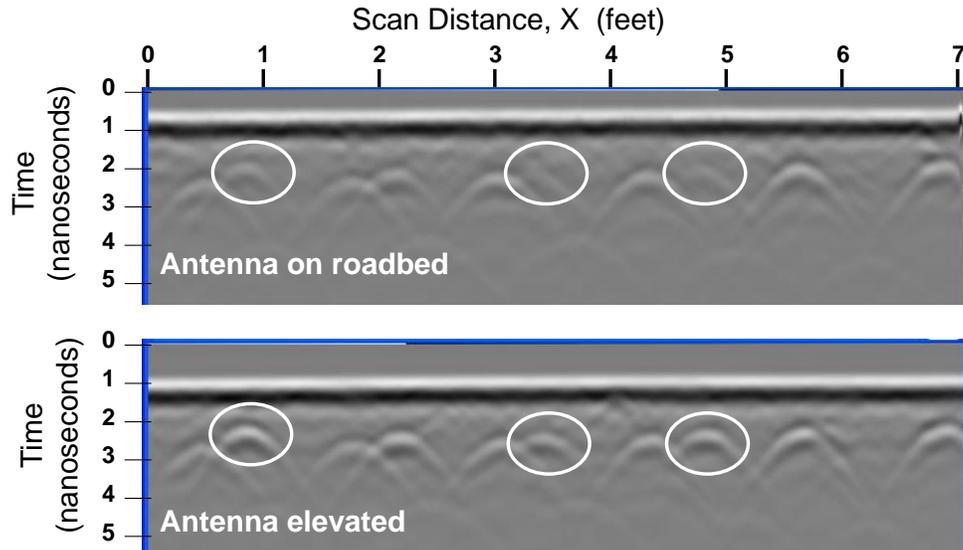
Figure 50. Comparison of GPR B-scans for antenna carriage flush with bridge deck (top) and carriage elevated by the 2 by 4 (bottom)

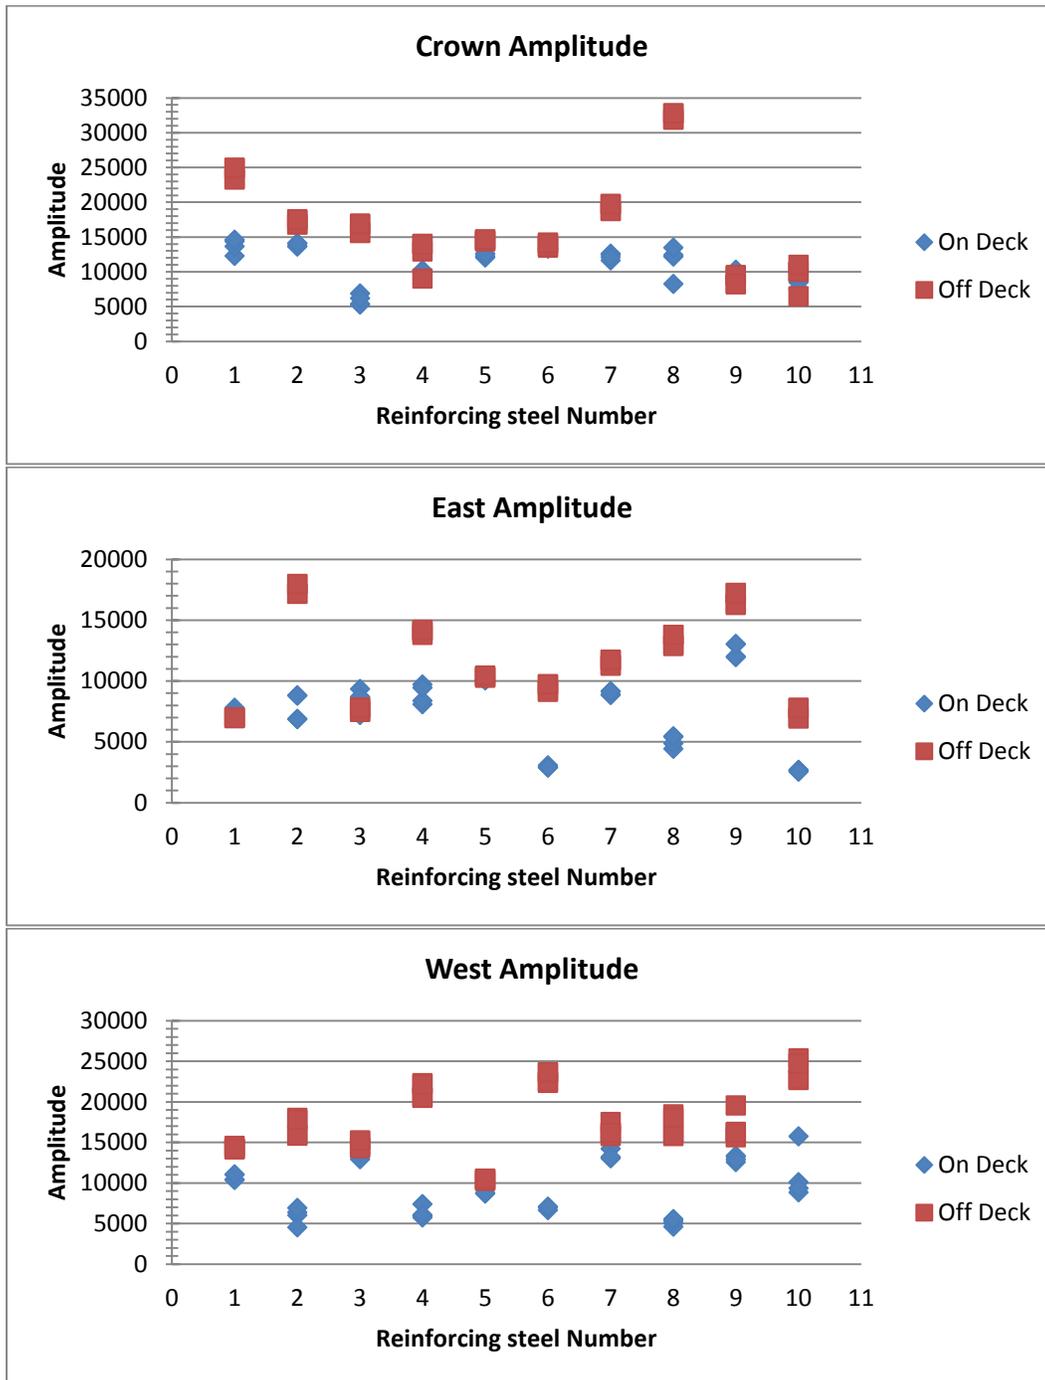
Figure 51. Summary of measured peak reinforcing steel responses for GPR inspection of the bridge barrier rails
