Feasibility Study for Detection and Quantification of Corrosion in Bridge Barrier Rails

Final Report
April 2013

Sponsored by
Federal Highway Administration
Iowa Department of Transportation
(InTrans Project 11-413)

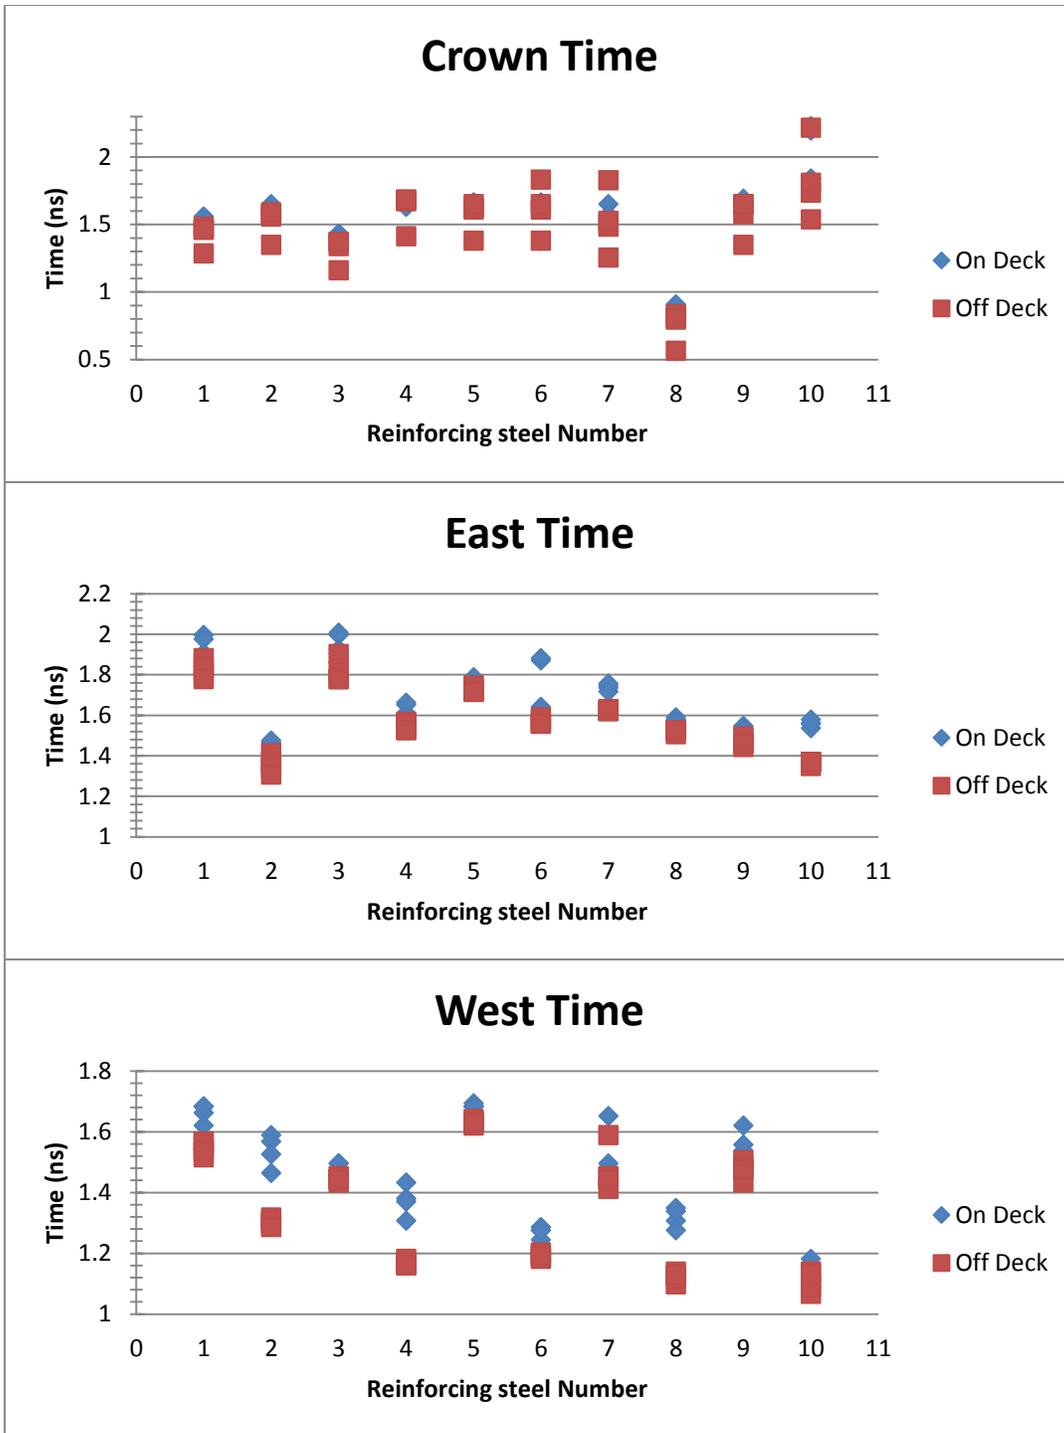
Figure 52. Reinforcing steel signal time of flight on deck versus off deck number for locations near the east, crown and west end of the bridge

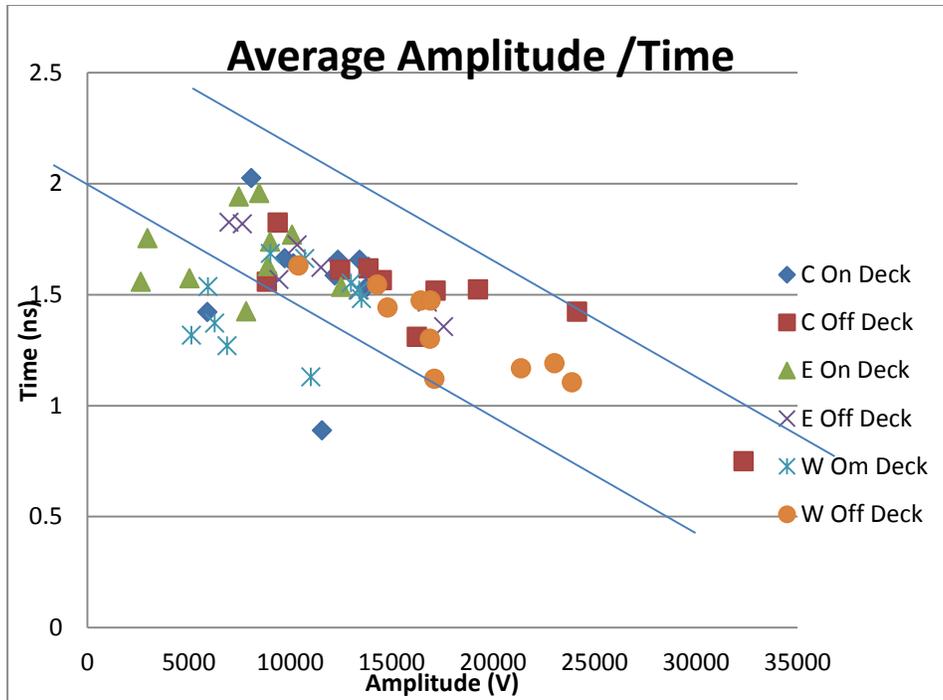
Figure 53. Average time versus average amplitude for all reinforcing steel

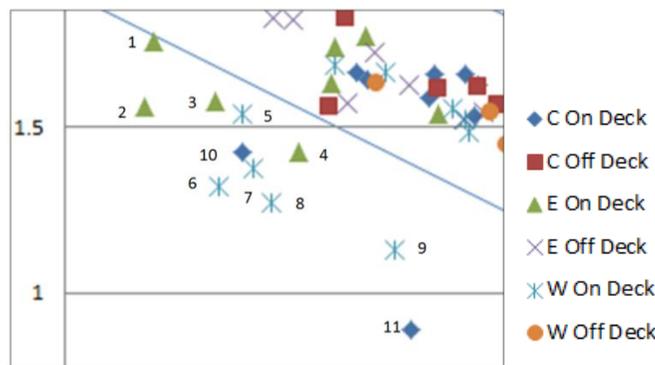
Figure 54. Identification of suspect reinforcing steel

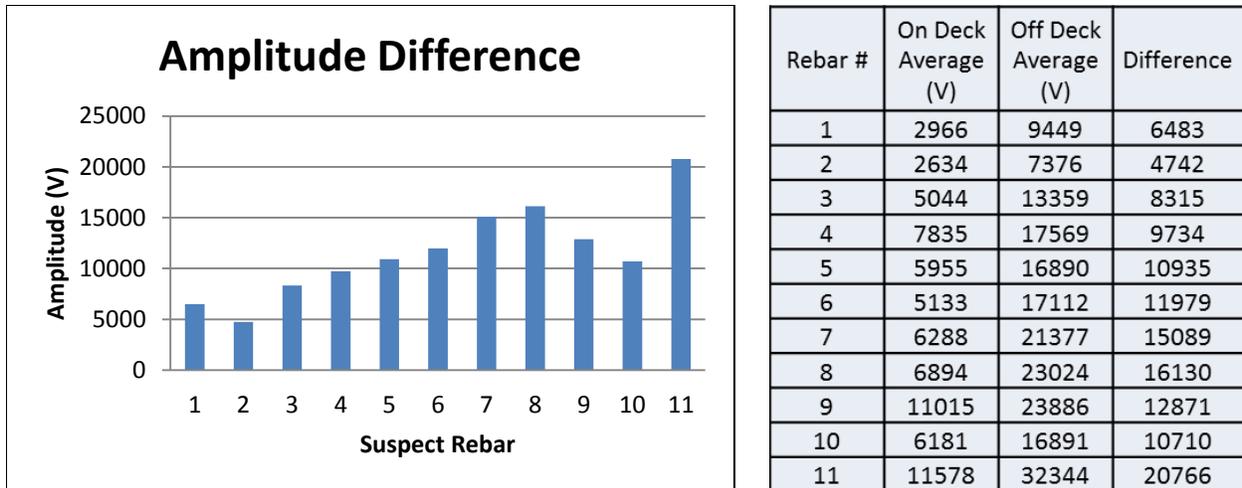
Figure 55. Amplitude difference data for the 11 suspect reinforcing bars

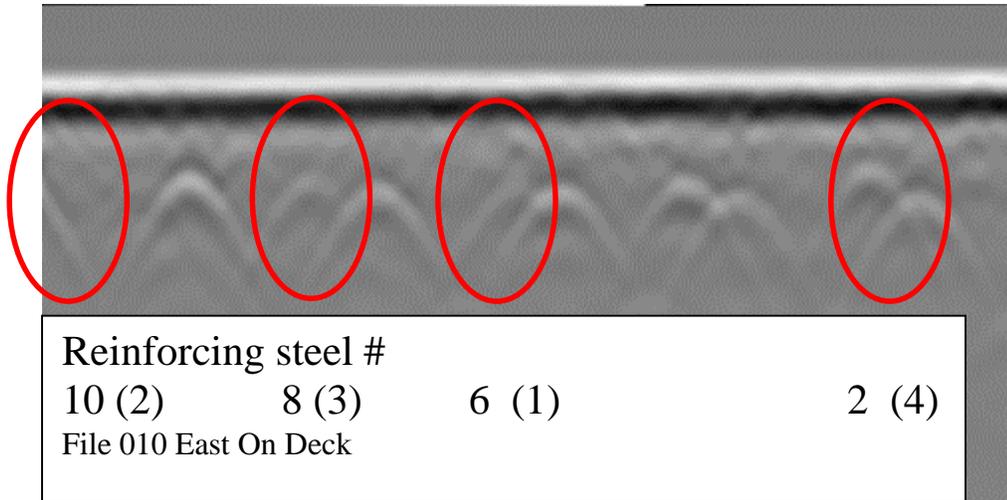
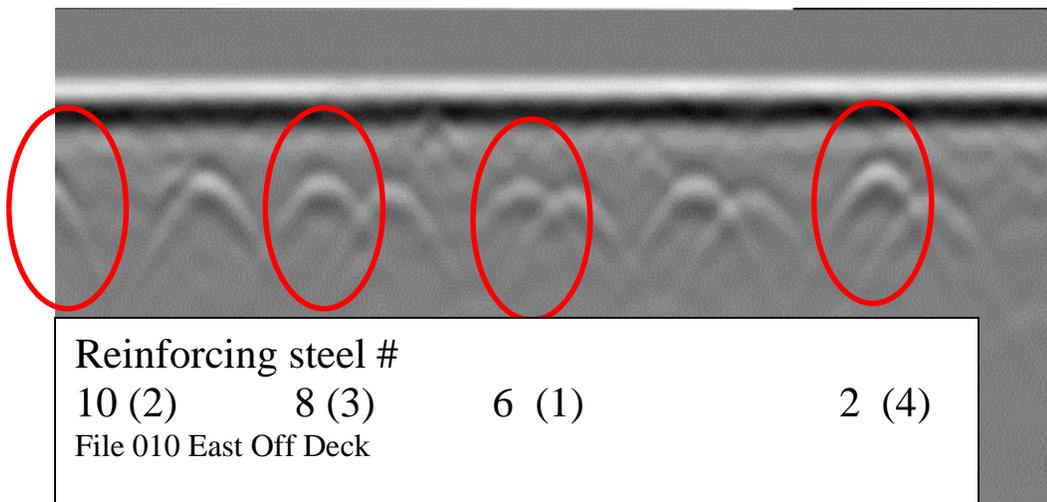
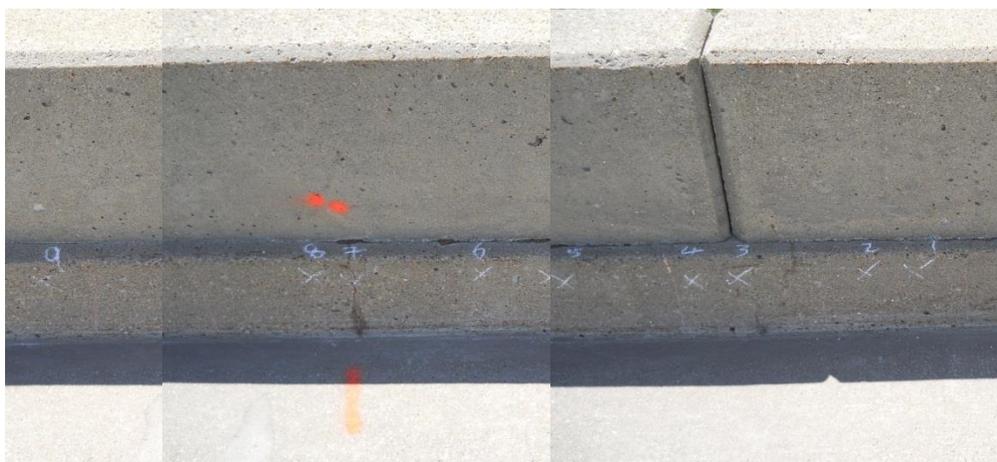
Figure 57. Suspect locations on the east end of the bridge

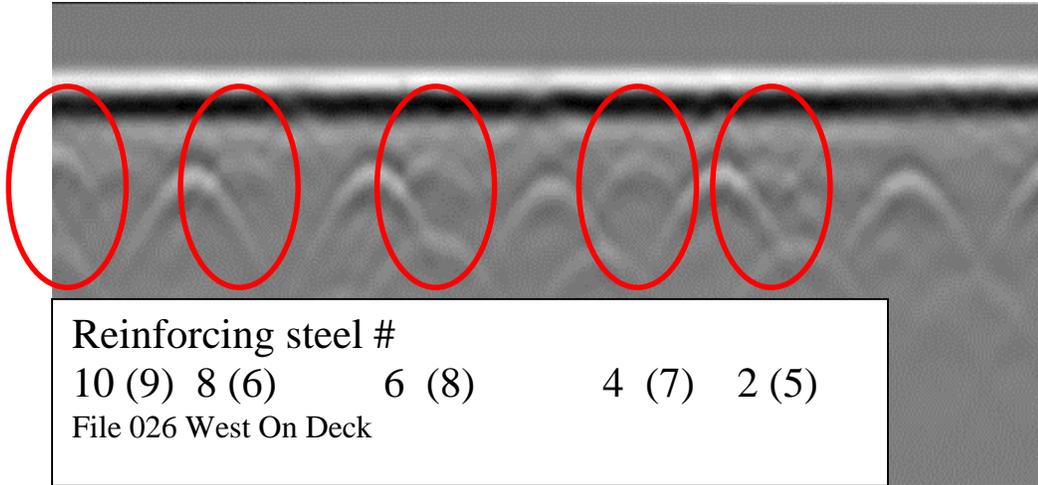
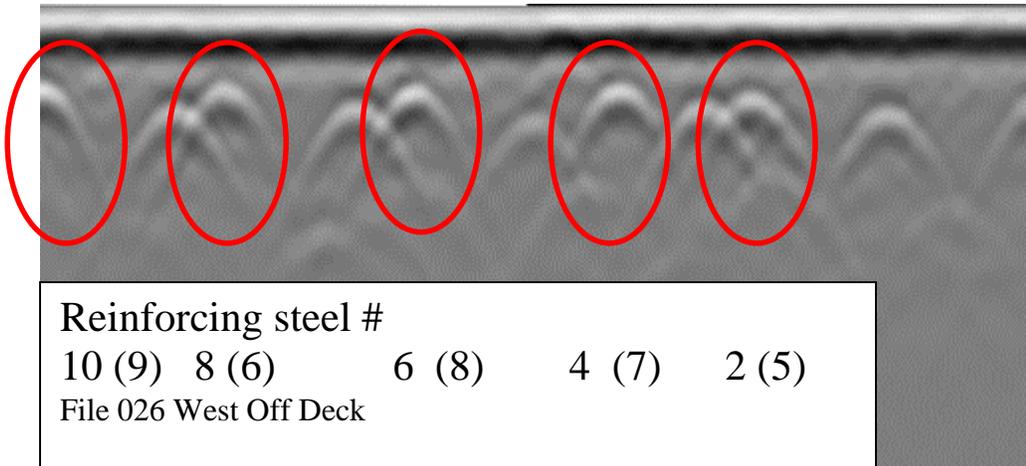
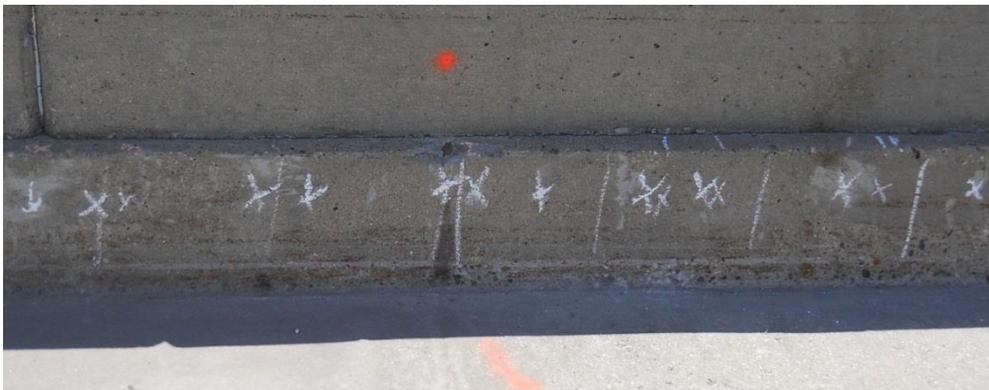
Figure 58. Suspect locations on the west end of the bridge

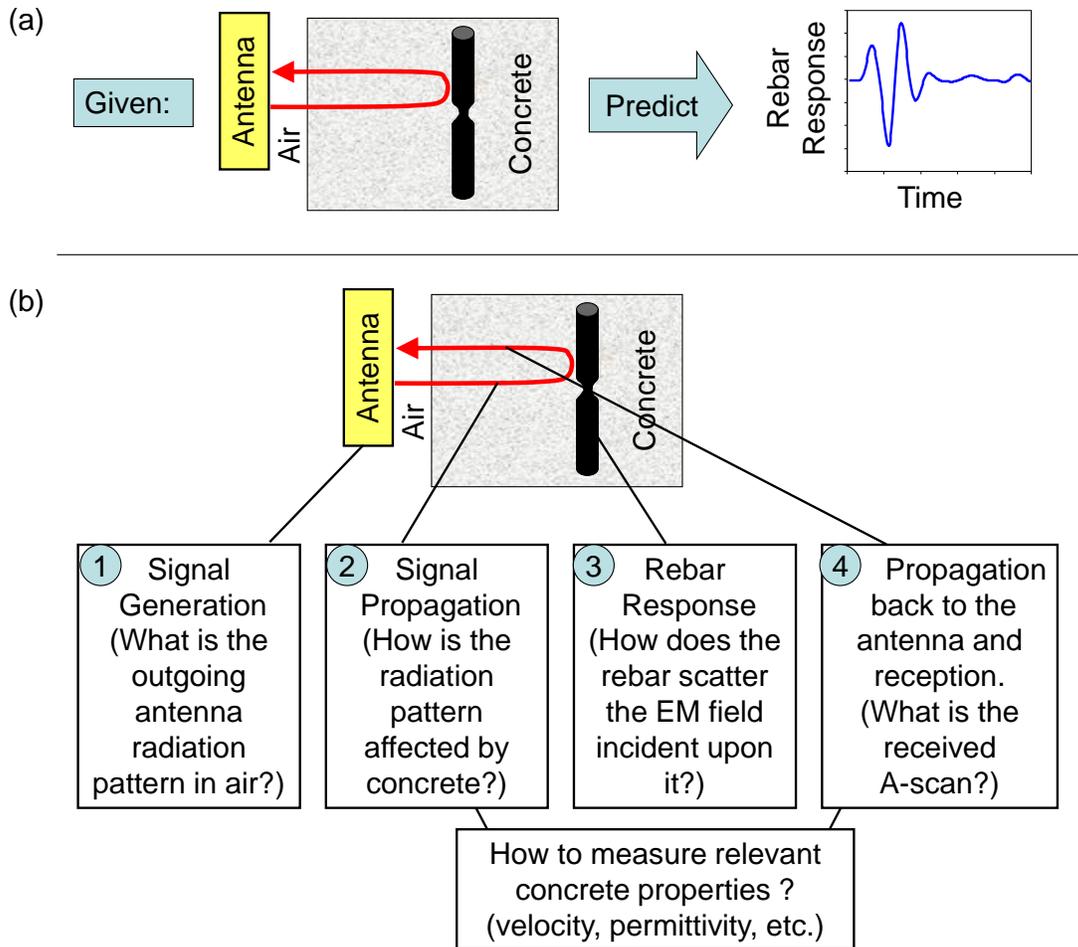
Figure 59. (a) Simulation tools under development to predict GPR reinforcing steel responses and (b) several processes contribute to the measured response

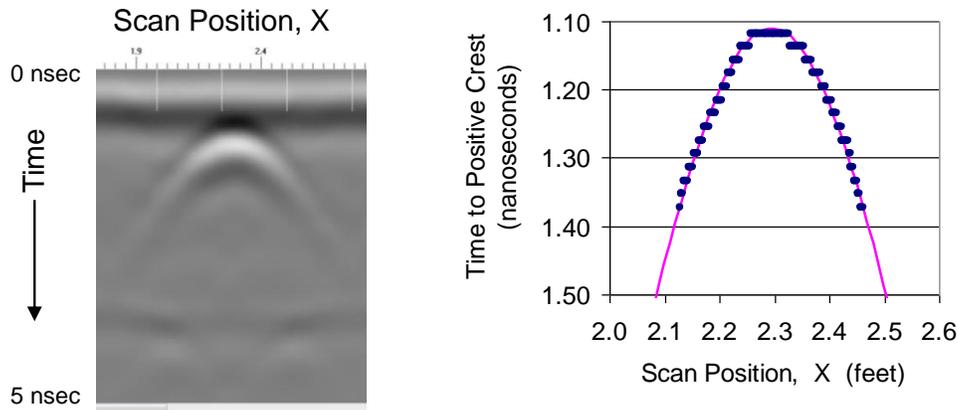
The B-scan image above shows the response obtained by scanning the antenna over a concrete test block containing one rebar target. Note the white crest (positive voltage crest) of the rebar response. At right we plot the pixel coordinates closest to that crest at each discrete scan position.

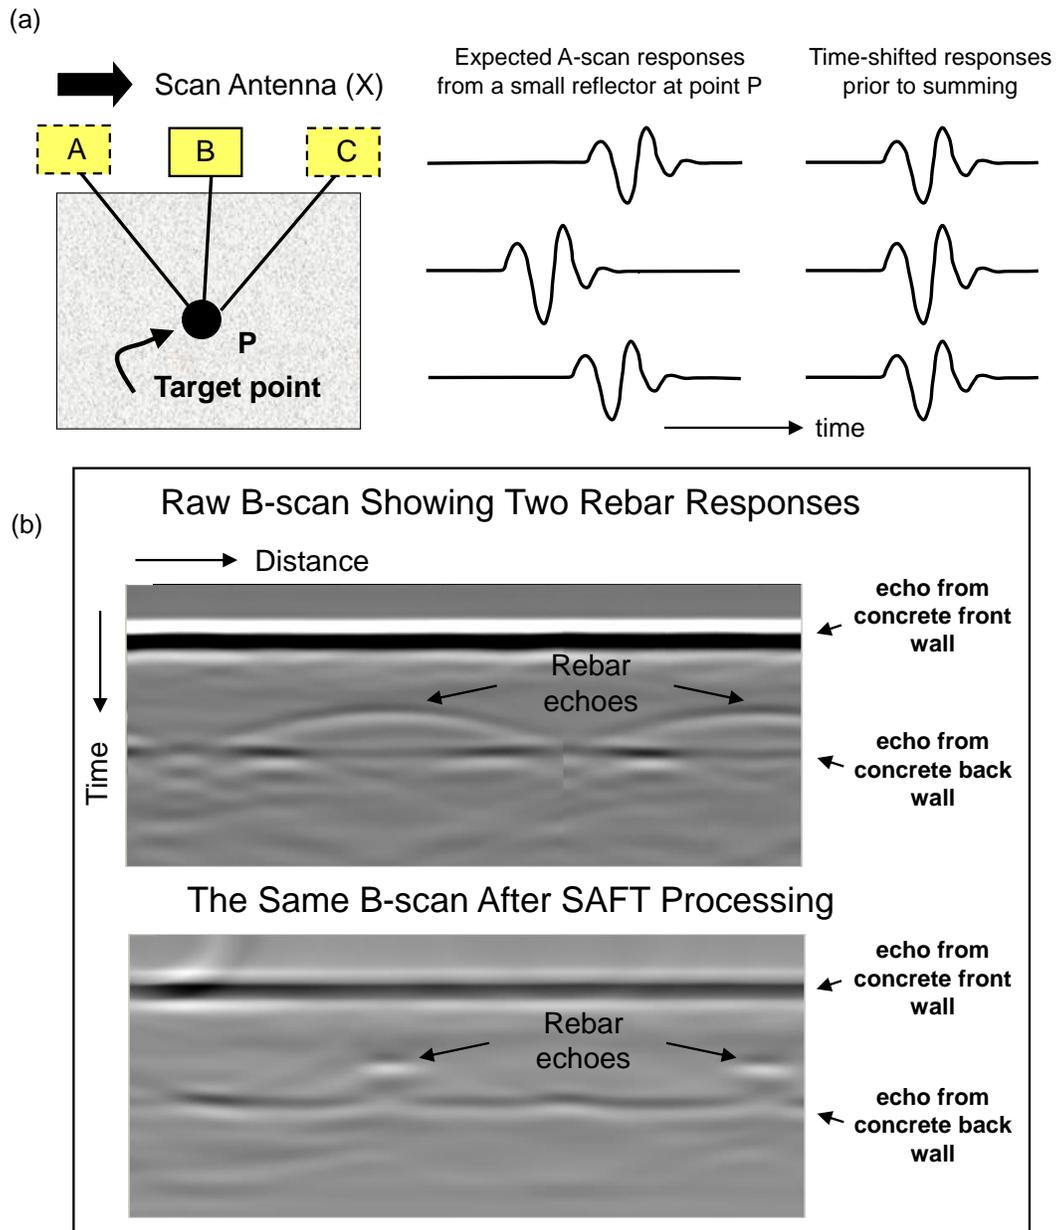
Figure 62. (a) Principle underlying SAFT processing and (b) application of SAFT to a scan over abutting concrete test specimens containing two reinforcing steel targets

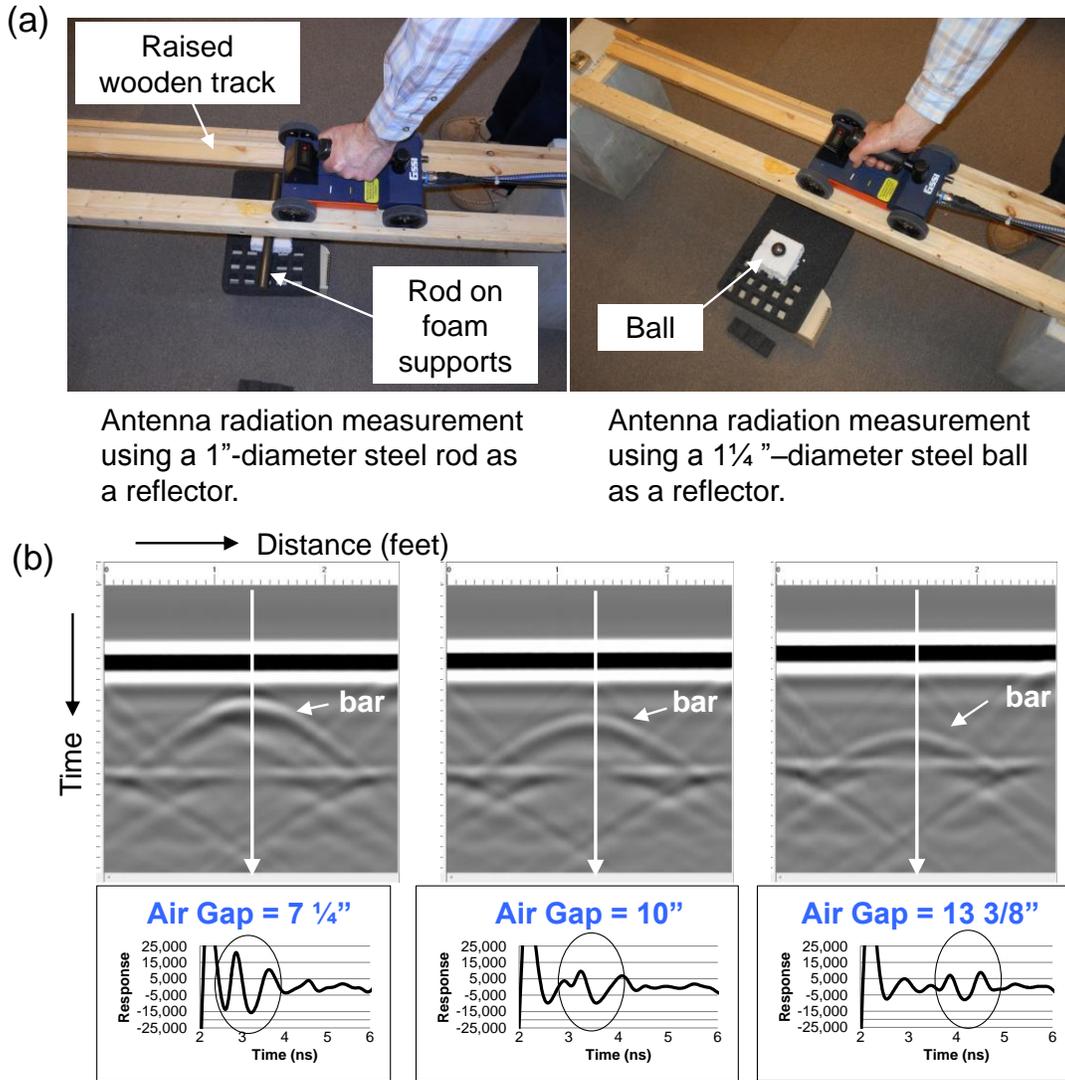
Figure 63. (a) Mapping the antenna radiation pattern using rod and ball targets and (b) B-scans for three choices of the air gap between the antenna and the rod target and corresponding A-scans for the peak response points

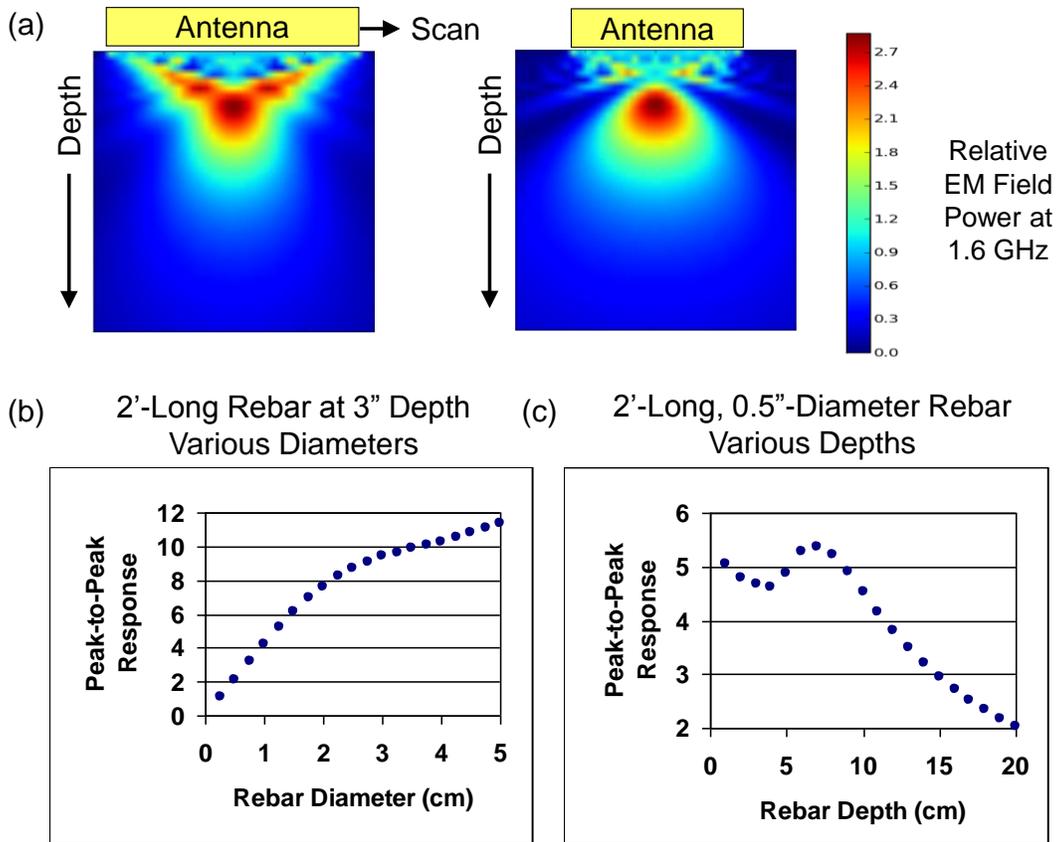
Figure 64. (a) Predicted antenna radiation pattern at 1.6 MHz assuming antenna size parameters based on the physical dimensions of the antenna housing (b-c)
