Increasing service life at bridge ends of moveable abutment bridges

A thesis submitted to the graduate faculty
in partial fulfillment of the requirements for the degree of
MASTER OF SCIENCE

Major: Civil Engineering (Structural Engineering)

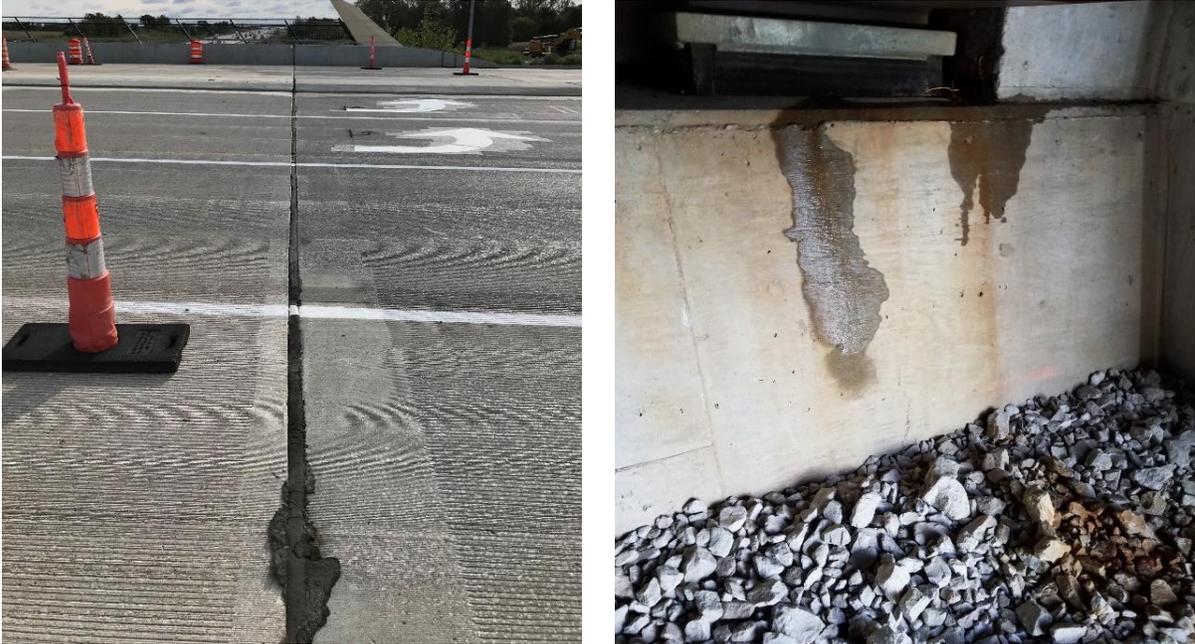
Figure 4.1. (a) South Bridge Deck to Approach Slab Joint with Excess Sealant (left), (b) Water and Abutment Staining at the Outermost Girder (right)

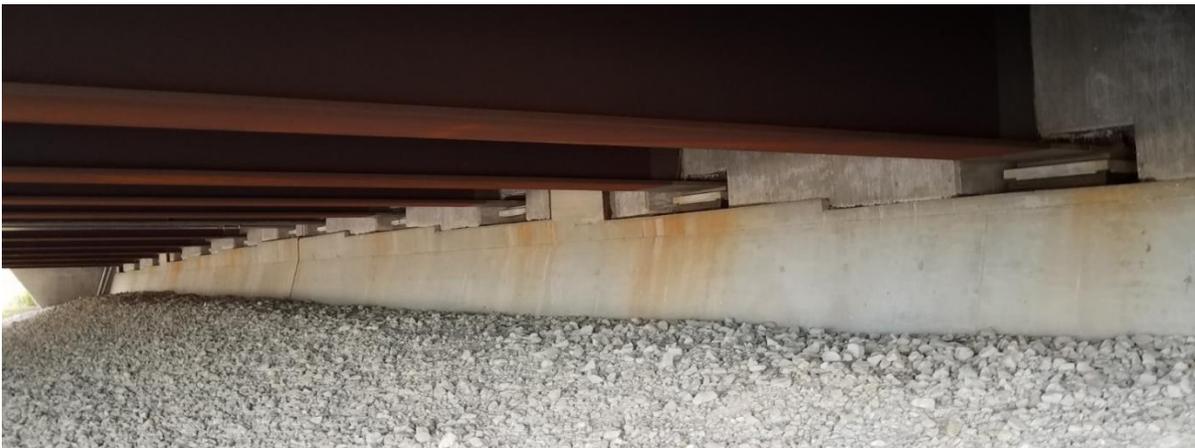
Figure 4.2. North Abutment Face

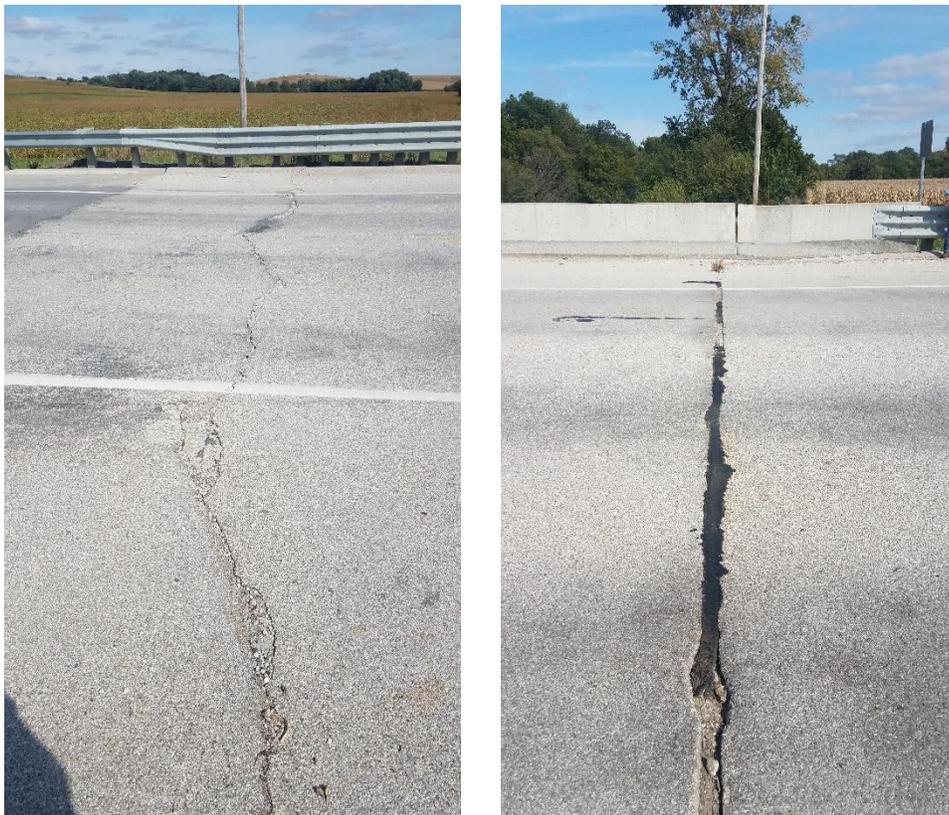
Figure 4.3. (a) Transverse Approach Slab Crack (left), (b) Bridge Deck to Approach Slab Joint (right)

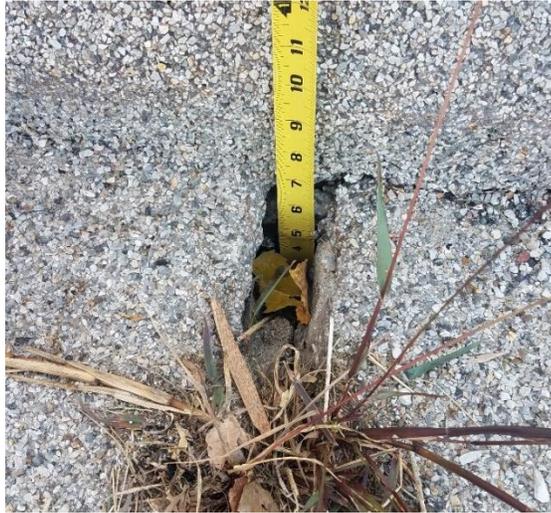
Figure 4.4. Void at the Intersection of Deck to Approach Joint and Barrier

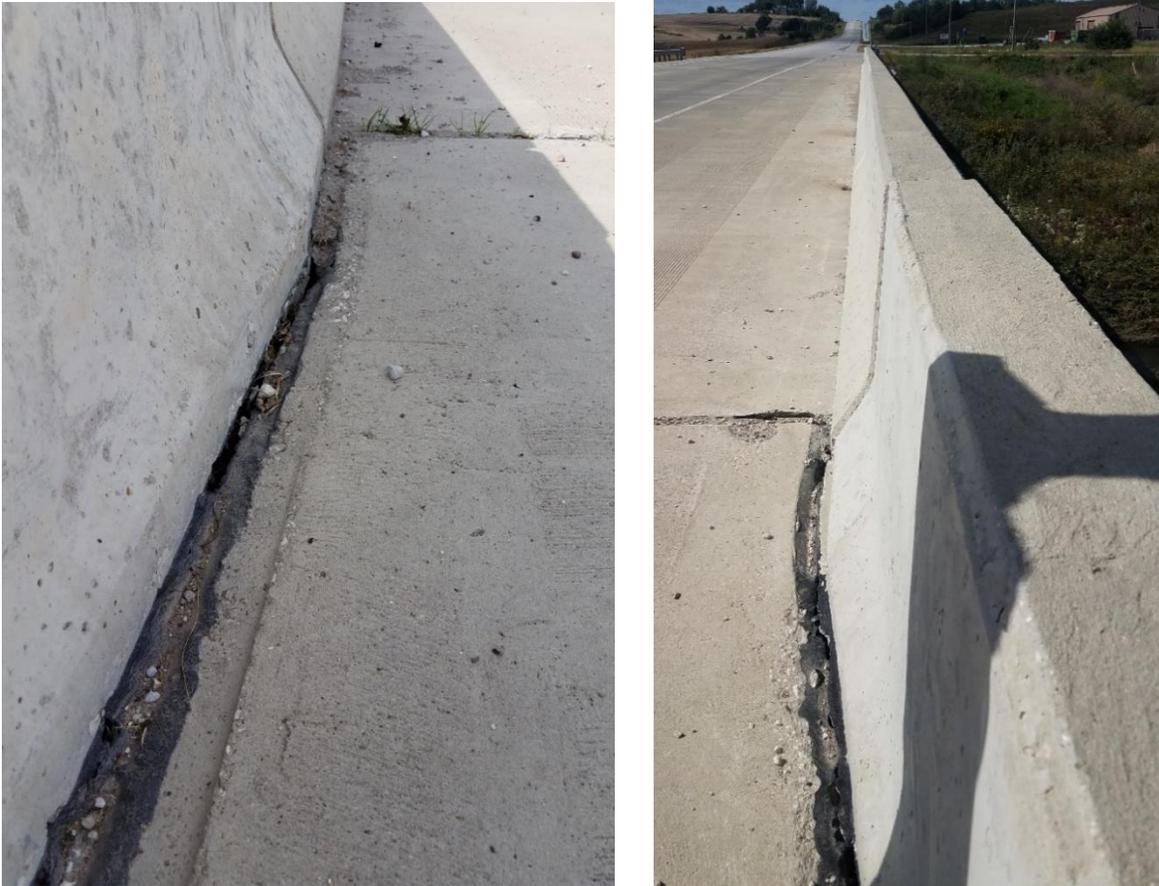
Figure 4.5. (a) Approach Slab to Wingwall Joint Showing Separation (left), (b) Misaligned Wingwall and Barrier (right)

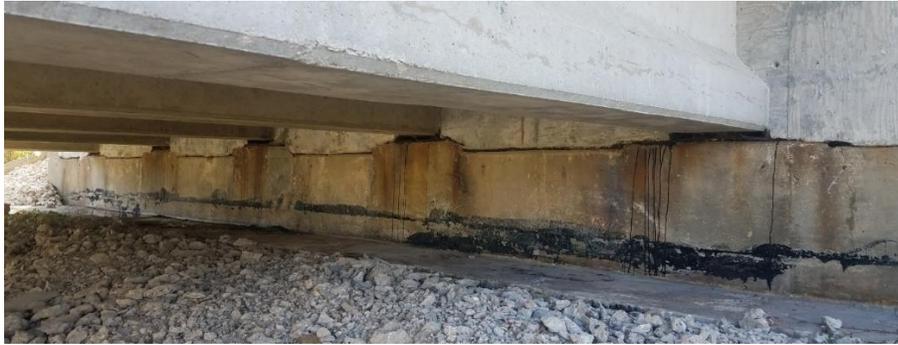
Figure 4.7. Abutment Face Showing the New Backwall on top of the Old Footing

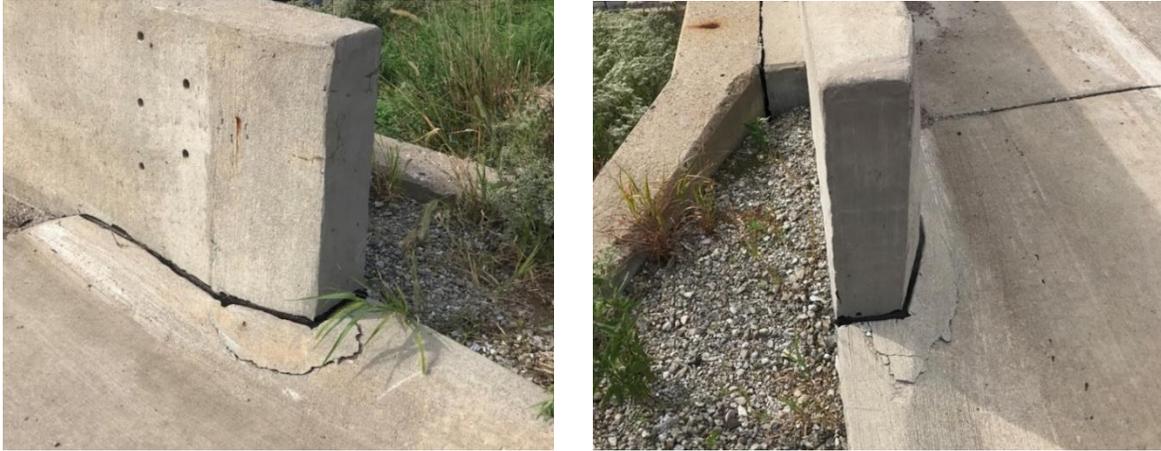
Figure 4.8. (a) Concrete Cracking at the end of the Wingwall (left), (b) Additional Cracking at the end of the Wingwall (right)

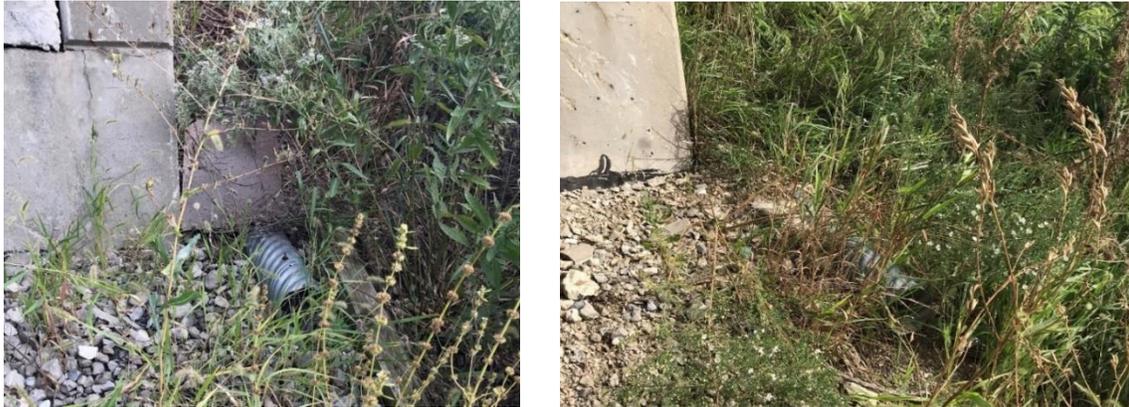
Figure 4.9. (a) Blocked Embankment Drainage (left), (b) Additional Blocked Embankment Drainage (right)

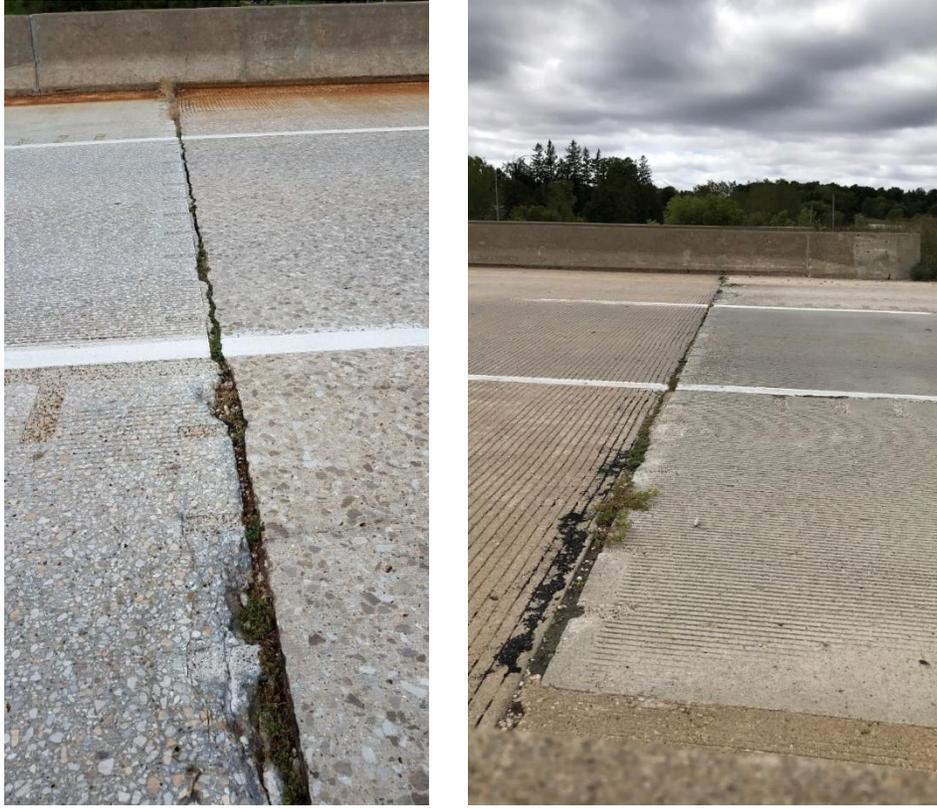
Figure 4.10. (a) Deck to Approach Slab Joint Showing Severe Spalling (left), (b) Additional Deck to Approach Slab Joint Showing Severe Spalling (right)

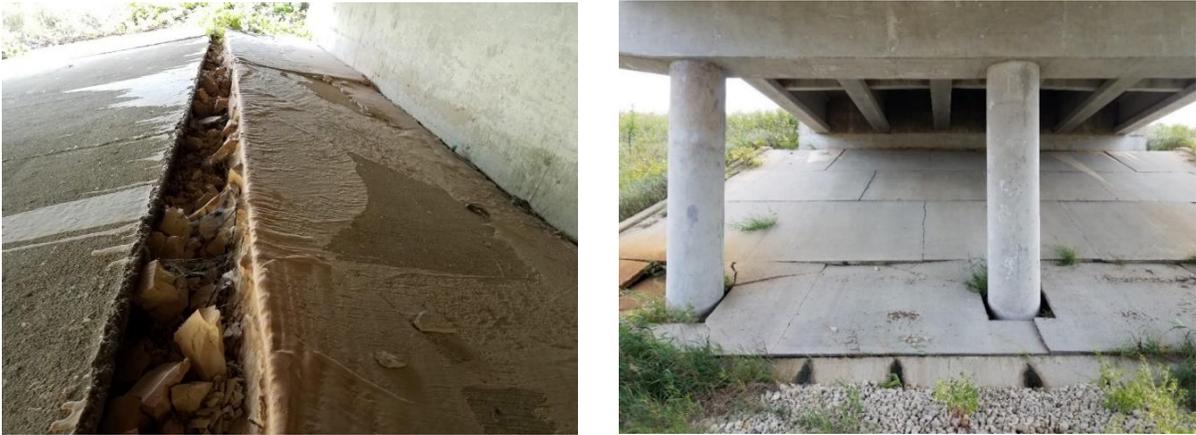
Figure 4.11. (a) Typical Embankment Condition (left), (b) Embankment Condition at the Abutment (right)

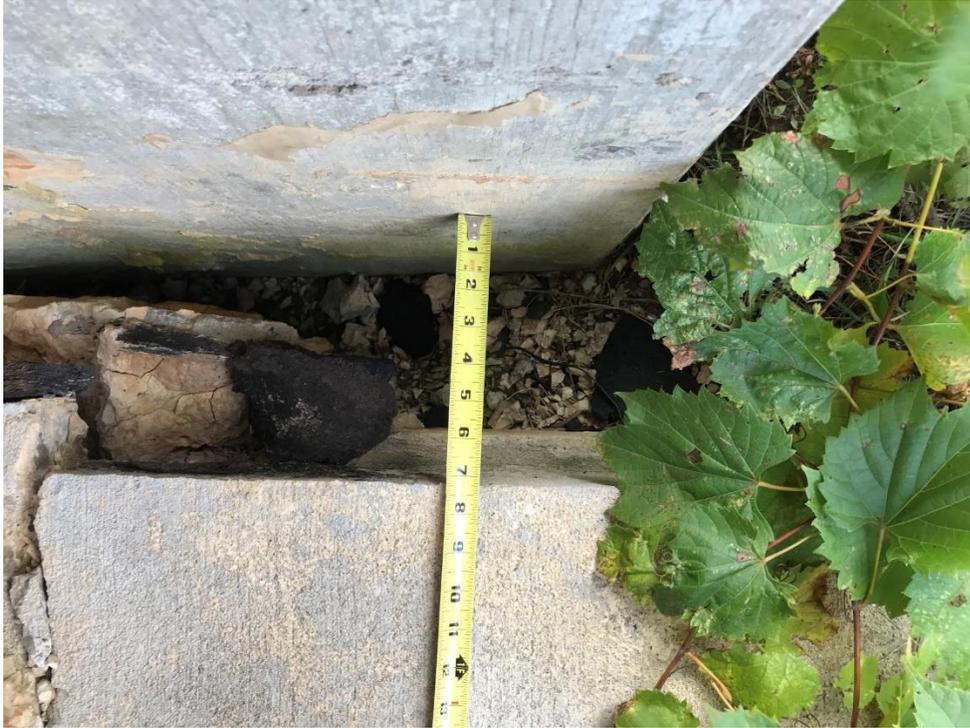
Figure 4.12. Horizontal Void Created by the Embankment Pulling away from the Abutment

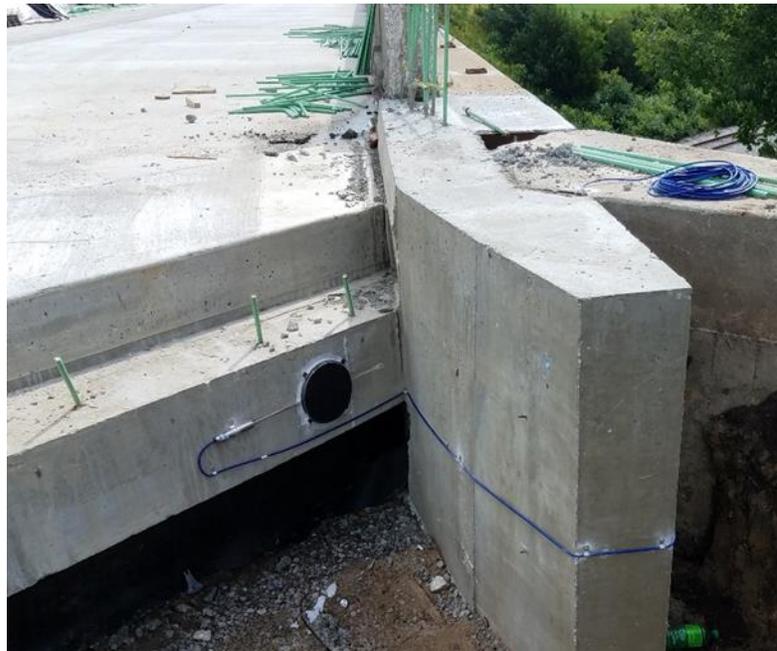
Figure 5.4. Jasper - EP1-W Earth Pressure Sensor after Installation

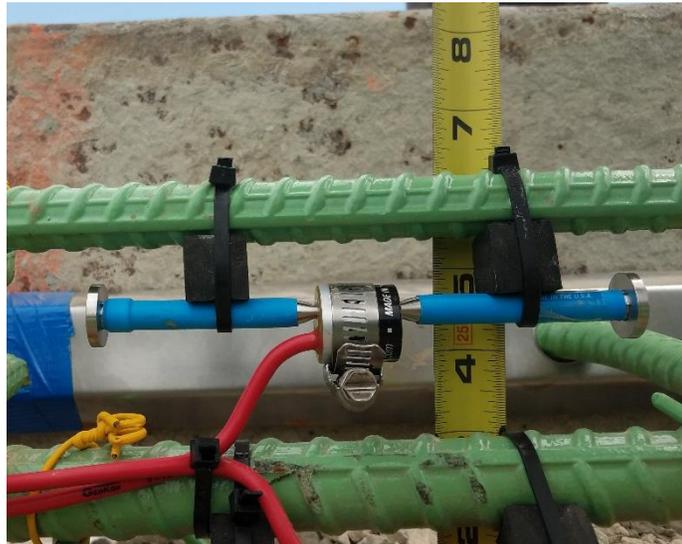
Figure 5.5. Jasper - Typical Strain Gauge Installation

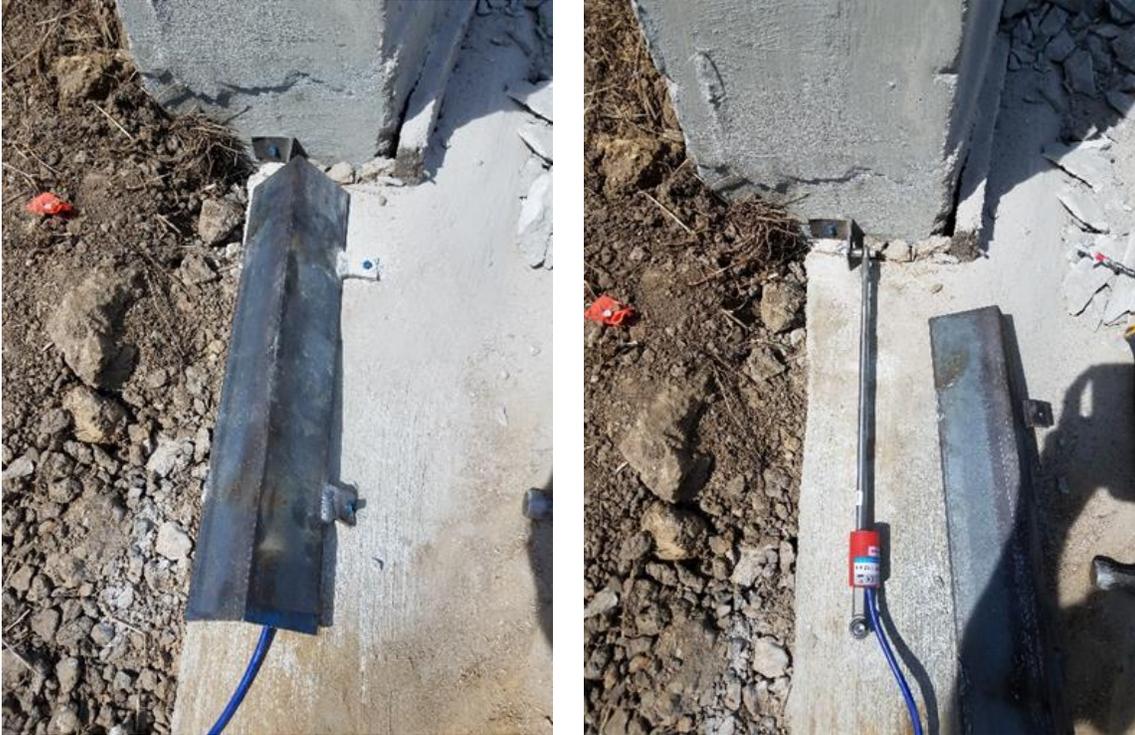
Figure 5.6. Jasper - (a) Crackmeter without Protective Cover (left), (b) Crackmeter with Protective Cover Installed (right)

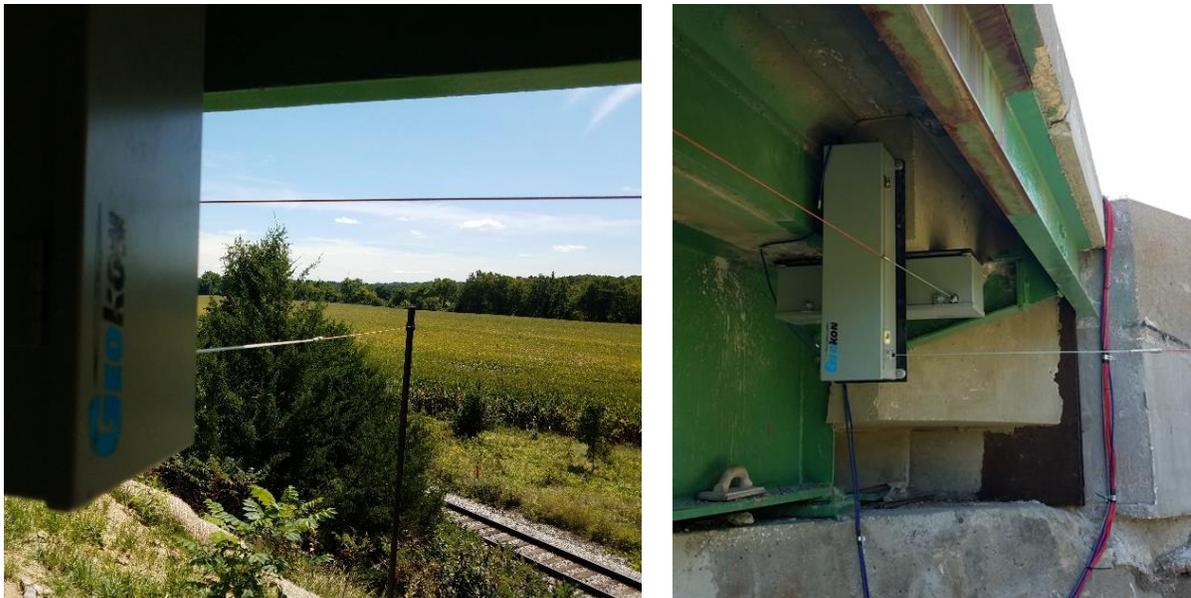
Figure 5.7. Jasper - (a) Displacement Transducer with Reference Post (left), (b) Longitudinal and Transverse Displacement Transducers Attached at the Acute Bridge Corner (right)

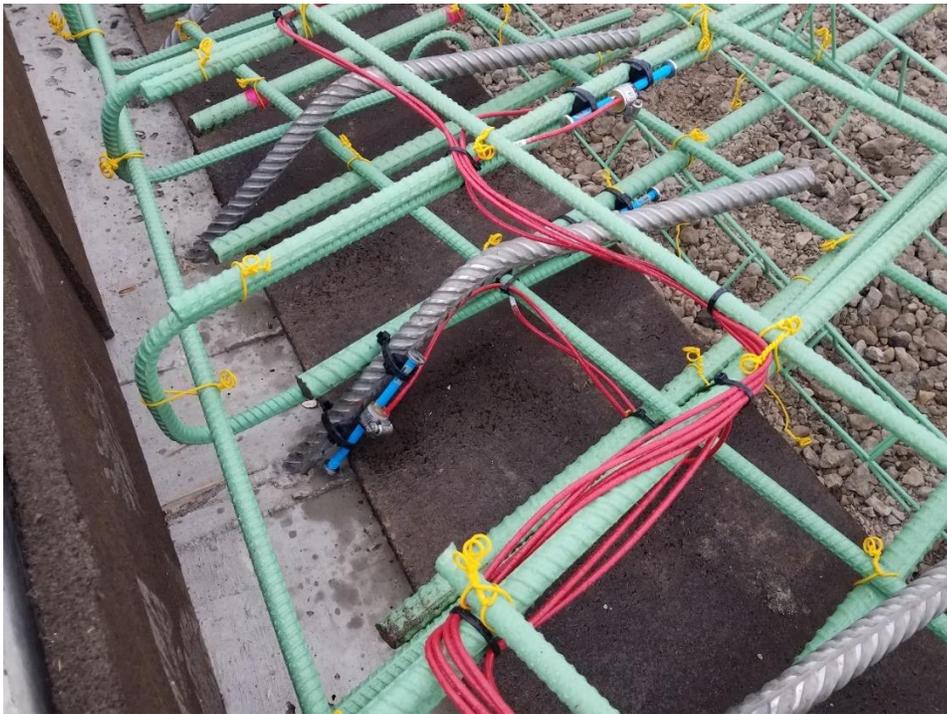
Figure 5.26. Story - Strain Gauges Installed on the Longitudinal Rebar and Tie Bars

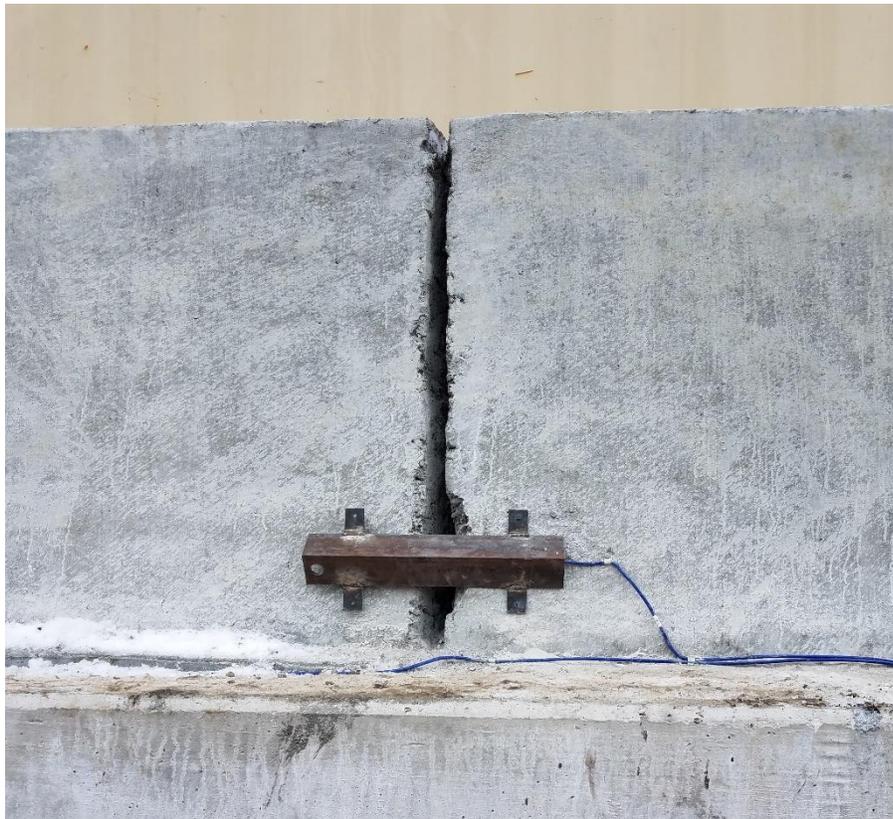
Figure 5.27. Story - Crackmeter Installation across the Barrier Rail Joint

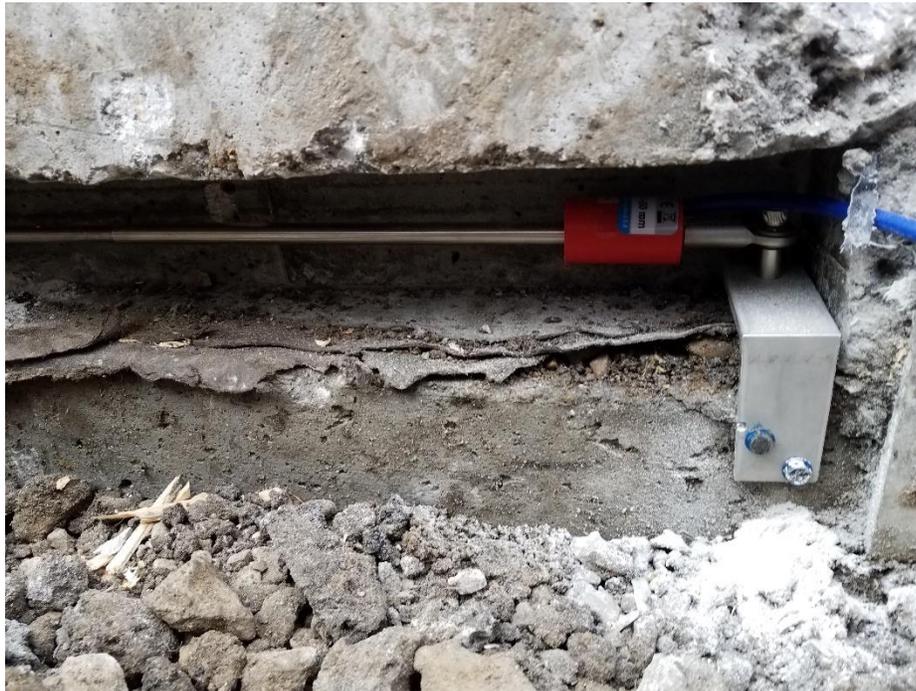
Figure 5.28. Story - Crackmeter Approach Slab Side Blockout Location

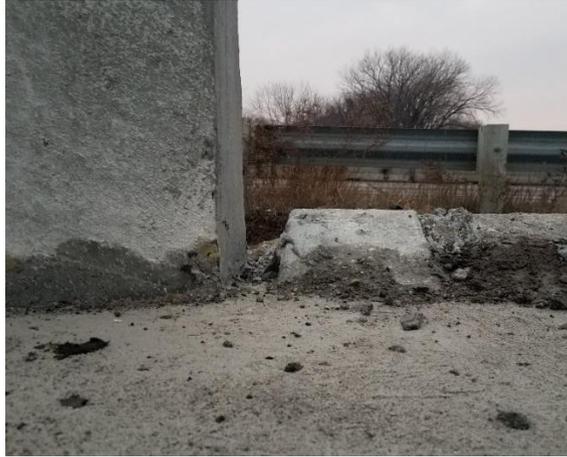
Figure 5.40. Story - Curb Gap at the Barrier End (Typical)

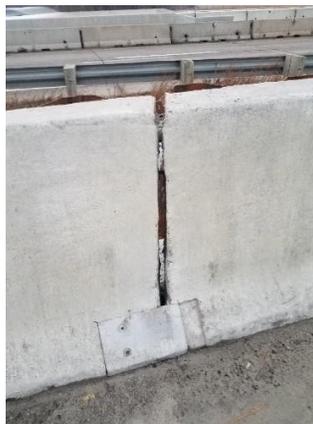
Figure 5.41. Story - Open Barrier Joint (Typical)

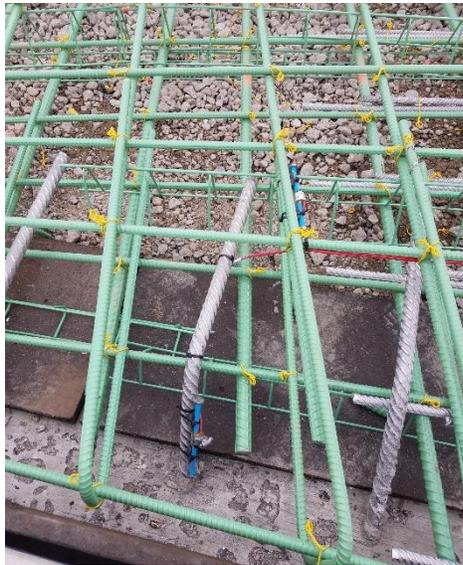
Figure 5.43. Story - Approach Slab Modified Subbase Condition Immediately before Concrete Pouring

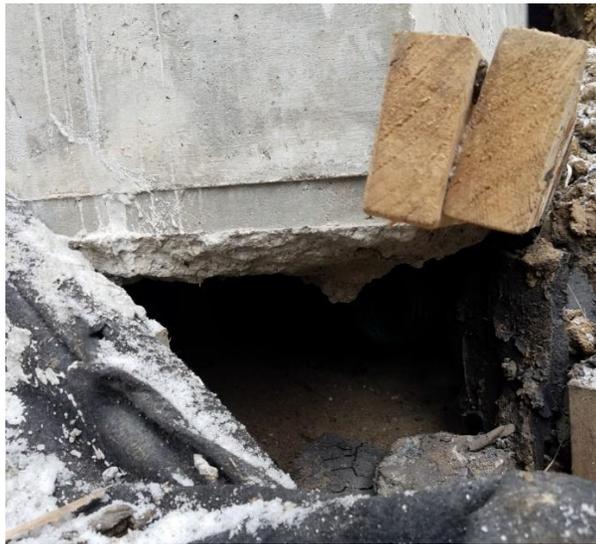
Figure 5.44. Story - Large Void under the South Abutment Corner

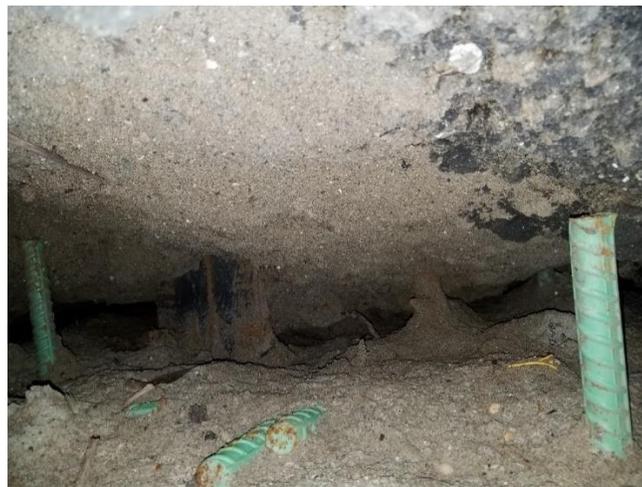
Figure 5.45. Story - Visible Exposed Rebar and Foundation Pile
