LASER-ULTRASONIC INSPECTION OF THE COMPOSITE STRUCTURE OF AN AIRCRAFT IN A MAINTENANCE HANGAR

Marc Choquet, René Héon, Christian Padioleau and Paul Bouchard
UltraOptec Inc.
Boucherville, Canada

Christian Néron and Jean-Pierre Monchalin
Industrial Materials Institute
National Research Council of Canada
Boucherville, Canada

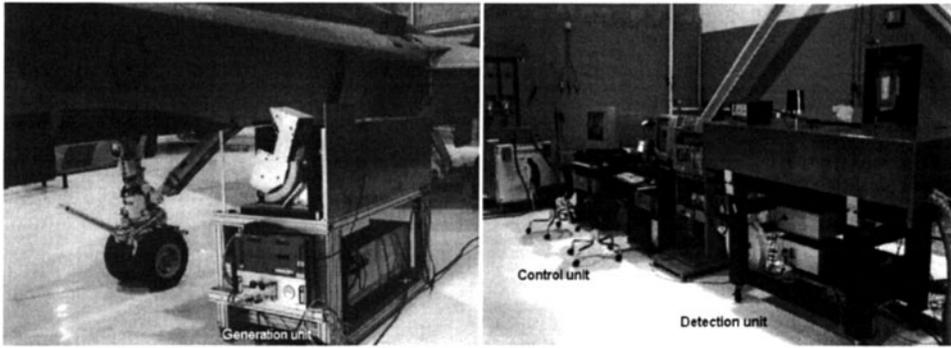
Figure 1: On-site installation of laser-ultrasonic system.

To inspect a structural component on an aircraft, the generation unit is moved to a distance of roughly 1.4 meters from the component (see figure 1). For vertical or near vertical surfaces, the generation and detection beams are directly focussed onto the component. For horizontal surfaces, such as those of the wing or the horizontal stabilizer, a large folding mirror set at an angle of 45° is used to deflect the beams upwards towards the inspected part.
