FIELD AND BETA-SITE TESTING OF THE DRIPLESS BUBBLER ULTRASONIC SCANNER

Daniel J. Barnard and David K. Hsu

Center for NDE - FAA Center for Aviation Systems Reliability
Iowa State University
Ames, Iowa 50011

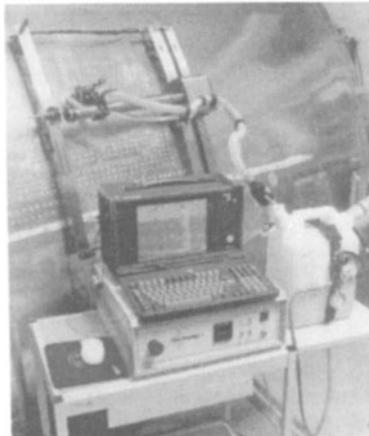
Figure 1. Dripless Bubbler ultrasonic scanner

The DB scanning head consists of a captured water column which houses a focused immersion probe, a series of concentric brush seals for containment of the couplant, and ports for supply and recovery of couplant. The lower end of the captured water column features an acoustically transparent membrane, effectively a "window" for the focused ultrasonic beam. Between the membrane and the scan surface is the contained water pool, which provides the coupling between the captured water column and the fuselage skin. The immersion probe is glued into a nylon ring that is held firmly within the water column by o-rings, which act as a seal for the captured water column and allow for changes in the focus of the immersion probes. The current design uses standard 0.5 inch immersion probes and can accommodate 1.0 – 3.0 inch focal length transducers. The three inner concentric brush seals form three zones of contained couplant that are continually replenished. This continuous supply of couplant aids in maintaining a bubble-free pool. The

The couplant supply and return system consists of an integrated compressed air operated diaphragm pump, venturi vacuum, and couplant reservoir with couplant supply and return hose connections. This configuration was chosen because of the readily available compressed air in aircraft maintenance facilities. The flow rate of the diaphragm pump is controlled by an in-line pressure regulator and normally operates between 0.4 and 1.0 gpm. The 2.5 gallon couplant reservoir is filled with .75-1.25 gallons of fresh tap water that is normally replaced after an 8 hour shift because of dirt, dust and lint the vacuum return picks up. The entire system, with DB head, scanner, motion control cabinet, control/data acquisition computer, and couplant handling unit is shown in Fig. 1. Please refer to [3] for figures showing the DB head and the couplant handling unit in more detail.

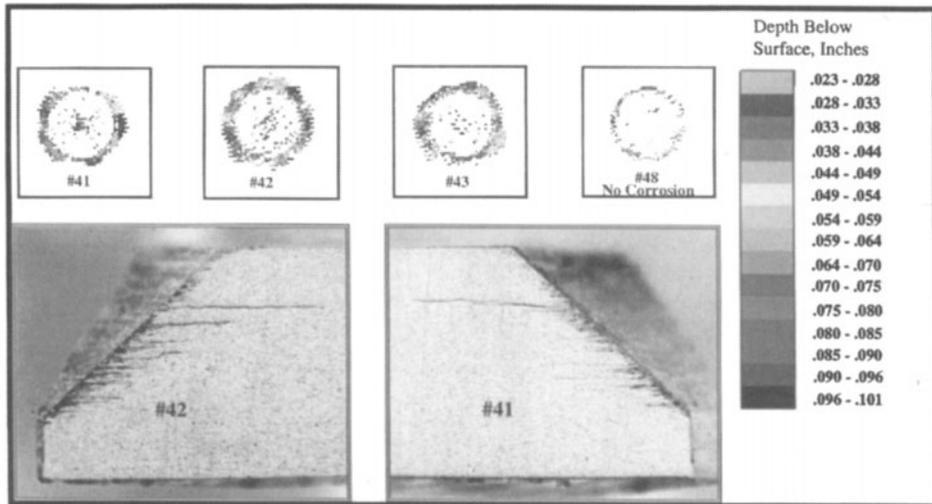
Figure 2. Time-of-flight C-scans showing corrosion around corroded and uncorroded fastener countersinks and optical micrographs showing exfoliation corrosion.

In tests on the C/KC-135 samples, the DB was used to scan over a line of fasteners, collecting full waveform data which was post processed to produce C-scan amplitude and time-of-flight images. By simply comparing the size of the "halo" around the fasteners in the amplitude C-scan images, it was a simple matter to distinguish between corroded and uncorroded fastener countersinks. Time-of-flight images were used as to confirm the results from the amplitude images and provided additional information about the depth of the

corrosion. Test results indicated that this method correctly identified all 40 corroded countersinks with a single false call. Figure 2 shows time-of-flight C-scan results from the C/KC-135 skins, with results of metallographic examination of selected countersinks showing the extent of exfoliation corrosion.

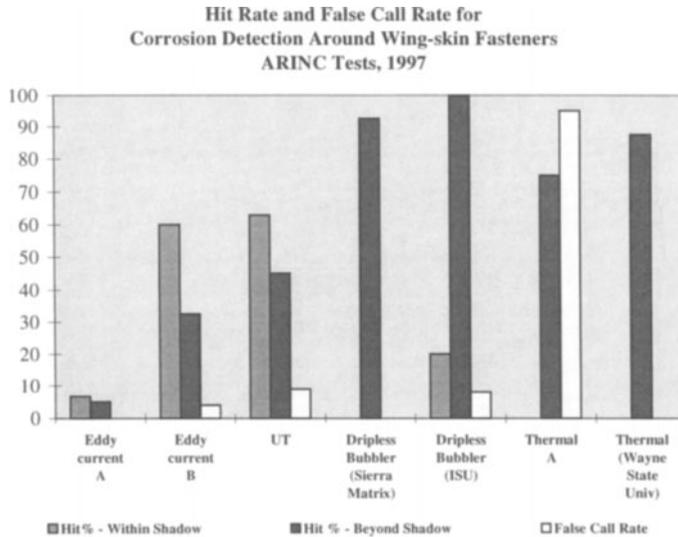
Figure 3. Results of tests to identify exfoliation corrosion in C/KC-135 and B-52 wing skin samples.

B-52 wing skin test samples, produced in same manner as the C/KC-135 panels, were also scanned using the DB. Test results were relatively poor, with the correct identification of only 3 of 15 corroded fastener countersinks and one false call. During later inspection of the countersinks by metallographic methods at ARINC, it was found that the corrosion treatments primarily only produced pitting of the countersinks in the B-52 samples. In light of this, it would be expected that the normal incidence method used with the DB would not be very successful in the tests of the B-52 samples. Figure 3 shows results from the ARINC tests, indicating "hit" and false call rates for the methods tested.

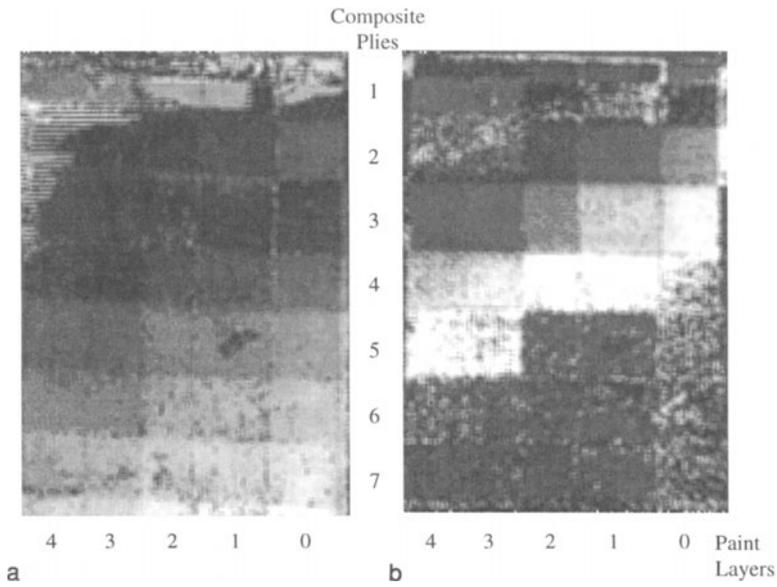
Fig. 4a) Time-of-flight C-scan showing the ability of the DB to resolve 40 composite and paint layer combinations, processed using a single wide flaw gate, 4b) Time-of-flight C-scan image showing higher resolution when using a narrower flaw gate, centered about the 3 and 4 ply region.

At the United Airlines Beta-site test, United NDT engineers proposed to test the ability of the DB to resolve the number of composite ply and paint layer in a test sample. A rectangular fiberglass sample with a ply build-up from 1 to 7 along one axis and a paint layer build-up of 0 to 4 coats along the other axis was scanned using full waveform capture and post processing. The time-of-flight C-scan results shown in Figure

4a were produced with a single wide flaw gate in the post processing and show fair resolution between the 335 (7 by 5) composite ply and paint layer combinations. Figure 4b shows a much enhanced resolution over a smaller number of composite ply and paint layer combinations when a narrower gate is applied. United engineers are interested in this type of test because of their need to identify loss of composite layers due to excessive sanding during paint removal from composite panels. Tests at Northwest Airlines on a B757 elevator panel successfully demonstrated the ability to image ply drop-offs at an internal member. The result, shown in Figure 5, are time-of-flight and amplitude C-scans produced with a single wide gate and clearly shows the ply drop-offs from bottom (15 plies) to top (8 plies). Note the sharpness in the time-of-flight images, clearly indicating the edges of the plies compared to the gradually changing amplitude across the drop-offs in the amplitude image.

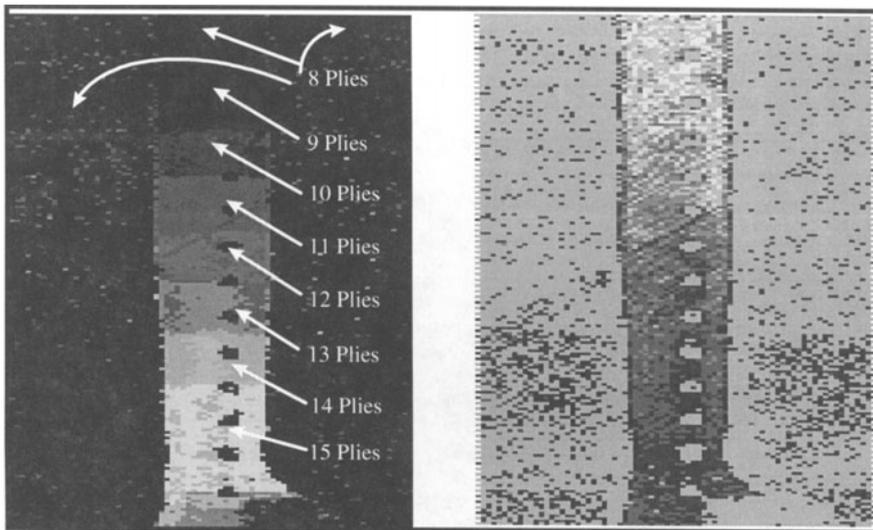
Fig. 5 Time-of-flight (left) and amplitude C-scan results of scans of ply dropoffs at an internal structural member in a B757 elevator.

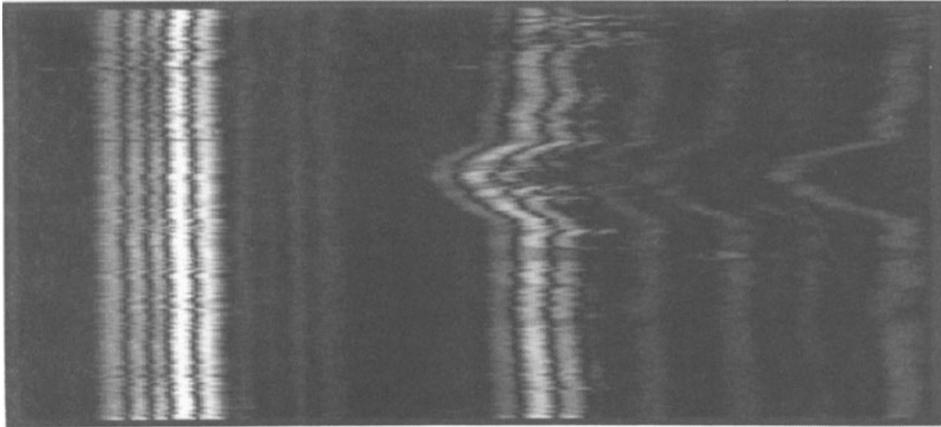
Fig. 6 B-scan results from a blended corrosion pit found in a DC-10.

Scans on aluminium fuselage structures at both United and Northwest Beta-site tests were very successful. The testing at Northwest was aimed at verifying the remaining metal thickness after the blending-out of a corrosion pit found on a DC-10. The B-scan images produced, shown in figure 6, clearly showed the thickness of the remaining skin but also revealed the smooth curvature of the blended area. Scans over a lap splices on a B727 and a B747 revealed no corrosion or disbond but did show the increased thickness along fastener rows in chemical milled skin panels, and clearly demonstrated the dripless nature of the system when scanning over button-head fasteners and lap splice edges.
