ULTRASONIC TECHNIQUES TO PRODUCE DAMAGE PROFILES THROUGH
THE THICKNESS OF A SAMPLE

William J. Murri, Kirk W. Bailey, Bradley W. Sermon, and
Tammy J. Todaro

Advanced Methods Group
Hercules Aerospace Company
Bacchus Works, Magna Utah 84044

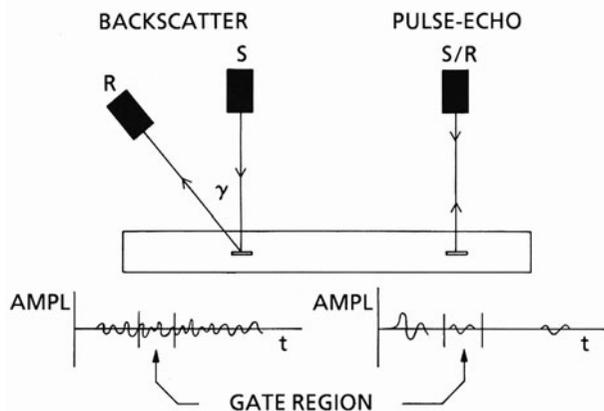
Fig. 1. Schematic diagram showing the elements of time-gated ultrasonic measurements (S and R signify sending and receiving transducers respectively).

Figure 1 shows the schematic arrangement of the ultrasonic transducers and the sample. Two transducers were used (although three are shown for descriptive purposes), one whose beam was normal to the sample surface and one inclined at an angle γ to the surface normal. As a sender, the normal transducer emits a pulse which impinges upon the sample and is scattered in all directions as well as being transmitted through the sample and reflected from the back wall. The angle transducer receives that portion of the total signal which is backscattered at the angle γ . The sending transducer also receives that portion of the incident pulse reflected from the front and rear sample surfaces as well as from the entire sample thickness. By proper signal processing, a backscatter signal and a pulse-echo signal may be obtained.

The time interval between the front and back surface reflections is twice the ultrasonic wave transit time through the sample. This time interval was divided into several equal increments. The received signals from the front and rear surface of the sample were peak detected. The output of the received signal from the front surface was used to establish a zero time. In the usual backscatter or pulse-echo C-scan, the transducers receive energy from the entire sample thickness. In these experiments, the peak detector gate for each transducer was set to cover only a specified time window (i.e. twice the sample transit time divided into a predetermined number of equal intervals each of width Δt). A delay was introduced between the reception of the front surface reflection by the normal transducer, the start of the angle transducer detector gate, and the normal transducer gate. The delay was set at 0 for the first scan, at Δt for the second scan, at $2 \Delta t$ for the third scan, at $3 \Delta t$ for the fourth scan, etc., until the time window had progressed entirely

through the sample. The backscattered and pulse-echo signals for each scan came from that portion of the total backscattered and pulse-echo signal appropriate to a particular layer of the sample. By using the reflected signal from the front surface as zero time, the system had, in effect, a front surface follower. Any misalignment between the scan plane of the transducers and the surface of the sample is negated. With this transducer arrangement, a backscatter and a pulse-echo C-scan can be obtained at the same time.

are shown, each scan covering three to four plies of the sample. Although the time interval gates for the backscatter and pulse-echo scans were identical, the number of plies covered by the two types of scans was different because of the difference in path length of the signal in the sample (see Figure 1). In the sample, the backscatter signal travels at an angle to the sample surface normal while the pulse-echo signal travels normally.

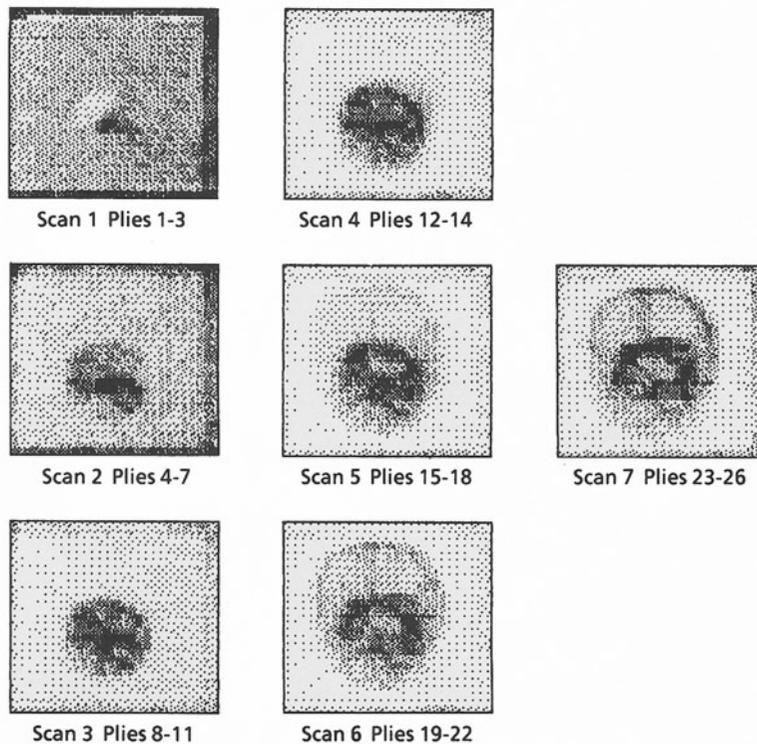
Fig. 2 Time-gated backscatter C-scans showing impact damage profile through the sample thickness in a laminate plate.

The gated backscatter results are shown in Figure 2. Seven scans

The first backscatter scan shows damage very near the surface. In Figure 2, Scans 2 and 3 show a central region of damage about 1 inch in diameter. The same central damage region is evident in Scans 4 through 7. In addition, a larger oval region becomes evident in Scan 4 and becomes more apparent in Scans 5, 6, and 7. Note the vertical feature just above the central area in Scans 6 and 7.

The ultrasonic measurements of Figures 2 and 3 and the damage area shown in Figure 4 compare very well. The sharp line outside the central region in Scans 6 and 7 of Figure 2 and the sharp boundary between the light and dark areas in the corresponding place in Scans 4 and 5 of Figure 3 correspond to the sharp delamination boundary shown in the 23rd ply damage of Figure 4.

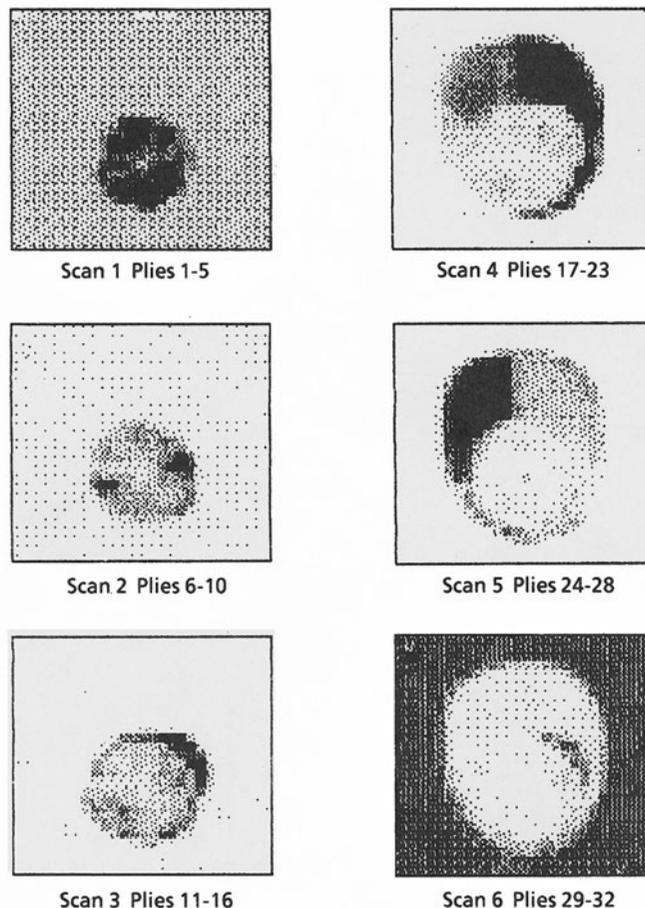
Fig. 3 Time-gated pulse-echo C-scans showing impact damage profile through the sample thickness in a laminate plate.

The results of the gated pulse-echo experiments are shown in Figure 3. Six time intervals were chosen for this test, each scan covering about five plies of the sample. In the first three scans, the impact damage is confined to an area of about 1 inch in diameter. In Scans 4 and 5, a larger area outside the 1 inch diameter area is evident.

Note that the darker portion (the darker the image, the higher the amplitude of the reflected signal) of this outside area shifts sides in Scan 4 vs. Scan 5. Also, there is a sharp vertical boundary separating the darker and lighter parts (compare with the vertical feature in Scans 6 and 7 of Figure 2). Only a few details are visible inside the light oval area of Scan 6.

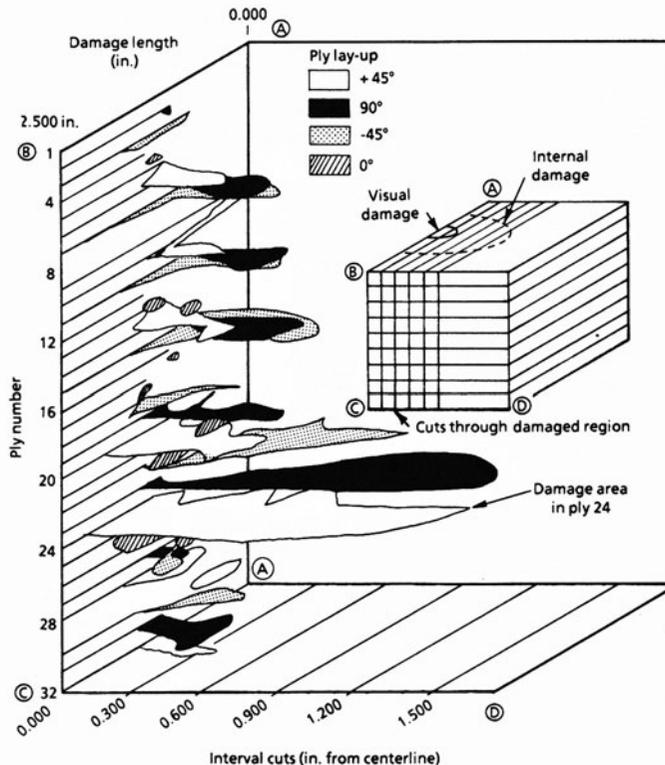
Fig. 4 Microscopy cross section results were used to develop damage area maps for each ply in a graphite/epoxy composite plate. Compare with ultrasonic results from same plate shown in Figures 2 and 3.

Figure 4 presents damage area maps for each ply obtained from photomicroscopy. The graphite/epoxy plate discussed above was sectioned through the center of the impact and one half was potted in epoxy. Additional slices were cut from the potted section at 0.075" intervals. One face of each slice was polished and examined with a microscope for the type and extent of damage in each ply. The extent of damage from each slice was combined to produce the isometric damage map shown in Figure 4.

The damage (as shown in Figure 4) is slight in the first four plies (as shown by Scan 1 of Figures 2 and 3) then increases in area in Ply 5 and is roughly constant down to Ply 22. Large delaminations are apparent in Plies 22, 23, and 24. From Ply 25 to Ply 32, the damage area is again about the same size as from Ply 5 to Ply 22. Notice that the delamination in Ply 23 has a very sharp inner edge. Photomicrographs of this region show that the delamination is along the interface between Plies 22 and 23 and then cuts through Ply 23 and runs along the interface between Plies 23 and 24. The cut is very sharp and is shown in Figure 4 as the sharp inner edge on the delamination in Ply 23.

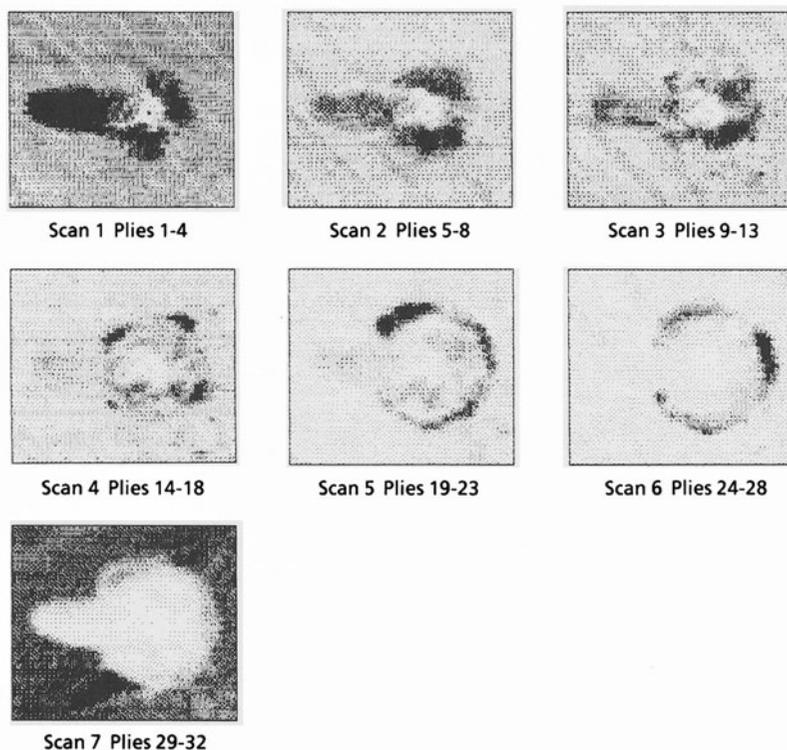
Fig. 5 Time-gated pulse-echo C-scans showing impact damage profiles through the thickness of an IM6/3501-6 graphite/epoxy laminate.

A graphite-epoxy panel (IM6/3501-6) 4 inches X 6 inches X 0.180 inches thick (32 plies) was impacted by a 5/8 inch diameter ball with an impact energy of 22.5 ft-lbs. The layup was (0/+45/-45/90)_{4s}. This panel was supported in the same way as described above. Following impact, the gated pulse-echo technique was used to examine the damage.

Seven C-scans, each representing a thickness of about 4.5 plies, are shown in Figure 5. These C-scans were compared with results of thermal deplying combined with a gold chloride penetrant. The deplying method and application of the gold chloride solution are described in Reference 3. A comparison between the first C-scan of Figure 5 and a photomicrograph of the fourth ply is shown in Figure 6. The agreement between the damage areas shown by both techniques is quite good.

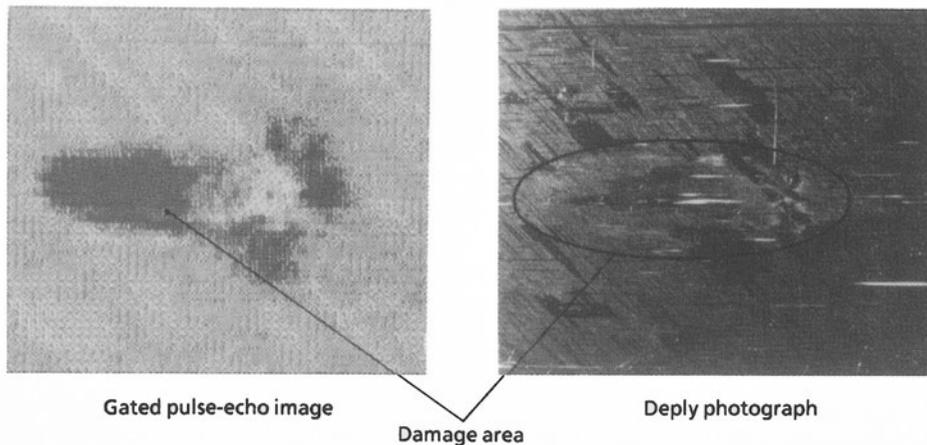
Fig. 6 Comparison of apparent zone of damage imaged by the gated pulse-echo technique with a photograph of damage indication from the deply technique with gold chloride penetrant.

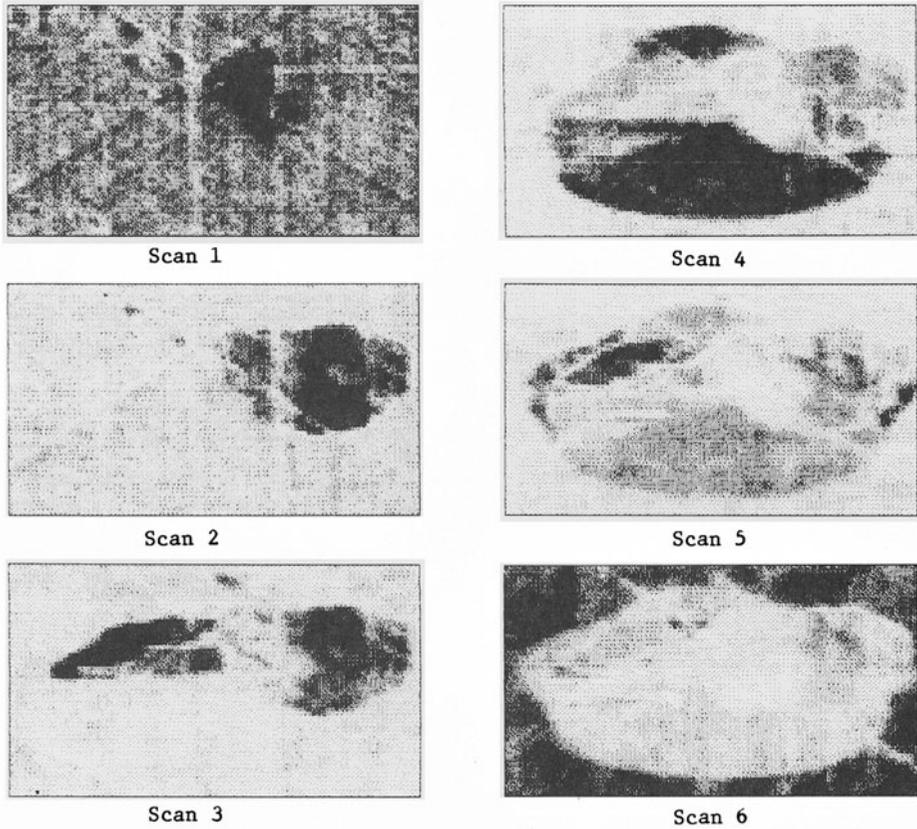
Fig. 7. Time-gated pulse-echo C-scans of a filament wound tube.

The gated pulse-echo technique was next applied to a filament wound tube. The tube was 12 inches in diameter and 22 inches long. It was filled with RTV silastic to simulate propellant and the exterior surface was covered with a silastic 45E protective layer.

The tube was supported in a wooden cradle and impacted by a 1 1/4 inch diameter tup with a 2 inch radius at an impact energy of 40 ft-lbs. The layup for this tube was (+21.8/0/90/0/+21.8/0/90/+45). The axial direction was the 0 degree direction. The actual wall thickness of the tube was about 0.2 inches.

The protective layer was removed before the C-scans were performed. The experimental results of the gated pulse-echo measurements are shown in Figure 7. Six scans were obtained, each corresponding to just over 1 ply layer. In Figure 7 black represents maximum reflected energy. Each scan covers an area about 3.5 inches by 4.5 inches. A delamination is evident very near the surface on the right of the impact (first scan). In the second scan, another delamination is apparent also on the right of the impact site. This delamination grows to the left in the next scan. A new delamination appears at the top and bottom of the fourth scan and is still evident in the fifth scan. The back wall signal shows little evidence of any delaminations indicating the the damage is internal.
