ULTRASONIC DETECTION OF SURFACE FLAWS IN GAS TURBINE CERAMICS

T. Derkacs and I. M. Matay
TRW, Inc.
TRW Materials Technology
Cleveland, OH 44117

ABSTRACT

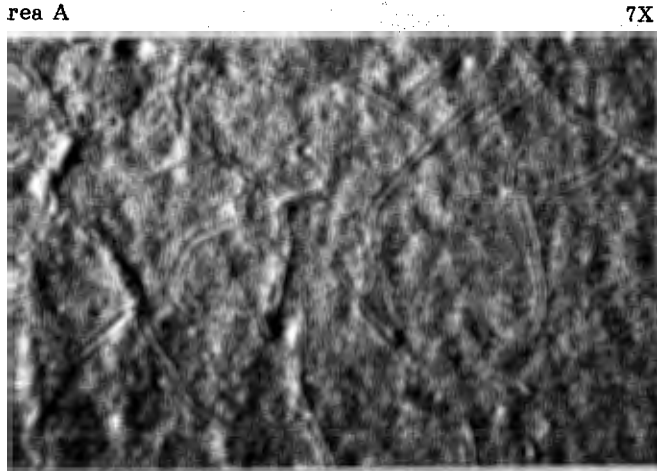
Area A
Area B
Fig. 6 Photomicrographs Showing Surface Condition of Two Typical Areas of As-Pressed Billet of Ceralloy 147A HPSN Where Large Numbers of Surface Wave Indications Were Detected.

Figures 5, 6 and 7 show another billet that was used to verify the presence of surface waves. This is a billet of Ceralloy 147A hot pressed silicon nitride (HPSN) which was received in the as-pressed condition and then was machined to remove a total of about 0.040 inches (1000 μ m) to provide smooth surfaces on both sides. The areas of heavy concentrations of indications in Fig. 5 correspond to the areas shown in the photomicrographs (7X) of Fig. 6 which contain surface ridges left by the pressing operation. After machining these ridges away, the indications in areas A and B disappeared. The billet of Ceralloy 147A HPSN was inspected by both shear and surface waves before machining and by surface waves after machining. A comparison of the before and after surface wave inspections shows no significant correlation in indications. This is to be expected given the amount of material removed. A comparison of the shear wave

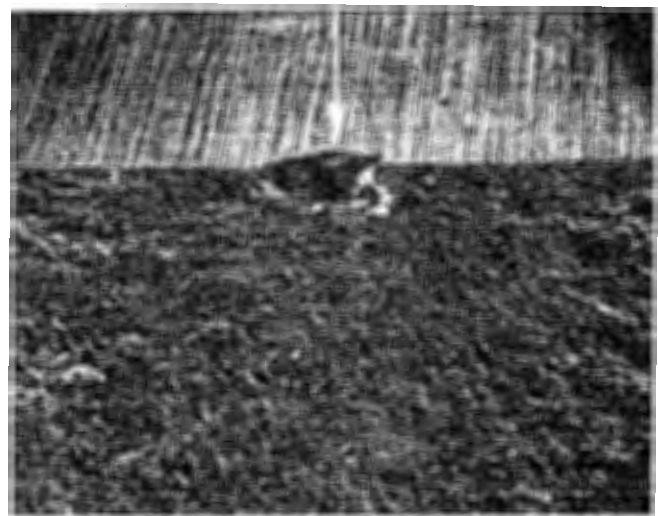
Fig. 12 Fracture Surface of Ceralloy 147A HPSN Specimen No. 9 Showing Fracture Origin at 50 kg Vicker's Indentation.

The four-point-bend tests along with SEM fractography provided data on material strength, fracture origin location with respect to indication location and the nature and size of fracture origins. From this data it was possible to correlate a number of strength limiting defects with their ultrasonic responses. Figures 11 through 16 show some typical ultrasonically detected fracture origins. Figure 11 shows a surface pit in specimen #2 of Ceralloy 147A HPSN. It is about 0.0072" (180 μm) across and 0.0030" (75 μm) deep. Figure 12 shows a typical 50 kg Vicker's indentation; a pit about the same size as in the previous specimen with a crack extending over 0.020 inches (500 μm) deep in the part. Figure 13 shows the 1 kg Vicker's indentation in the same material, an approximately 0.002 inch (60 μm) deep crack. Figure 14 shows a 0.020 inch (500 μm) wide by 0.012 inch (300 μm) deep area of very large grains in specimen #3 of Ceralloy 147A HPSN. Figure 15 shows a flake-like inclusion about 0.0004" (10 μm) thick and 0.0028" (70 μm) wide located 0.0008" (20 μm) below the surface. This is defect A in Fig. 7. Figure 15 shows the smallest defect correlated with an ultrasonic indication, a 0.0006" (16 μm) wide by 0.0008" (20 μm) deep area of large grains at the surface in specimen #1 of NC-132 HPSN (see Fig. 8 for the indication). A defect of about this same size was the largest one found at a fracture origin that could not be correlated with an ultrasonic indication. This suggests that this size defect may not have a high probability of being detected.

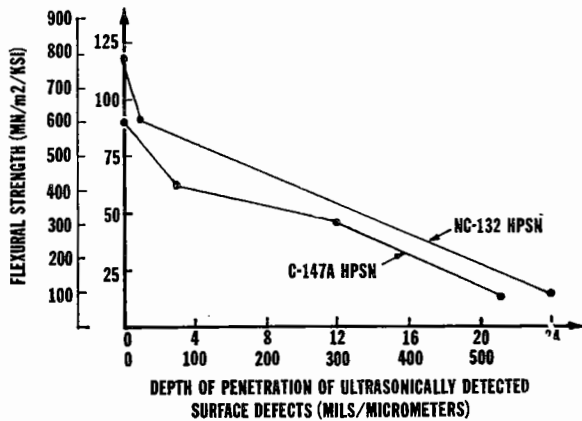
Fig. 17 Flexural Strength as a Function of the Depth of Penetration of Ultrasonically Detected Surface Defects.

Based on the strength measurements and SEM analysis, a graph was made of strength versus defect size for the two types of HPSN. This is shown in Fig. 17. The largest defects on the graph are 50 kg Vicker's indentations. The zero defect size is defect free material ground parallel to the major specimen axis. The points in between are ultrasonically detected defects. A graph was also made based on measured strengths parallel and perpendicular to grinding. This is shown in Fig. 18 for two types of HPSN and two types of HPSiC. The ultrasonic response is designated light damage (below a certain threshold) or heavy damage (above a certain threshold). Although the correlation shown in this graph is only qualitative, these results indicate that by assigning a numerical value to the magnitude of ultrasonic response, it may be possible to measure the material strength associated with a given surface finish.

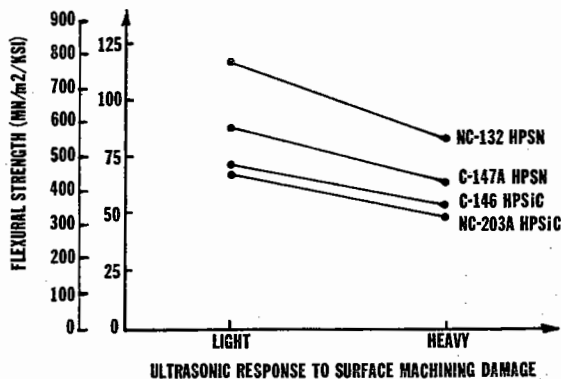
Fig. 18 Flexural Strength as a Function of Ultrasonically Detected Surface Damage in HPSN and HPSiC.
