ACOUSTO-ULTRASONIC TECHNIQUES FOR EVALUATION OF BOND INTEGRITY OF COMPOSITE REPAIR PATCHES

I. M. Daniel, J.-J. Luo and H.-M. Hsiao

Robert R. McCormick School of Engineering and Applied Science
Northwestern University
Evanston, IL 60208

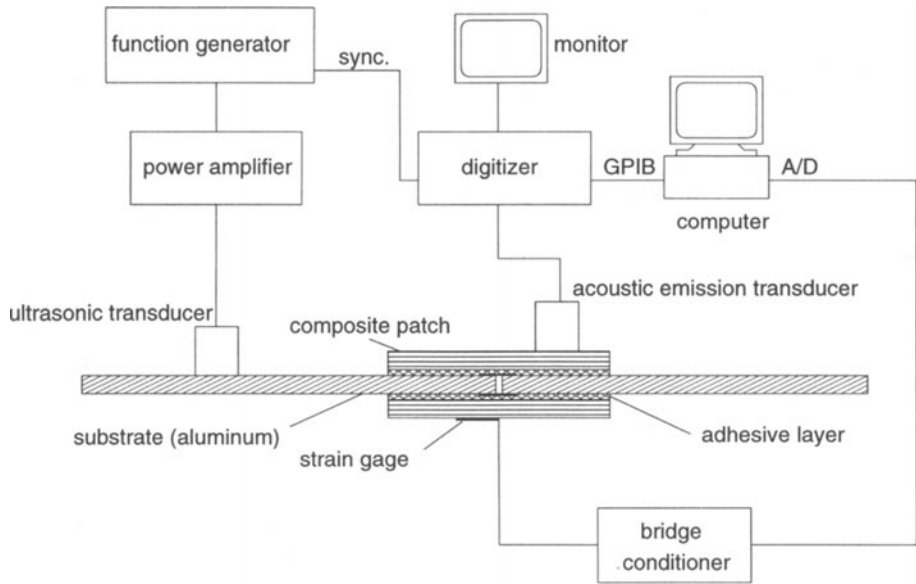
Fig. 2. Composite patch specimen and acousto-ultrasonic test setup.

For application of the acousto-ultrasonic (AU) technique two transducers were mounted on the specimen as shown in Fig. 1. A 1 MHz ultrasonic transducer was mounted on the aluminum surface near the patch. The receiver was an acoustic emission resonant transducer with a central frequency of 150 kHz (R15, Physical Acoustics). It was mounted on top of the composite patch as shown. Since the location and mounting of this transducer are critical, to insure reproducibility of results a special mounting fixture was built and used for the purpose. The ultrasonic transducer was excited with a toneburst pulse of five cycles of 150 kHz frequency at a repetition rate of 180 Hz. The acousto-ultrasonic test setup is illustrated in Fig. 2.

A typical waveform obtained by the setup of Fig. 2 is shown in Fig. 3. The results were characterized in terms of the following AU parameters:

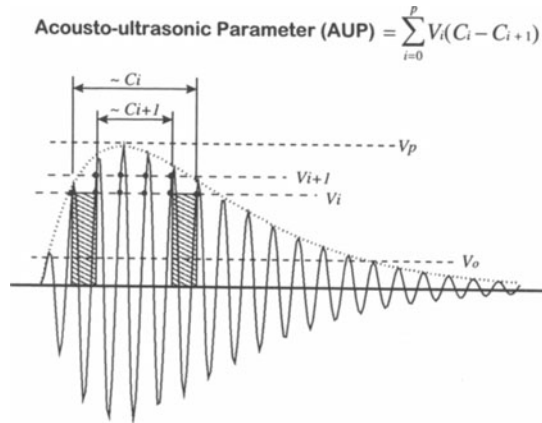
Fig. 4. Illustration of definition of acousto-ultrasonic parameter.

Referring to Fig. 4, we can see that the (AUP) is approximately proportional to the area under the positive portion of the waveform, therefore, it is related to energy.

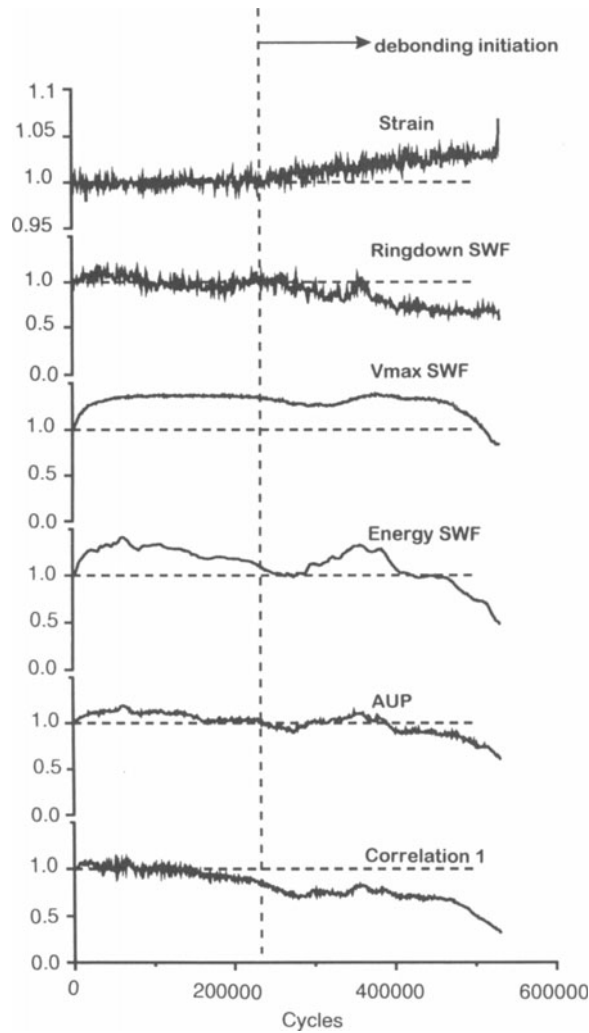
Fig. 6. Normalized acousto-ultrasonic parameters as a function of fatigue cycles.

(reference) state and plotted versus fatigue cycles. The strain gage signal serves as an indicator of debond initiation at around 200,000 cycles. Of the other measures, it appears that the waveform correlation factor is not only a viable and sensitive indicator of actual crack initiation but it appears to indicate microdamage preceding crack initiation.

Results of the first test, conducted at increasing stress amplitudes, show the sensitivity of the various recorded signals, i.e., rate of acoustic emission counts, strain and waveform (Fig. 5). It is seen that the count rate and strain show small changes when debonding of the patch starts, but the waveform variation seems much more pronounced. Results from another test conducted at a stress amplitude of 138 MPa (20 ksi) are illustrated in Fig. 6. Here, the various AU parameters were normalized with respect to the initial
