Evaluation of appropriate maintenance, repair and rehabilitation methods for Iowa bridges

Major: Civil Engineering (Structural Engineering)

Iowa State University

2001

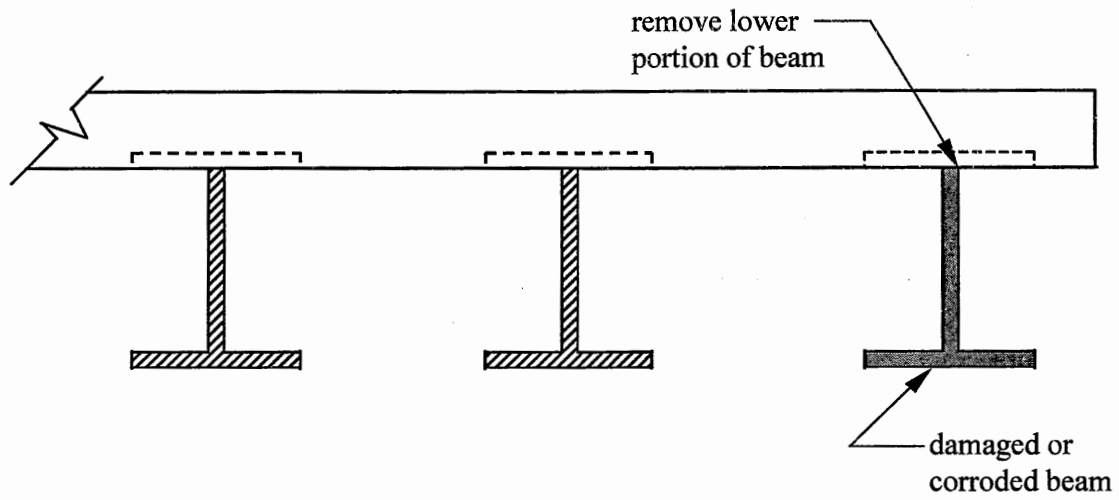
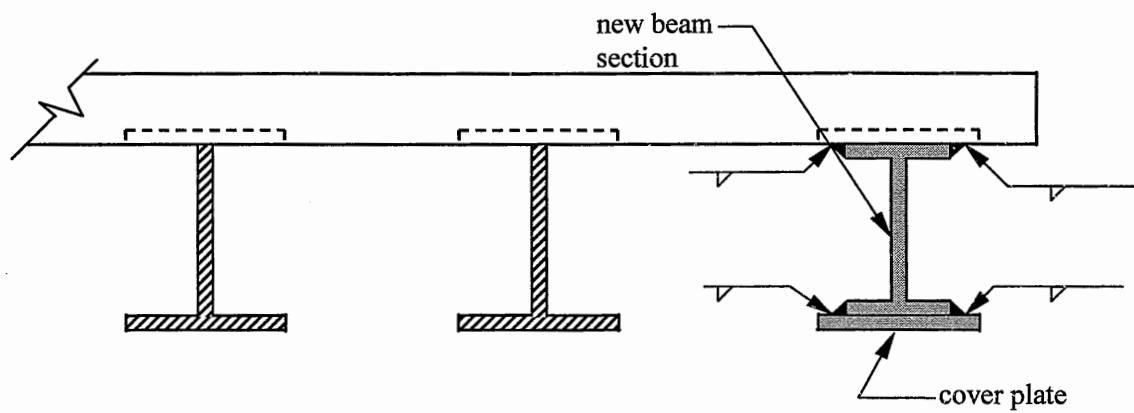
Figure 2.3.1 Replacement of Damaged or Corroded Steel Beams.

Lift the bridge so that the damaged beam is clear of the bearing surface. Remove the damaged portion of the beam by cutting through the web directly below the top flange. Weld the new steel beam in place by means of continuous fillet welds (see Fig. 2.3.1).

(a) Composite Slab with Damaged Beam

(b) New Beam Section Welded in Place

3. Provide temporary supports adjacent to the beam to be removed.
4. In the case of a composite deck, remove the damaged portion of the steel beam by cutting through the beam web directly below the top flange. The top flange must remain in the concrete slab.

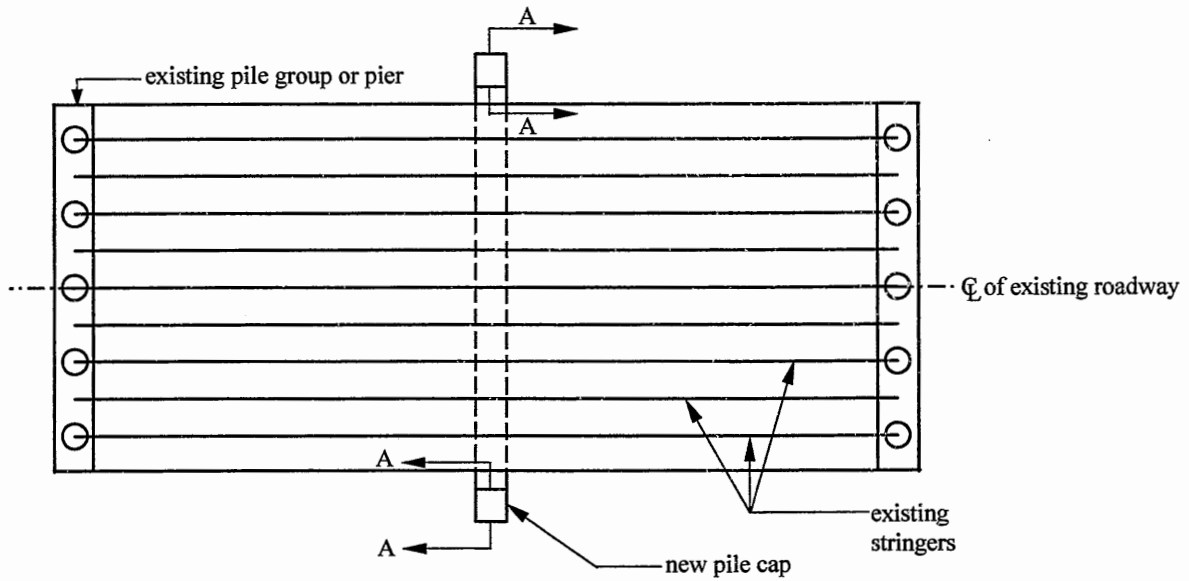
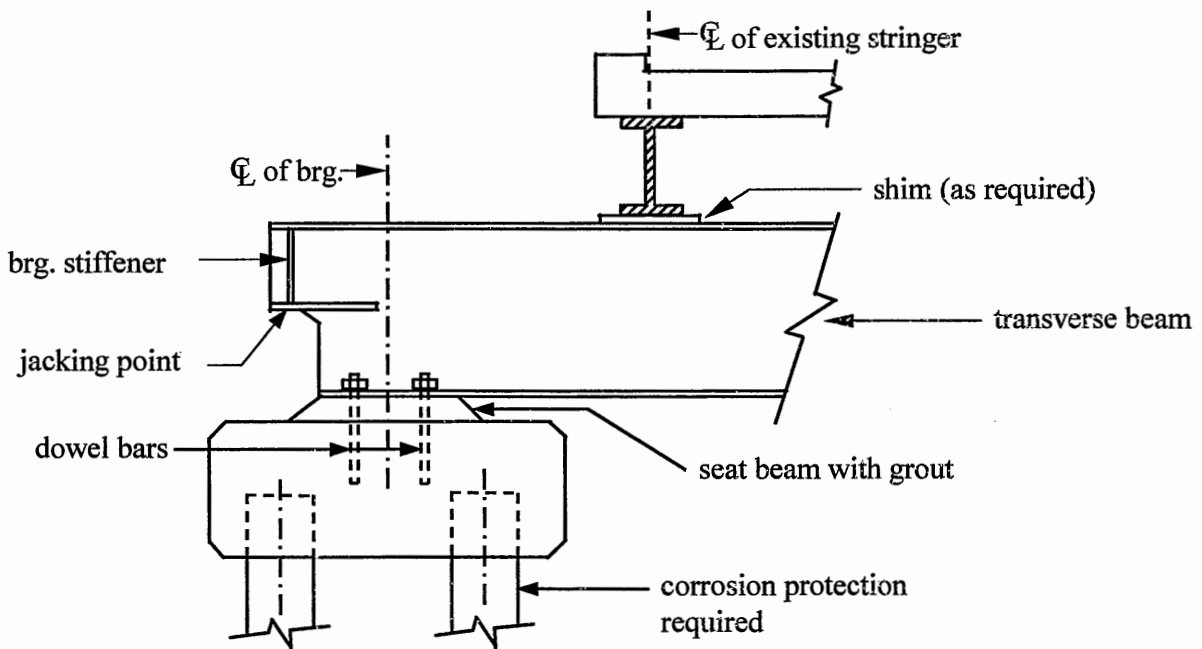
Figure 2.3.2 Installation of Intermediate Support Beam.

(a) Plan View

(b) Section A~A

6. Place the new support beam snug against existing stringers. Install shim plates as required; insert dowel bars or bolts between the beam and the pile cap. In case of concrete pile caps place non-shrink grout between the beam and the pile cap.
7. Remove the jacking apparatus after the grout has set.

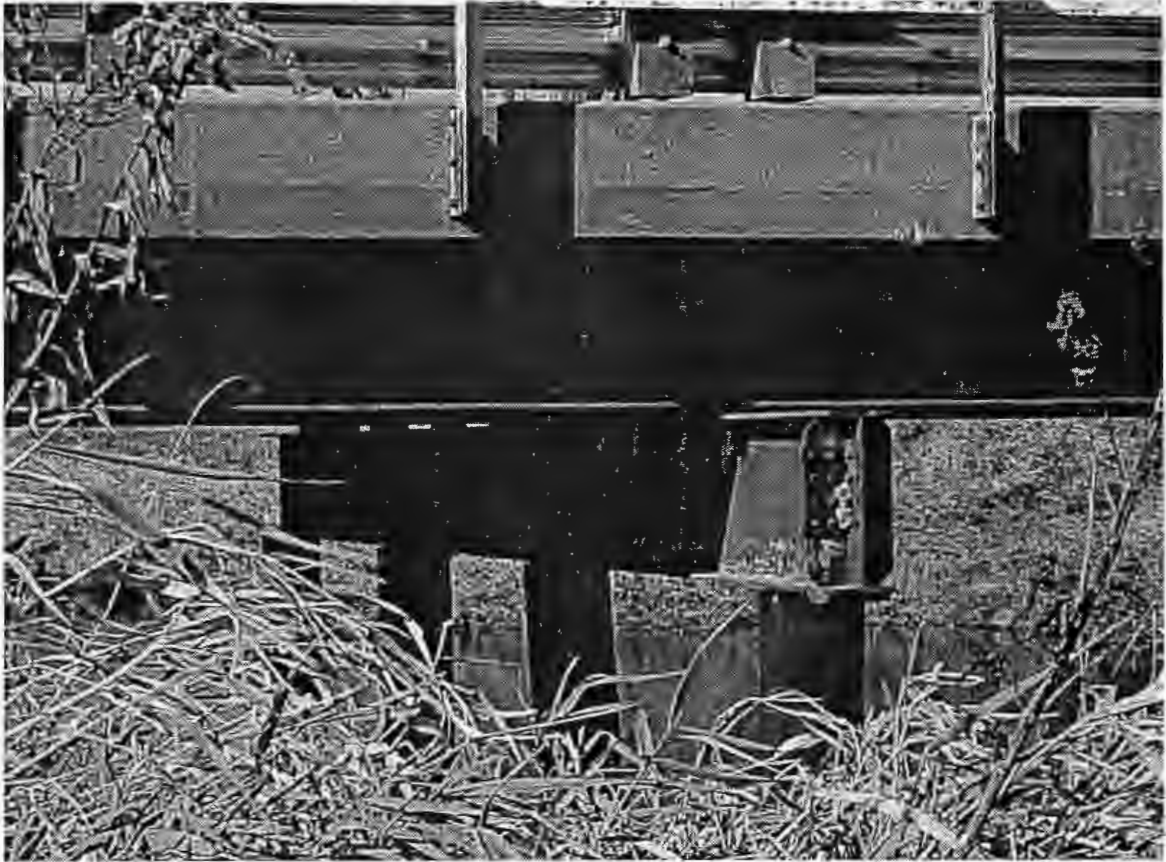
Figure 2.3.3 Example of an Intermediate Support Installed to Strengthen a Simple Span Bridge.

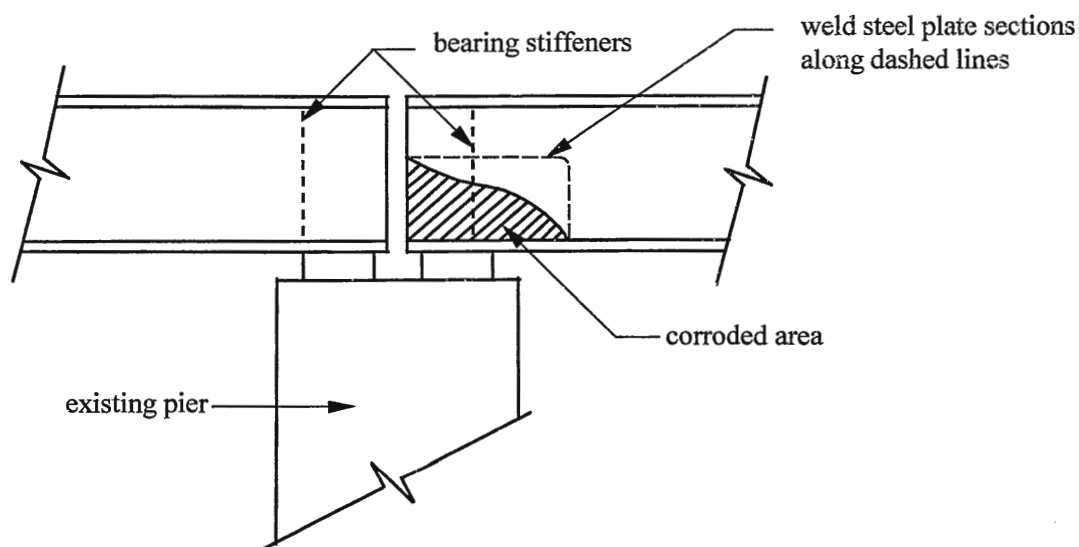
Cut out the corroded area and weld the new section into place.

Figure 2.3.4 Repair of Corroded Steel Beam Ends.

1. Close the bridge to vehicular traffic before initiating repairs.
2. Relieve the load at the bearing by jacking under the sound portion of the beams.
3. Cut out the corroded area, rounding the corners to a minimum radius of 3 in. to avoid abrupt changes (re-entrant corners that create stress concentrations). Also remove bearing stiffeners if they are present in the existing installation (See Fig. 2.3.4).
4. Weld the new section into place, using full penetration welds. The new section may be either a suitable rolled beam section or it may be shop fabricated from other suitable shapes. Replace bearing stiffeners where they are required.
5. Lower the span to bear and check for any immediate distress. Remove jacking equipment and other temporary supports.

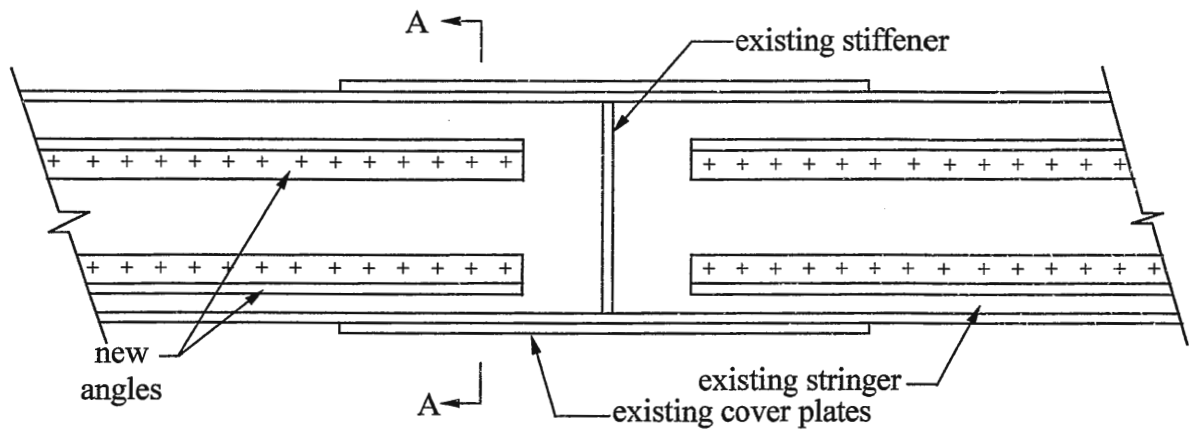
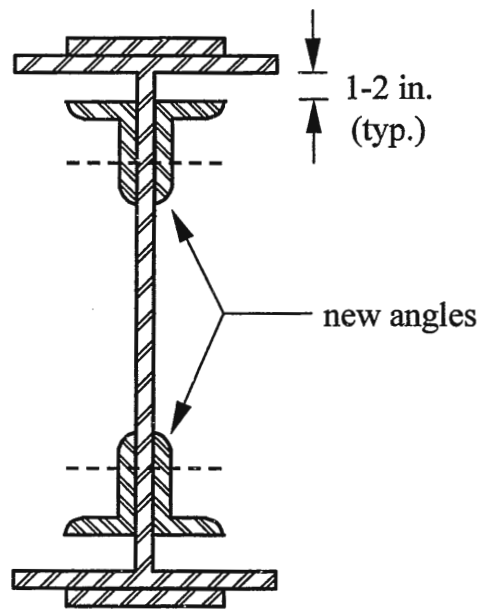
Figure 2.3.5 Reinforcement of Steel Beams by Addition of Angle Stiffeners.

(a) Elevation View

(b) Section A~A

1. Close the bridge to traffic before initiating the repairs.
2. Relieve the dead load stresses on the beams by uniformly jacking the beams up at midspan.
3. Position angles on both sides of the web near the top and/or bottom flanges (see Figs.2.3.5 and 2.3.6) and drill holes through the web and the angles for high strength bolts.
4. Bolt the angles to the beam web beginning at the center of the span and working toward the abutments.
5. Slowly reverse the jacking force to ensure equal distribution of dead load to the beams.

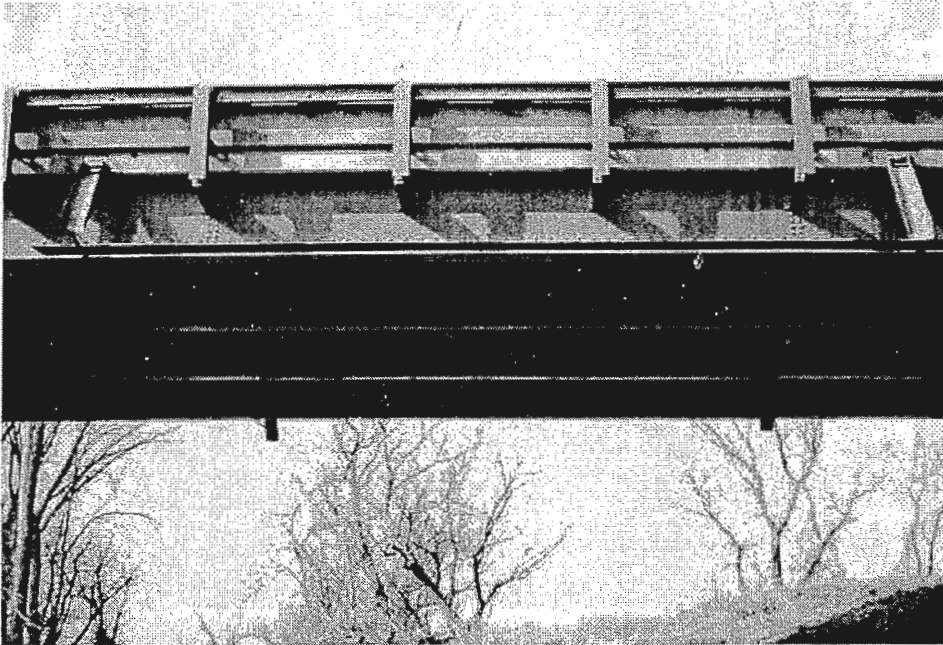
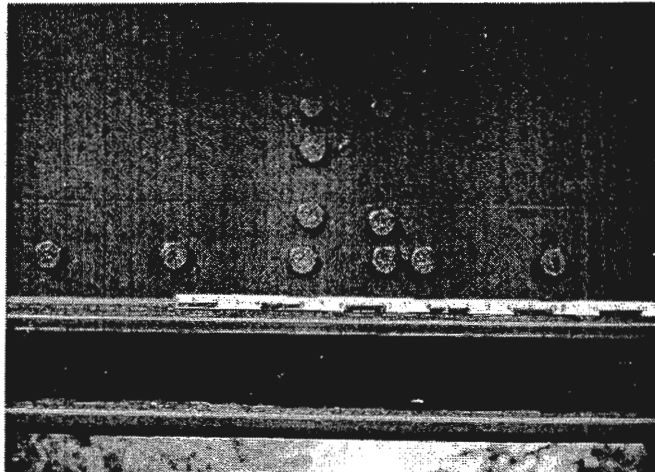
Figure 2.3.6 Example of Angle Stiffeners Used to Strengthen Bridges.

(a) Exterior Girder Strengthened Using Angle Stiffeners

(b) Close up View of the Angle Stiffeners

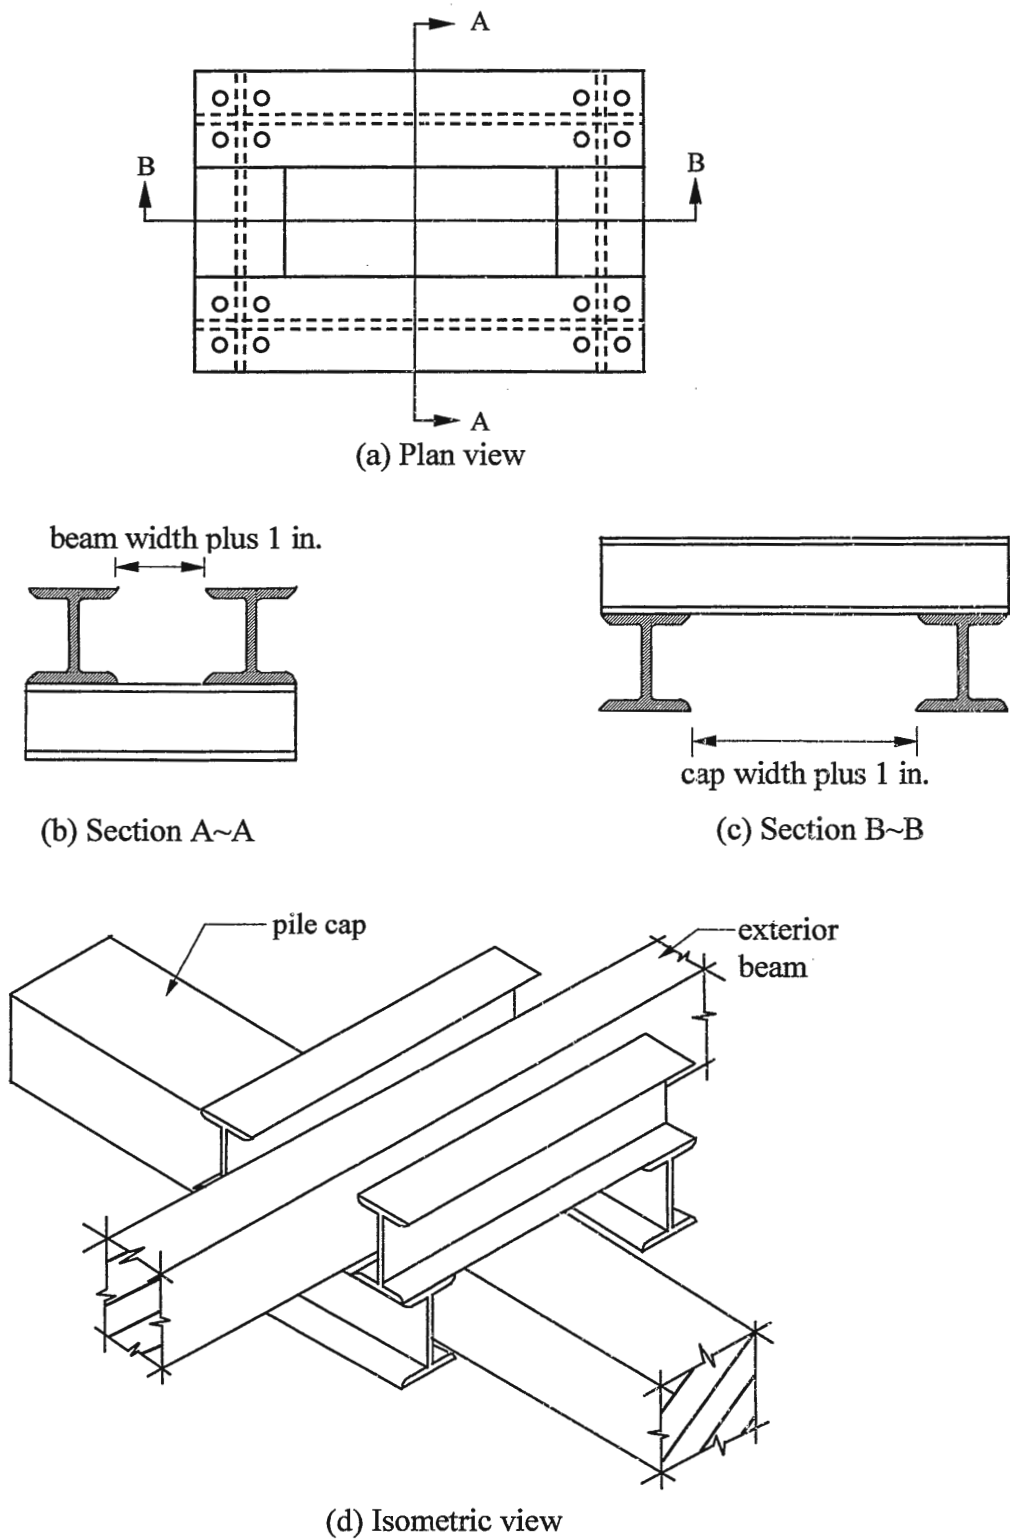
Figure 2.3.7 Installation of a Beam Saddle.

1. Close the bridge to traffic before initiating repairs.
2. Check plans for width of beam and cap or obtain field measurements.
3. Design the saddle to resist appropriate loads.
4. Fabricate and paint saddle members.

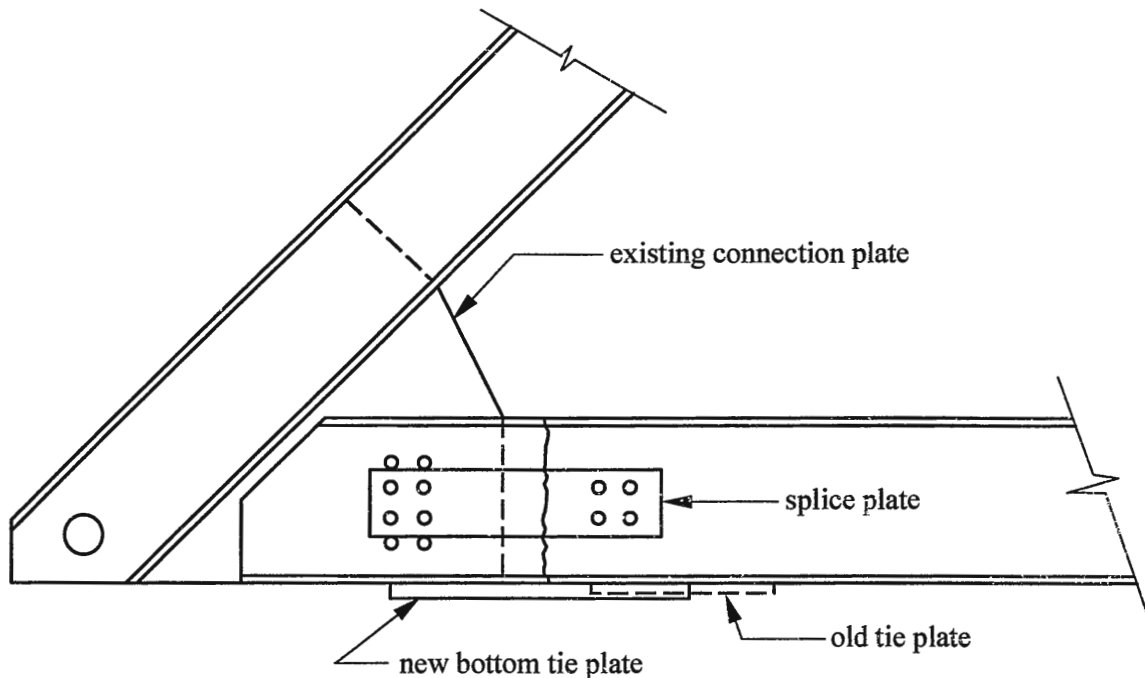
Bolt a splice plate to the damaged member. Remove the old tie plates or lacing bars and bolt the new bottom tie plate to the member.

Figure 2.3.8 Repair of Damaged Bottom Chord Truss Members.

1. Close the bridge to all traffic before initiating repairs.
2. Bolt a side splice plate to the damaged member. Remove any rivet heads or bolts that would interfere with the splice plate if the repair is near a connection. The plate should be centered over the damage.
3. Remove the old tie plates (or lacing bars) from the two channels in the area of the crack to facilitate the placement of the new bottom tie plate. Some temporary lateral bracing may be required before completing the repair.
4. Bolt the new tie plate to the bottom chord (see Fig. 2.3.8).

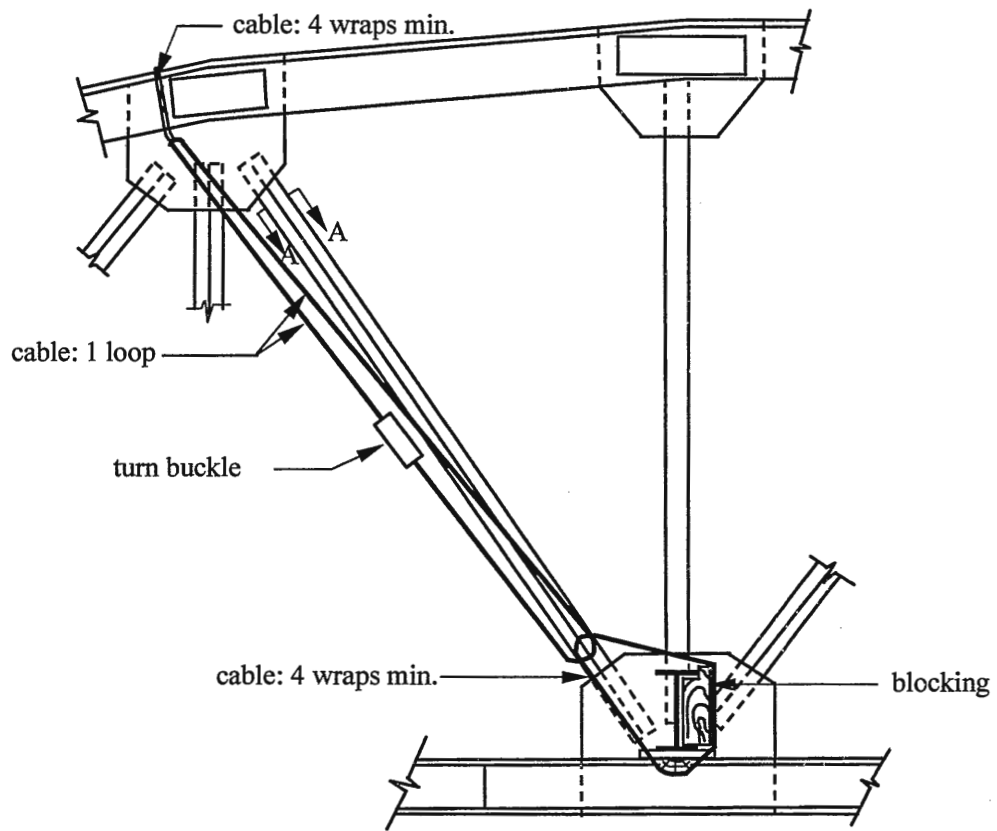
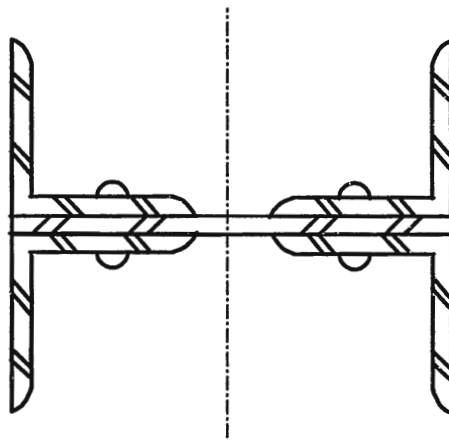
Figure 2.3.9 Replacement of a Diagonal Tension Member.

Design the new diagonal section and connections. Install wood blocking and cable having the capacity to carry the full dead load and the live load from the restricted traffic. Replace the member providing batten plates and lacing bars where required. Restore the bridge to normal traffic after completion of the repairs.

(a) Elevation

(b) Section A~A

1. Restrict traffic on the bridge to the lane opposite to the side where the diagonal member is to be replaced.
2. Design the new diagonal section and its connections.
3. Cut and install the necessary wood blocking.
4. Install a cable having the capacity to carry the full dead load in the diagonal plus the live load distributed from the restricted traffic (see Fig. 2.3.9).
5. Tighten the cable system.
6. Install batten plates or lacing bars at required intervals along the diagonal.
7. Remove cable slings and other temporary components and restore the bridge to normal traffic conditions.

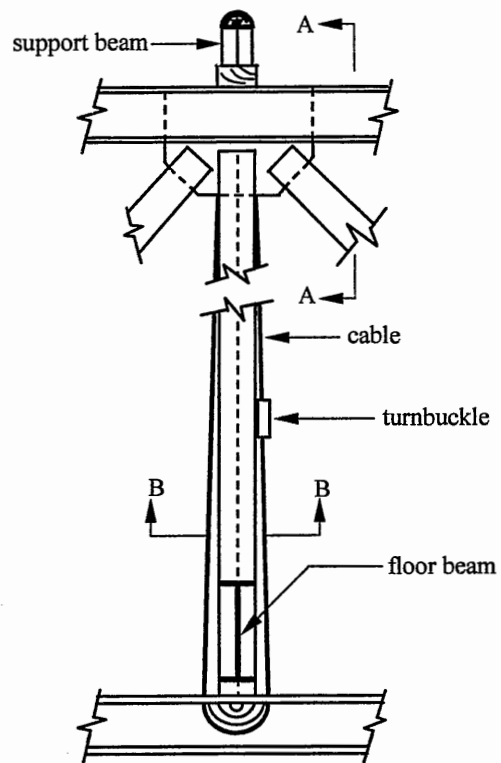
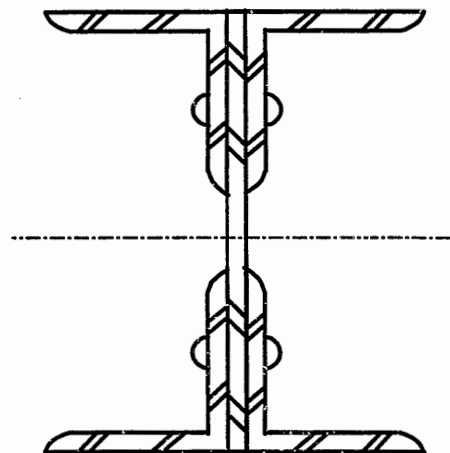
Figure 2.3.10 Replacement of Vertical Tension Members.

Design the new vertical member. Install wood blocking, support beam, and the cable. Tighten the cable system and replace the truss member, placing lacing bars and batten plates where required. Remove the cables and restore the bridge to normal traffic.

(a) Elevation

(b) Section A~A

(c) Section B~B

1. Restrict traffic to one lane on the opposite side of the bridge.
2. Design the new vertical section and its connections.
3. Install the wood blocking and the support beam as shown in Fig.2.3.10.
4. Install a cable having the capacity to carry the maximum load in the vertical member being repaired.
5. Tighten the cable system.
6. Install the batten plates or lacing bars at required intervals.
7. Remove cable slings and other temporary components and restore the bridge to normal traffic conditions.

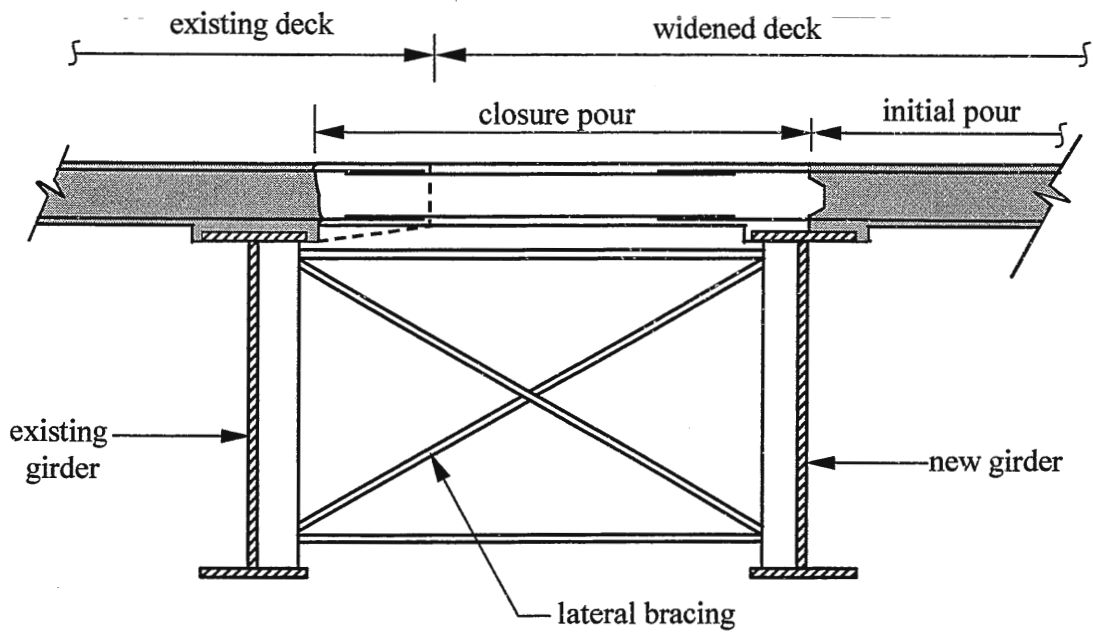
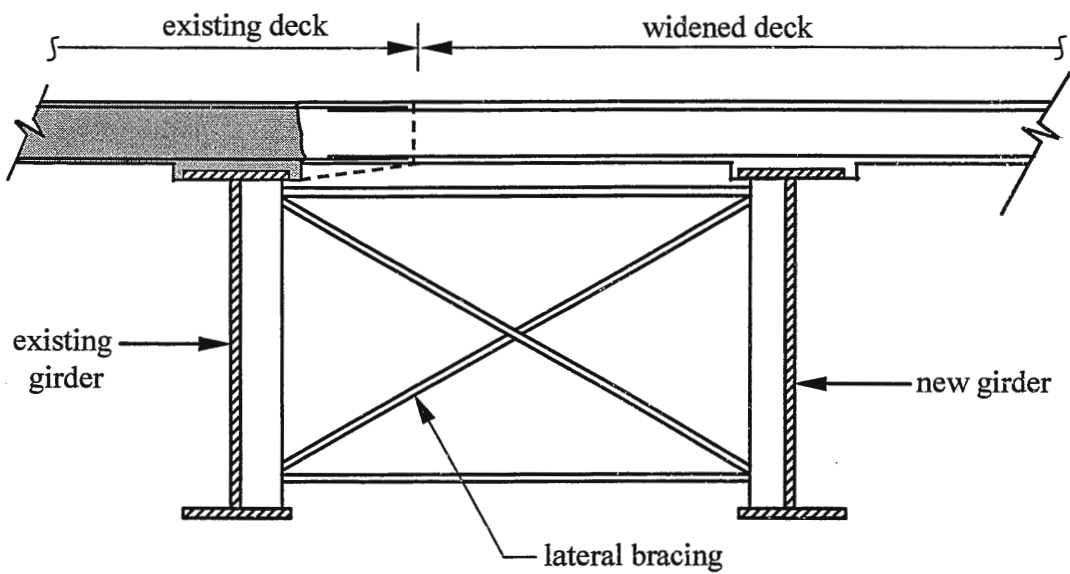
Figure 2.3.11 Widening Concrete Deck Bridges.

(a) Method A

(b) Method B

1. Eliminate traffic from at least the lane nearest the widening before the closure concrete is placed.
2. Widen the piers and abutments as necessary.
3. Design, fabricate, and erect the new girders for the widening.
4. Remove the concrete from the old deck area to expose the reinforcing steel to the length required to provide necessary development length.
5. Place adequate lateral bracing between the old exterior girder and the new adjacent girder.
6. Form the new deck area and attach the new reinforcing steel to the original by lapping both the top and bottom transverse deck steel (see Fig. 2.3.11 b).
7. Place the concrete for the widening.

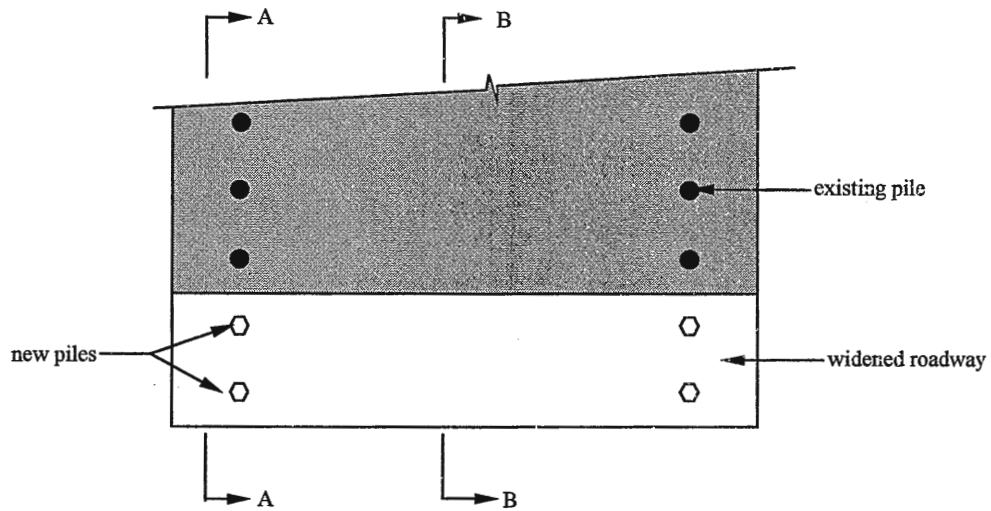
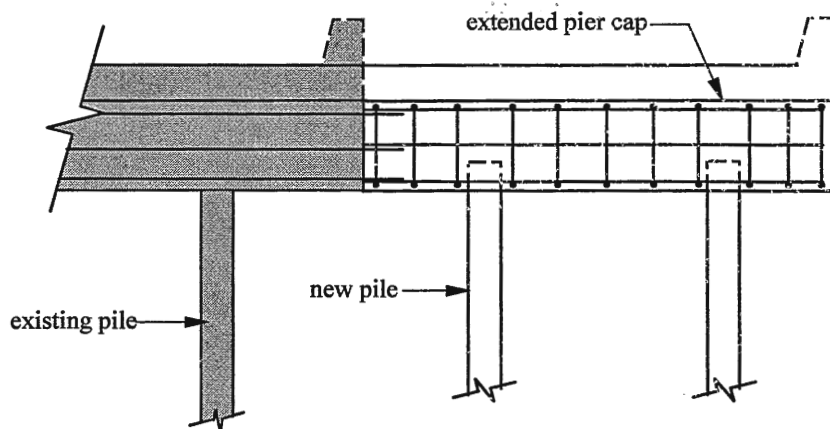
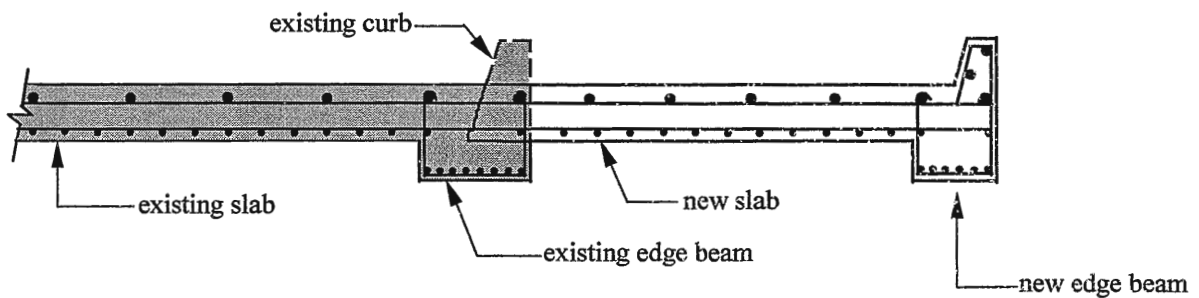
Figure 2.3.12 Widening of Concrete Slab Bridges.

(a) Plan View

(b) Section A~A

(c) Section B~B

1. Direct traffic to the opposite side of the bridge roadway during slab widening.
2. Widen the piers and abutments to the new width (refer to section 2.4.7 for information on widening piers). Support the existing slab with shoring before removing the edge parapet curb.
3. Remove the existing parapet concrete and approximately 12 in. of the existing concrete slab to expose the old transverse reinforcing steel.
4. The reinforcing steel in the new section of roadway slab is lapped with the transverse steel in the existing roadway slab.
5. Provide an edge beam for the widened slab by placing extra reinforcement and a new parapet integral with the slab similar to that removed (see Fig. 2.3.12).

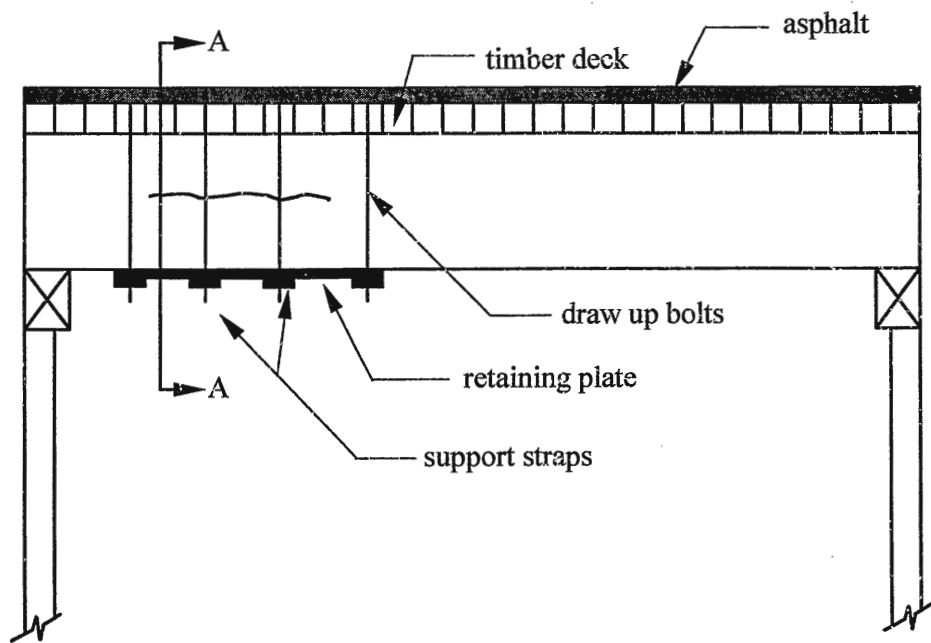
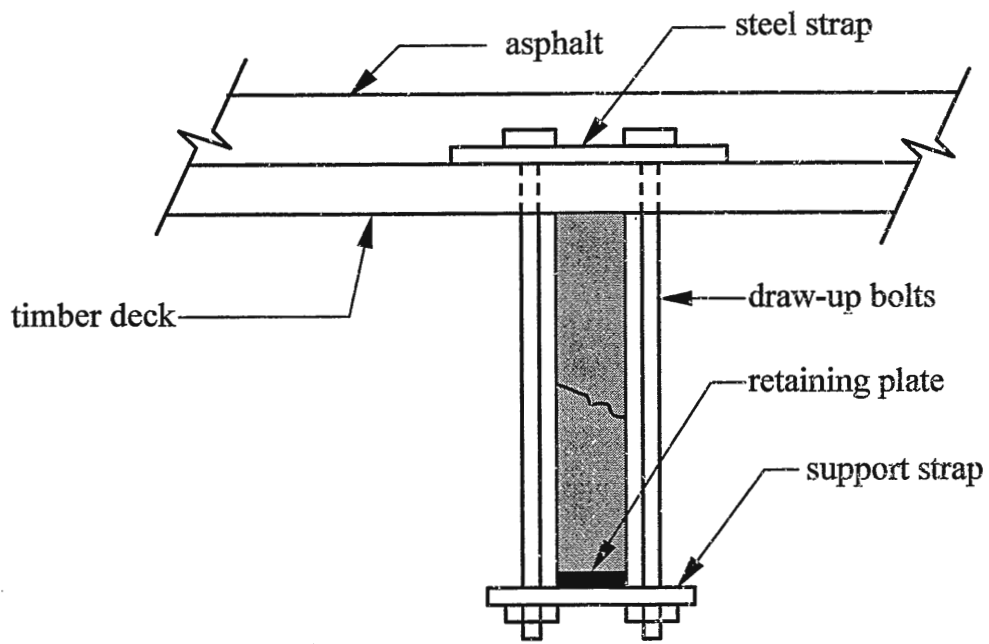
Figure 2.3.13 Repair of Cracked or Damaged Timber Stringers.

(a) Elevation

(b) Section A~A

1. Close bridge to traffic during the repair period.
2. Determine the load that would be necessary at a location near the cracked portion of the stringer to eliminate the dead load moment. Calculate the corresponding deflection this load would produce at the point where the beam is to be lifted up. The stringer to be repaired should be raised exactly this amount.
3. Remove the asphalt overlay in the area where the holes are to be drilled.
4. Drill holes for draw up bolts through the bridge deck.
5. Place the retaining and support plates (see Fig.2.3.13) and tighten the draw up bolts.

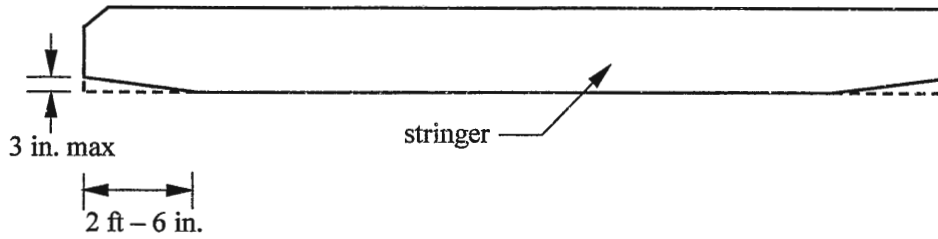
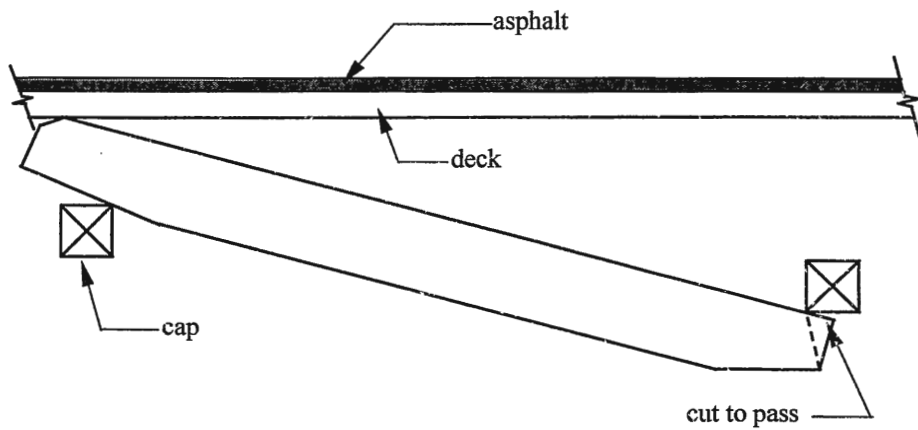
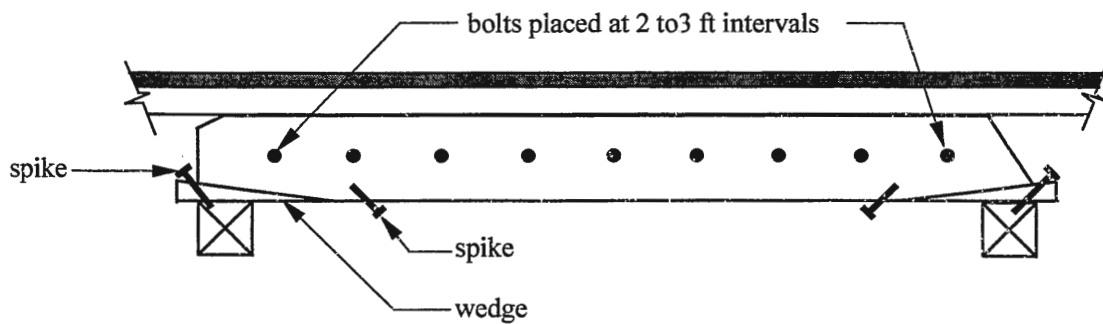
Figure 2.3.14 Replacement of Timber Stringers.

(a) Replacement stringer

(b) New stringer lifted into position

(c) New stringer secured in place using spikes and bolts

1. Close bridge to traffic before initiating repairs.
2. Cut the new stringer to the required length and taper the ends (see Fig 2.3.14 a).
3. Lift the new stringer into position (see Fig 2.3.14 b). Clip the ends of the beam as required, to facilitate the placement operation.
4. Drive wedges under the new stringer until it bears against the deck.
5. Secure the wedges with spikes (see Fig 2.3.14 c).
6. Secure the old stringer to new stringer at 2 ft to 3 ft intervals by using 3/4 in. ϕ bolts placed at mid-depth.

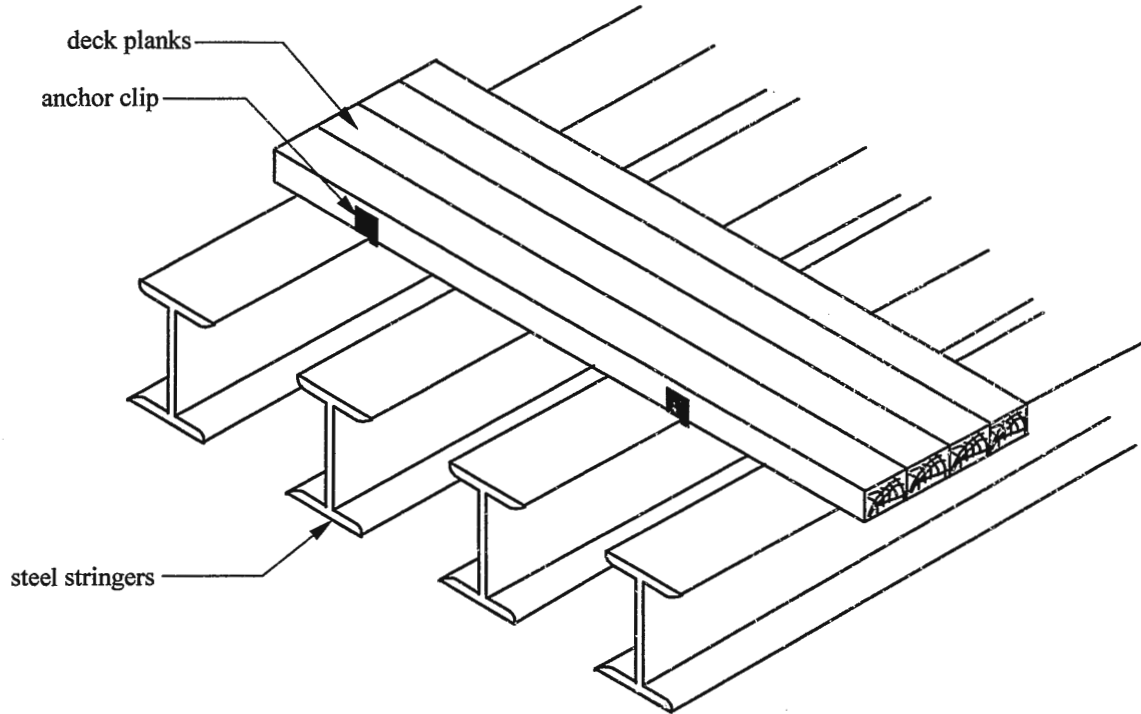
Figure 2.3.15 Replacement of Timber Deck Planks.

7. Place anchor plates and space them at approximately 12 in. centers (see Fig. 2.3.15)
8. Apply wood preservative to the ends of any plank that is field cut. (Treated lumber should always be used for timber deck maintenance and replacement).

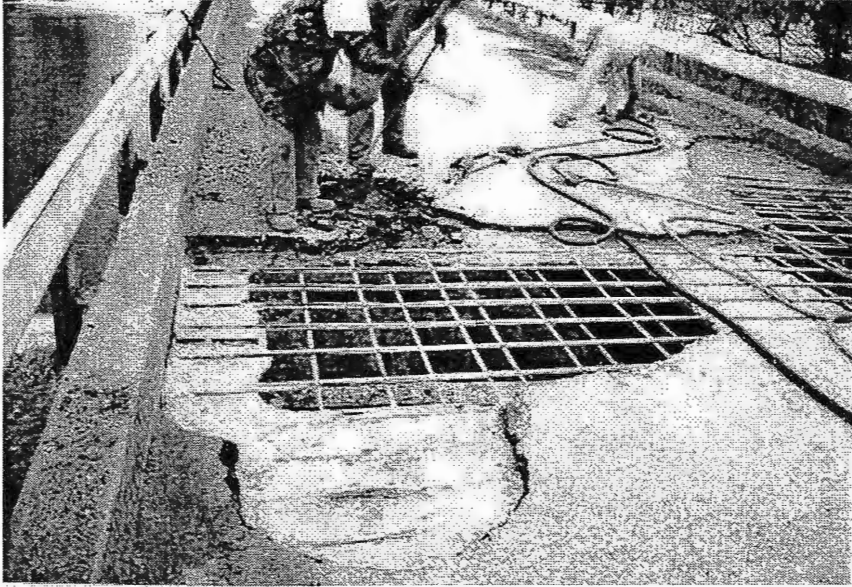
Figure 2.3.16 Full Depth Deck Patching.

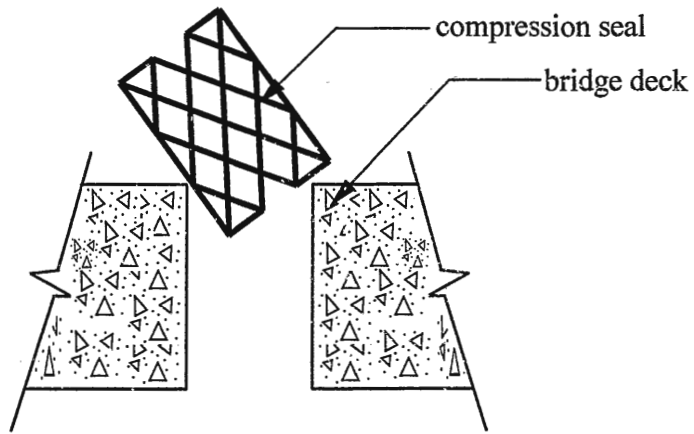
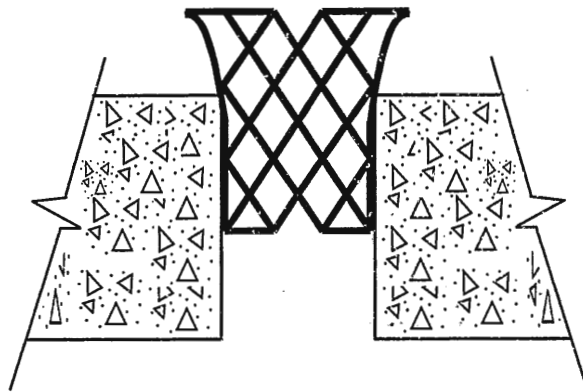
(a) Stage I of the Installation

(b) Stage II of the Installation

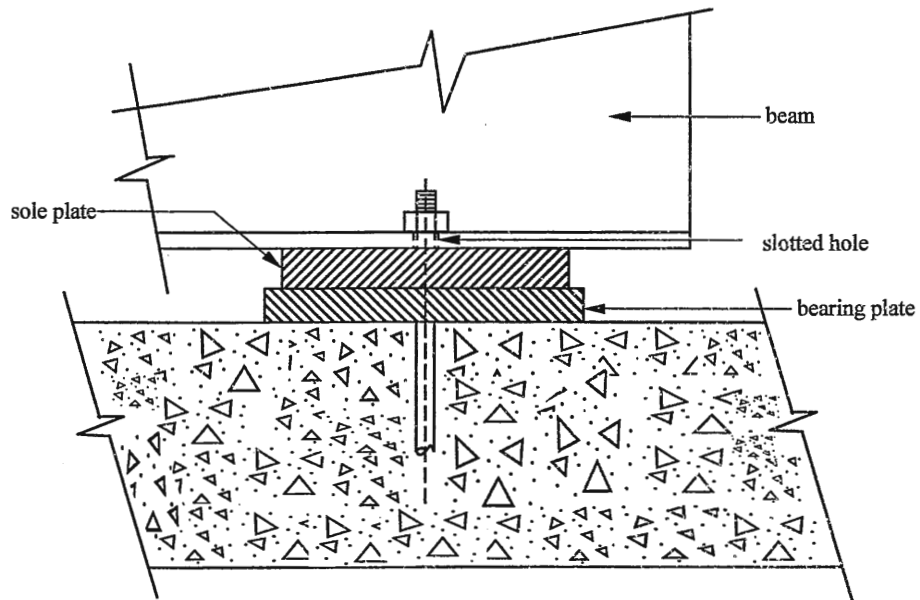
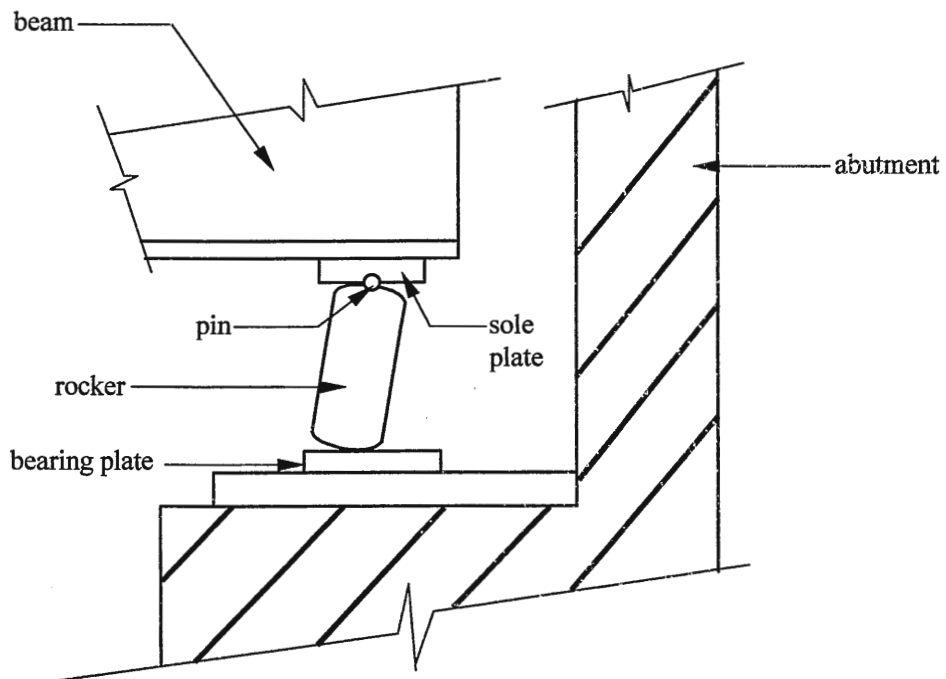
Figure 2.3.18 Maintenance of Common Bridge Bearings.

Lift up the beam, clean and then lubricate individual components. Reinstall the components.

(a) Sliding Bearings

(b) Rocker Bearings

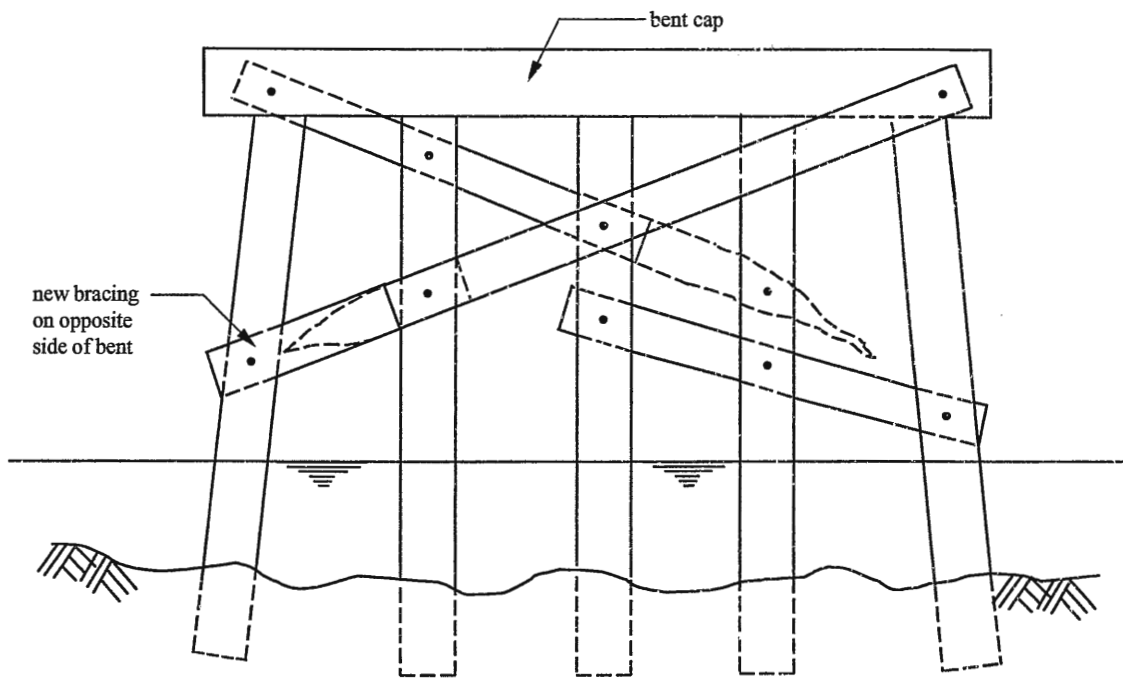
Figure 2.4.1 Installation and Repair of Timber Pile Sway Bracing.

1. Locate the terminus of deterioration or damage of the sway bracing. Cut off the bracing at the pile nearest to the terminus.
2. Measure length of new bracing required for reconnecting the piles. Cut new sections based on this length.
3. Use existing bolt holes in piles, where possible. Drill new holes in piles when sway bracing must be realigned. Treat both new bolt holes and old ones to be reused with hot oil preservative (see Fig. 2.4.1).

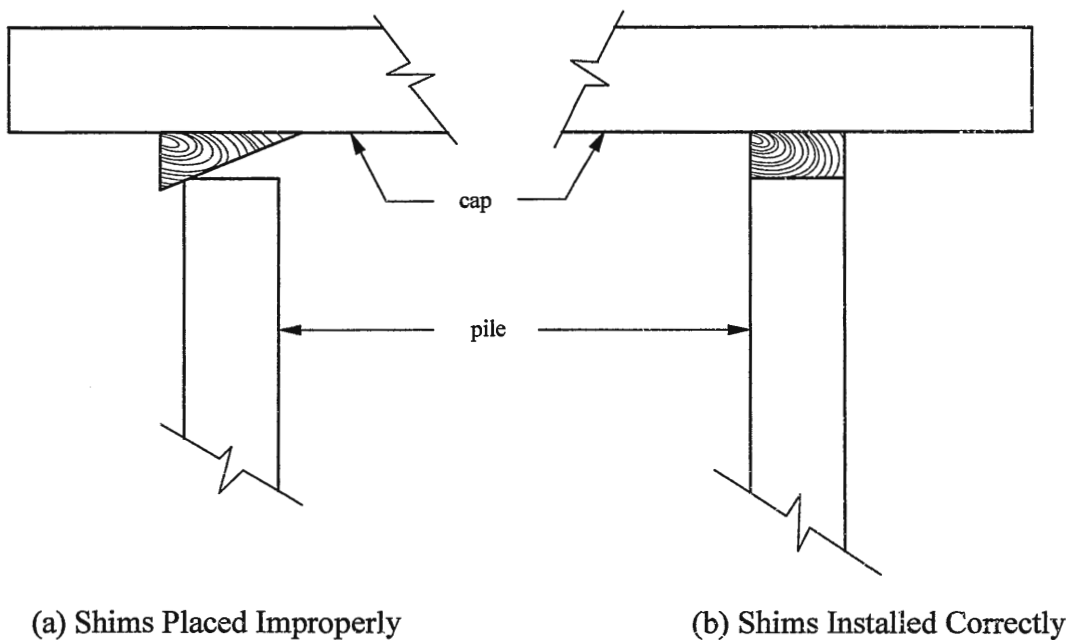
Figure 2.4.2 Shimming Timber Piles.

1. Close bridge to traffic before initiating repairs.
2. Place cribbing (strut) adjacent to pile to be shimmed. If several piles in one bent need to be shimmed, cribbing should be placed to allow shimming of all piles at one time.
3. Set the hydraulic lifts on the cribbing (strut) and raise the pile cap approximately 1/2 in. higher than the desired elevation.
4. Cut the shim pieces 1/4 in. less than the opening between the cap and the pile head and then place them into position.
5. Lower the pile cap and fasten the shim pieces to the pile using nails (see Fig. 2.4.2).
6. Remove the cribbing.

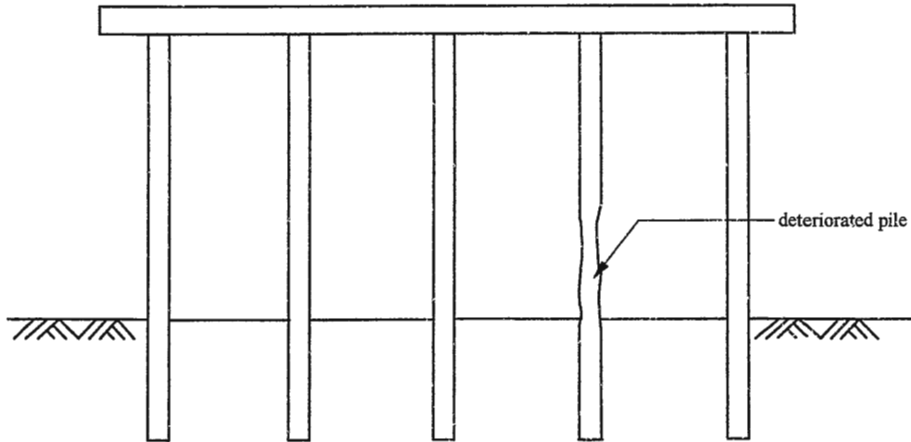
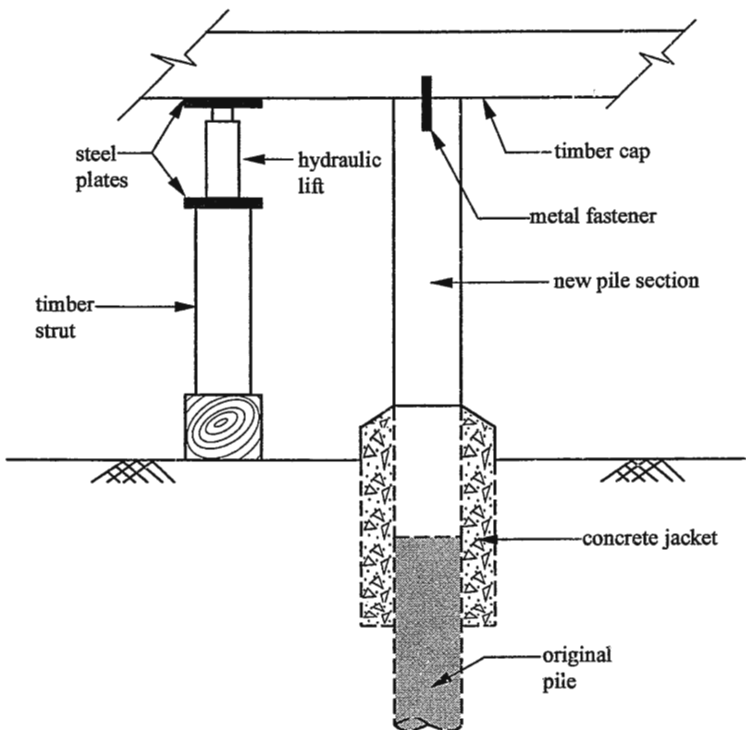
(a) Damaged Pile to be Retrofitted by Splicing

(b) New Pile Section Spliced to the Stub of the Original Pile
