Evaluation of appropriate maintenance, repair and rehabilitation methods for Iowa bridges

Major: Civil Engineering (Structural Engineering)

Iowa State University

2001

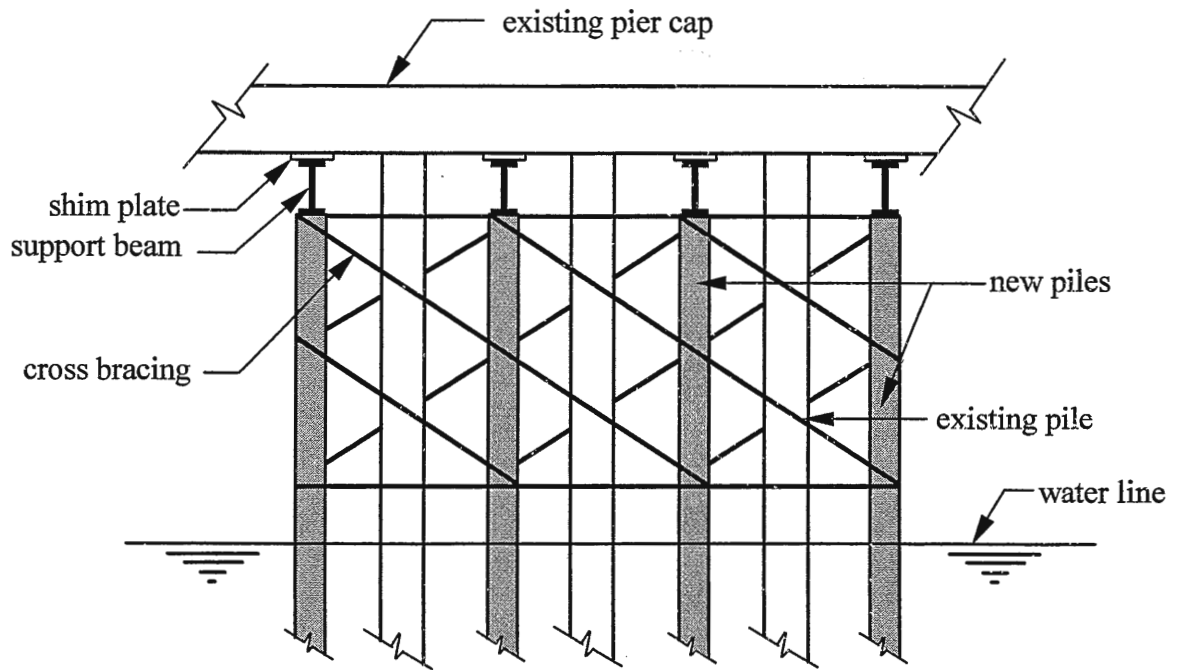
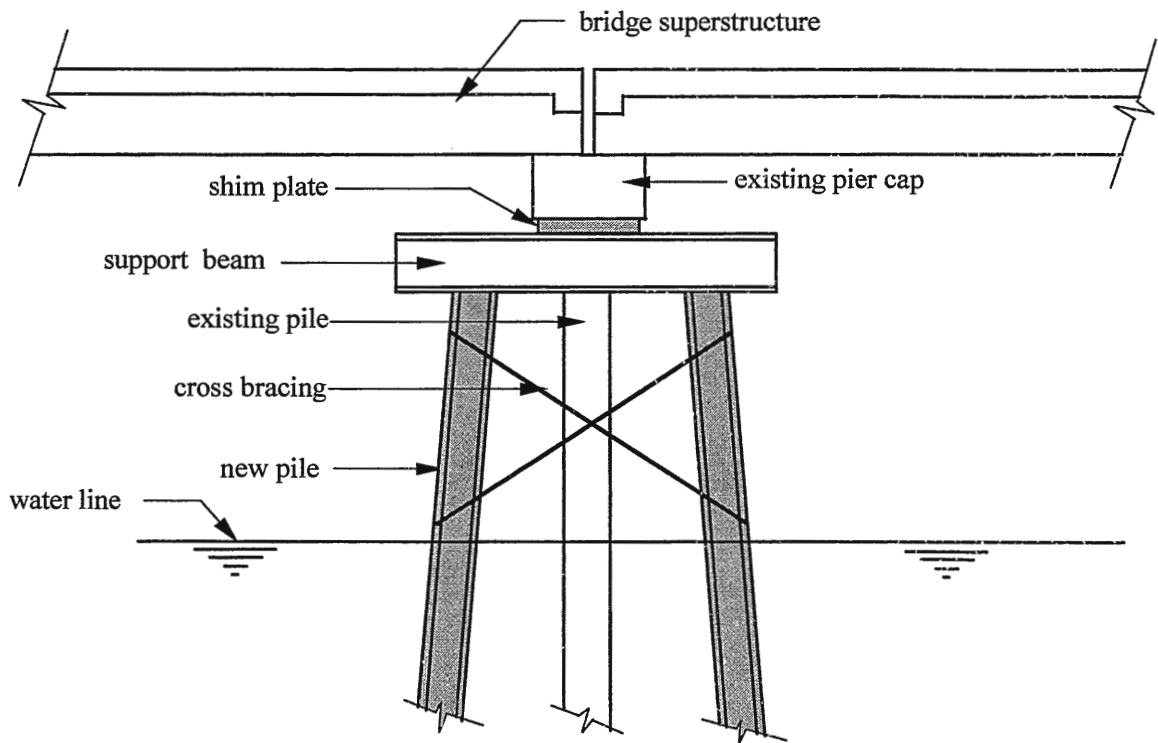
Figure 2.4.4 Addition of Supplemental Steel Piles.

(a) Front Elevation

(b) Side Elevation

1. Close bridge to traffic before initiating repairs.
2. Cut any deck reinforcement that may obstruct the installation of the new piles, adequate splice length should be provided.
3. Cut openings in the bridge deck to allow the new piles to be driven.

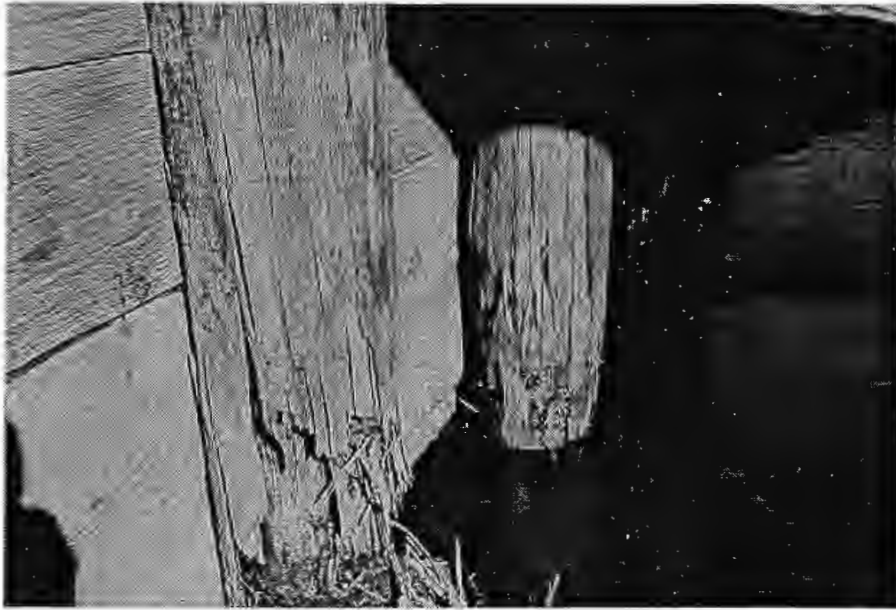
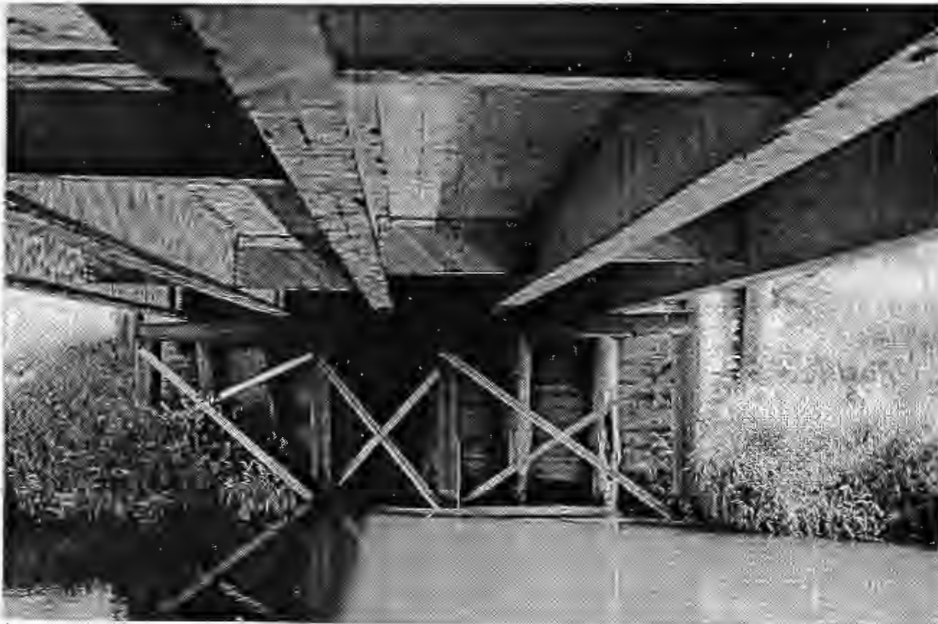
Figure 2.4.5 Example of Addition of Supplementary Steel Piles.

(a) Deteriorated Pile

(b) Strengthening by Addition of Supplementary Steel Piles

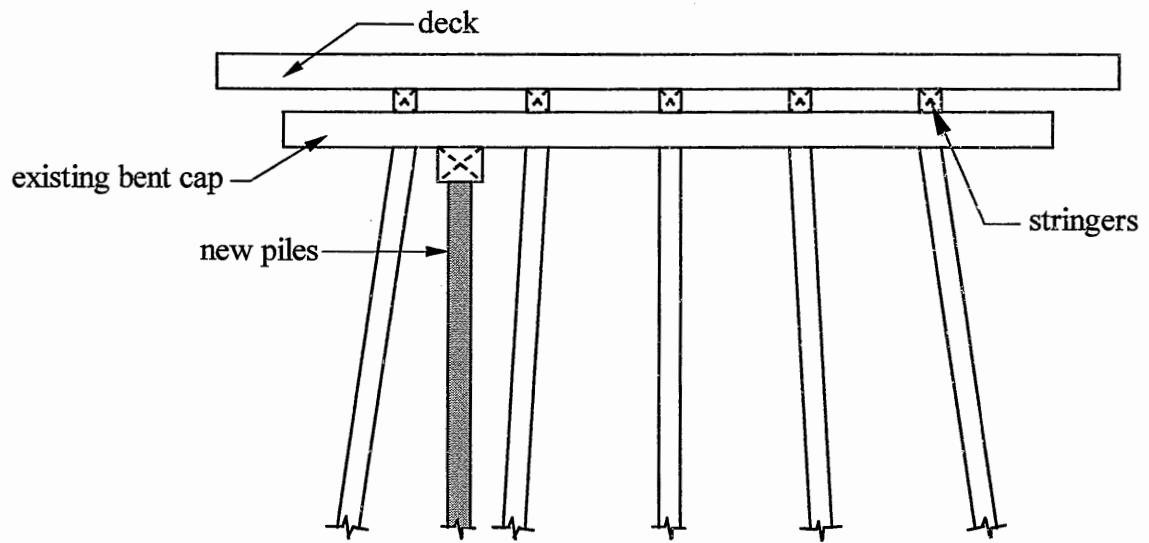
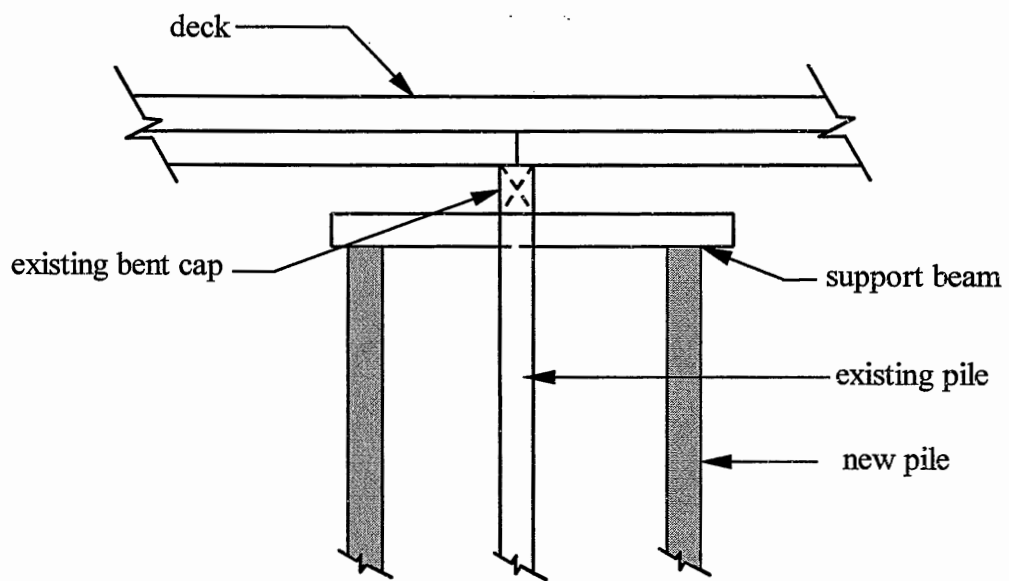
Figure 2.4.6 Pile Bent Strengthening with Supplemental Timber Piles.

(a) Front Elevation

(b) Side Elevation

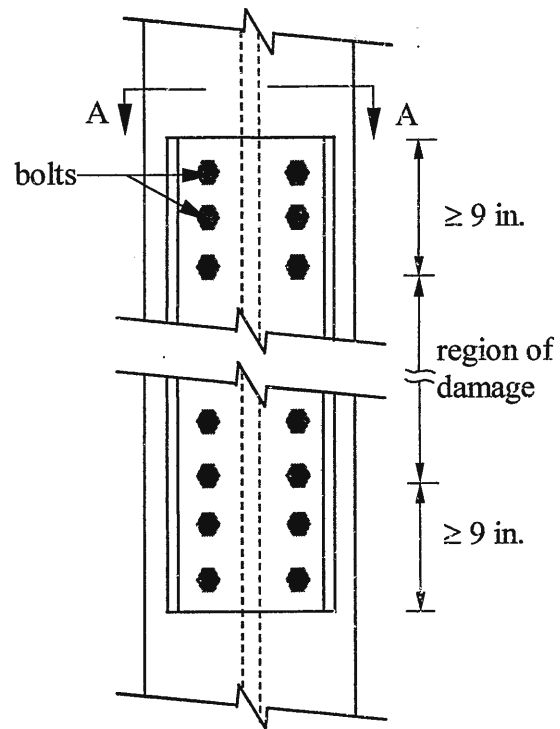
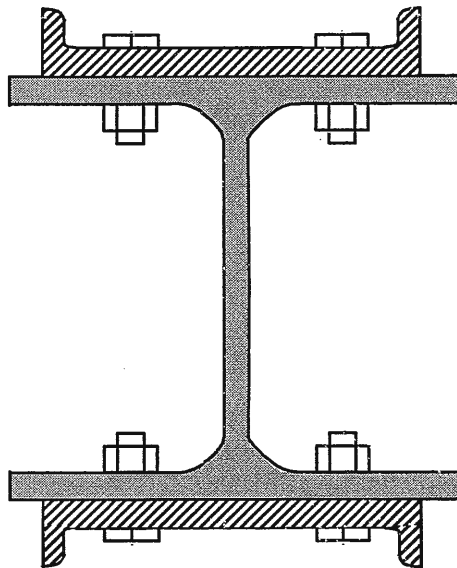
Figure 2.4.7 Repair of Steel H-Piles.

(a) Elevation View of H-pile

(b) Section A~A

1. Locate the extremes of the region(s) of deterioration. The channel sections to be spliced to the pile in these regions shall extend 9 in. past the deteriorated region.
2. Design the channel section based upon required axial capacity and stability criterion.
3. Thoroughly clean the area to which the channel is to be bolted.
4. Clamp channel section in place against the pile.

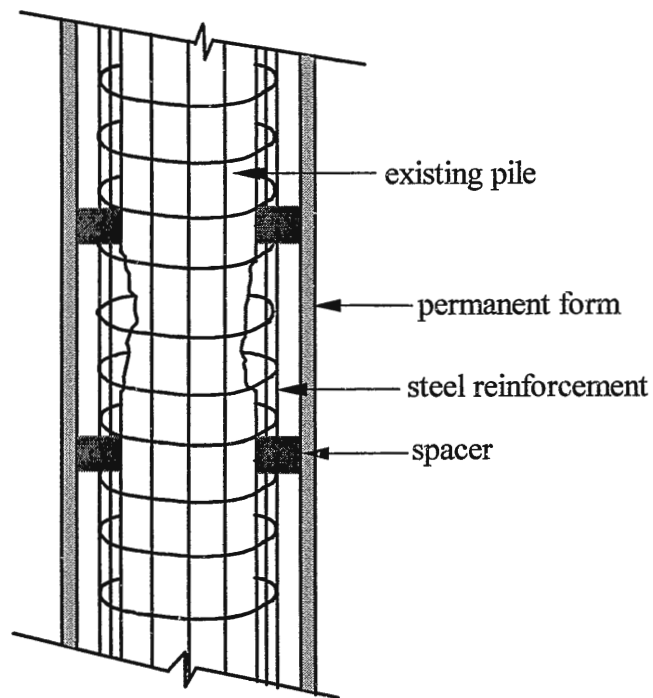
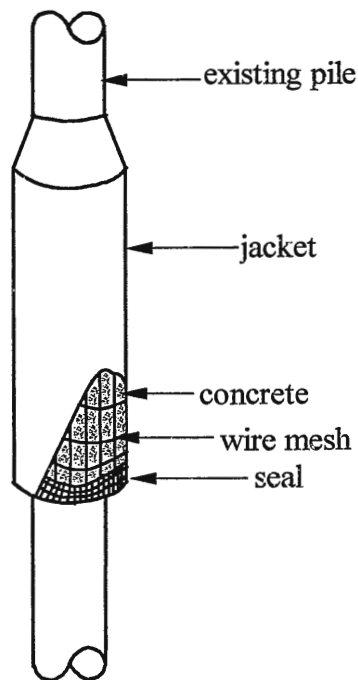
Figure 2.4.8 Repair of Deteriorated Timber or Concrete Piles.

(a) Construction of the Pile Jacket

(b) Completed Repair

1. Clean the surface of the pile where the jacket is to be installed.
2. Install a reinforcing cage around the pile; use spacers to keep the reinforcement in place.
3. Place the forming jacket around the pile and seal the bottom of the form.
4. Pump the concrete into the form through the opening at the top.
5. Finish top portion of the repaired area, the top surface of the pile jacket should be sloped to allow runoff (see Fig. 2.4.8).

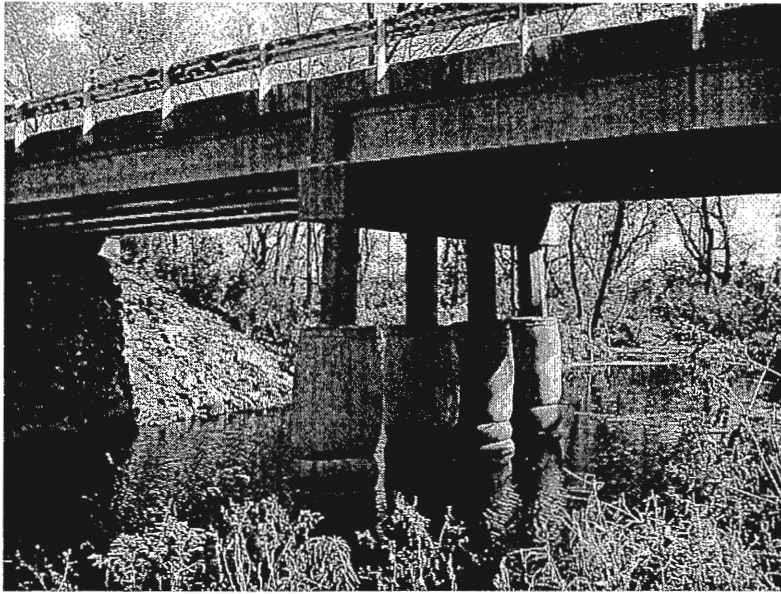
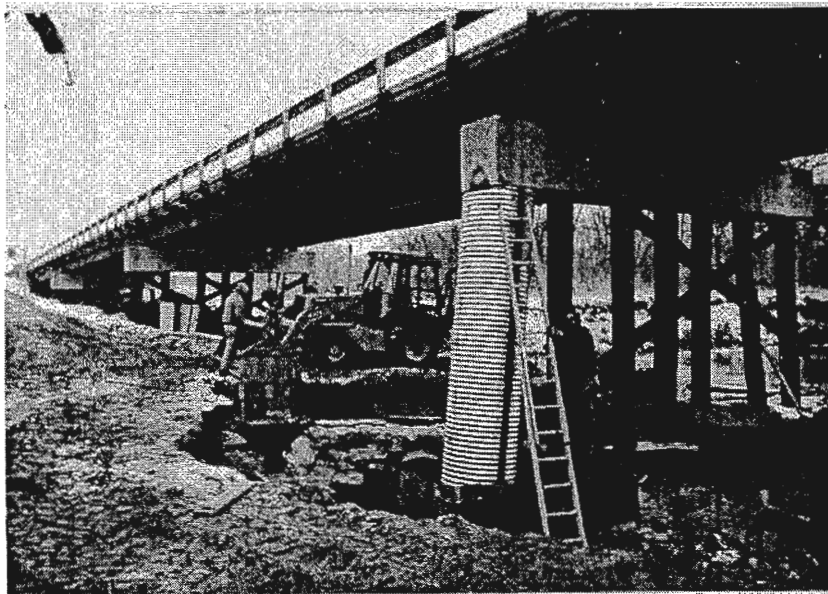
Figure 2.4.9 Examples of Pile Jacketing in Iowa.

(a) Jacketing of Concrete Piles

(b) Jacketing of Timber Piles

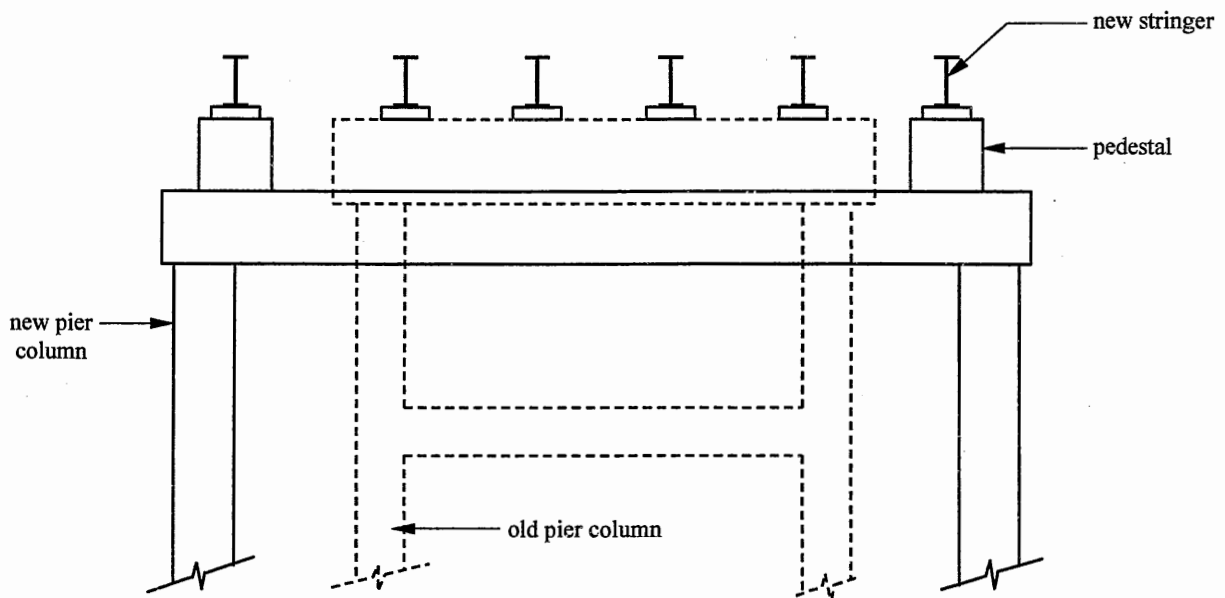
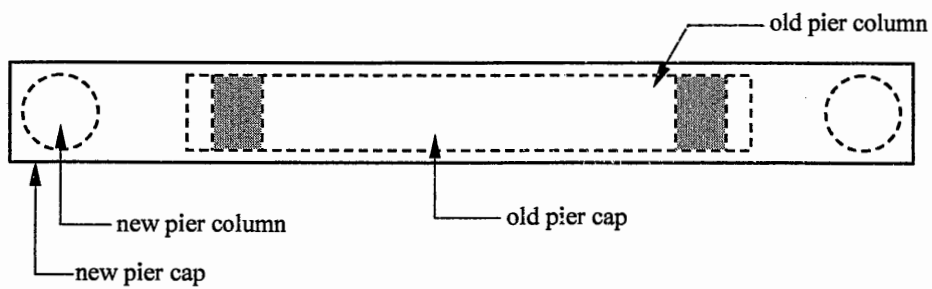
Figure 2.4.10 Widening Concrete Piers.

(a) Elevation

(b) Plan View

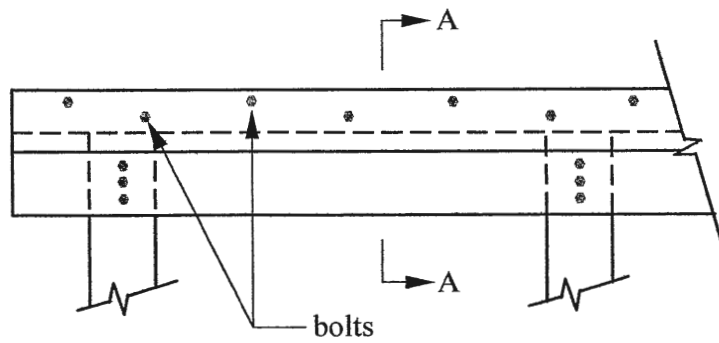
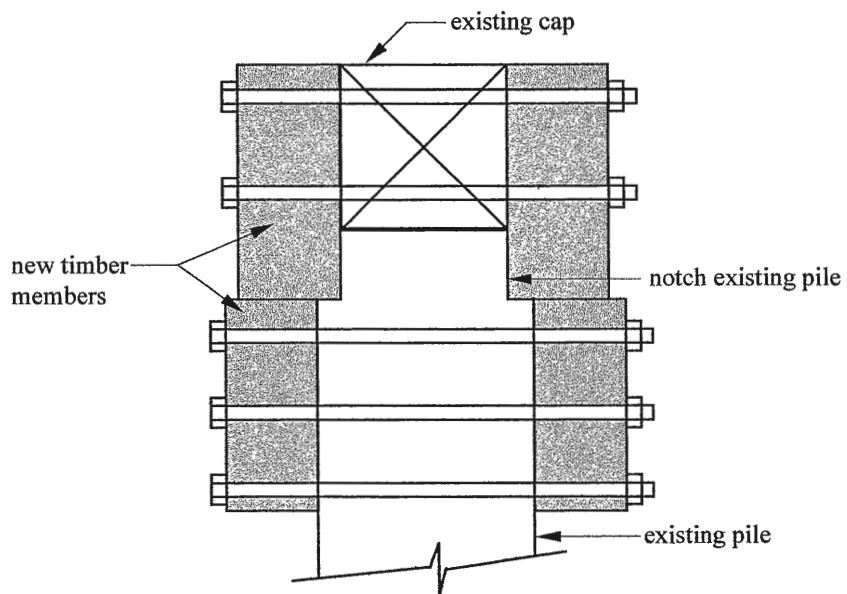
Figure 2.4.11 Strengthening Timber Pile Caps.

(a) Elevation

(b) Section A~A

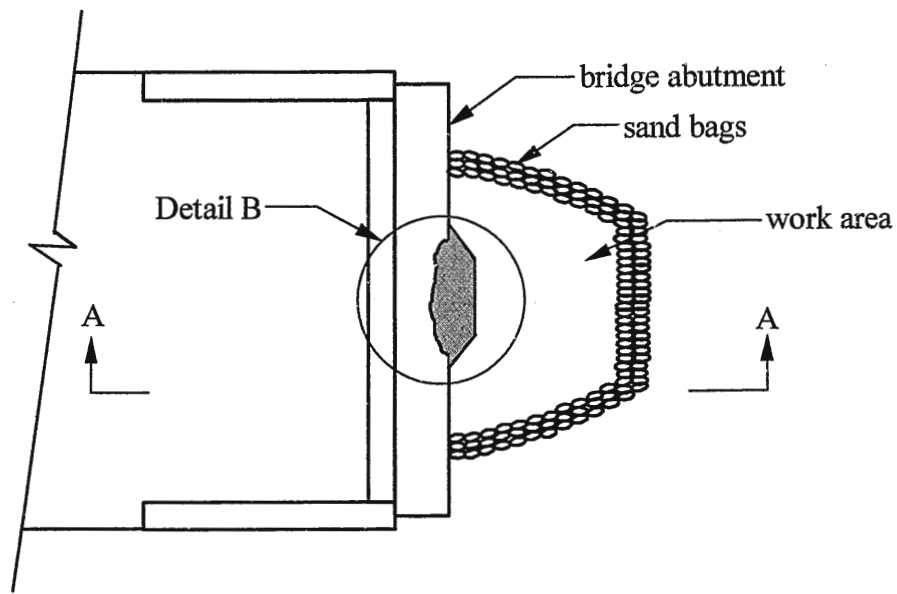
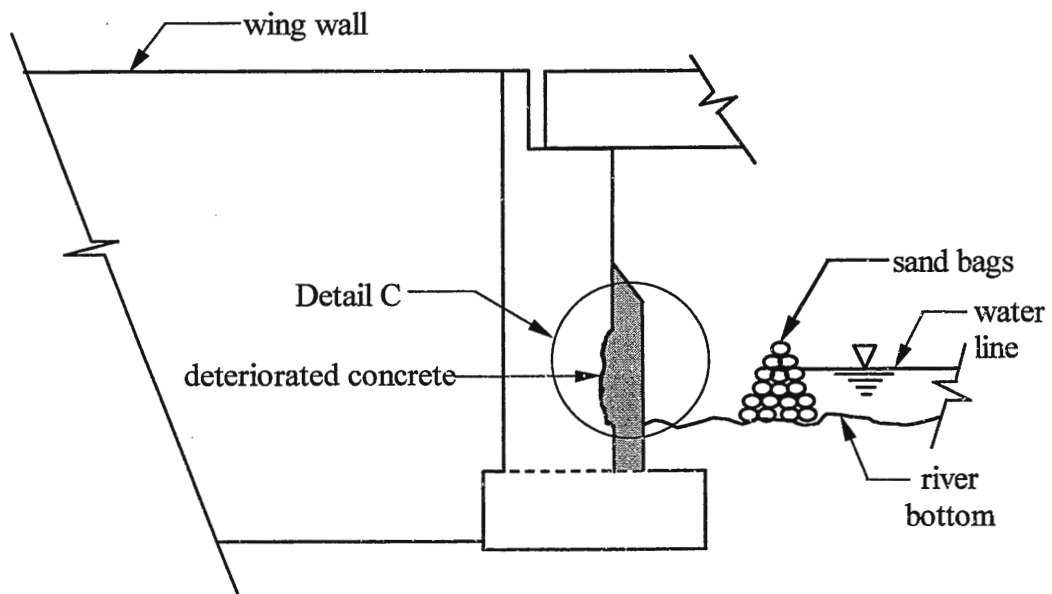
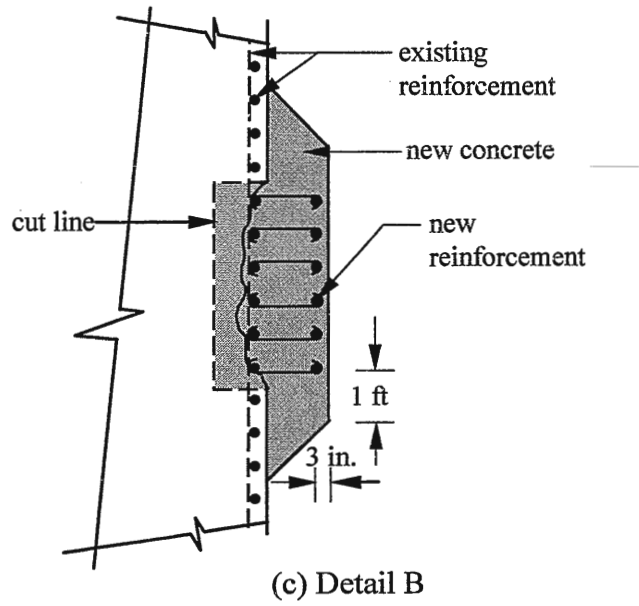
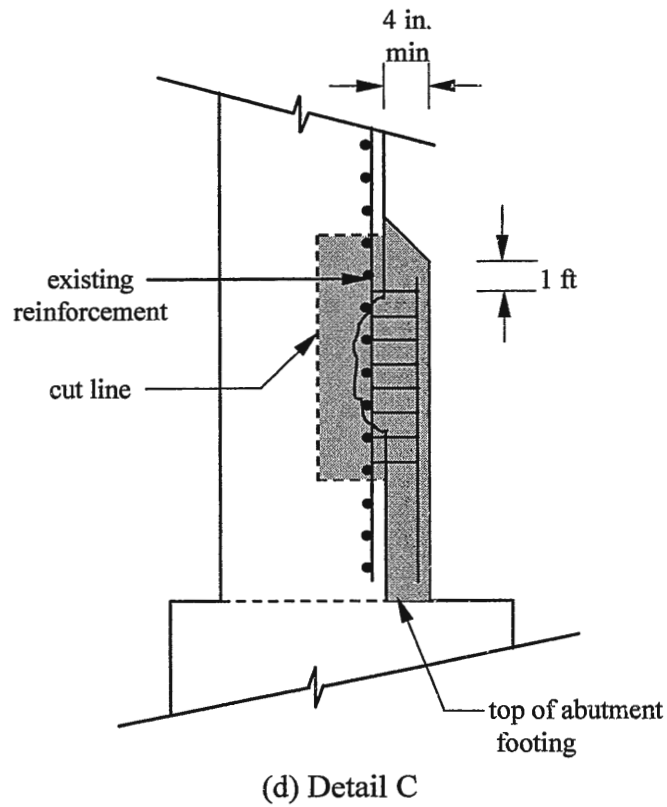
Figure 2.4.12 Repair of Concrete Abutments.

(a) Plan View

(b) Section A~A

1. Construct a cofferdam and pump out water if necessary.
2. Remove the deteriorated and expose steel reinforcement.
3. Form and add a new reinforcement mat and concrete to make the abutment 4 to 6 in. thicker. The newly placed concrete will be at least 1 ft wider than the region of damage, in all directions (see Fig. 2.4.12).
4. Remove the sandbags after concrete has gained sufficient strength.

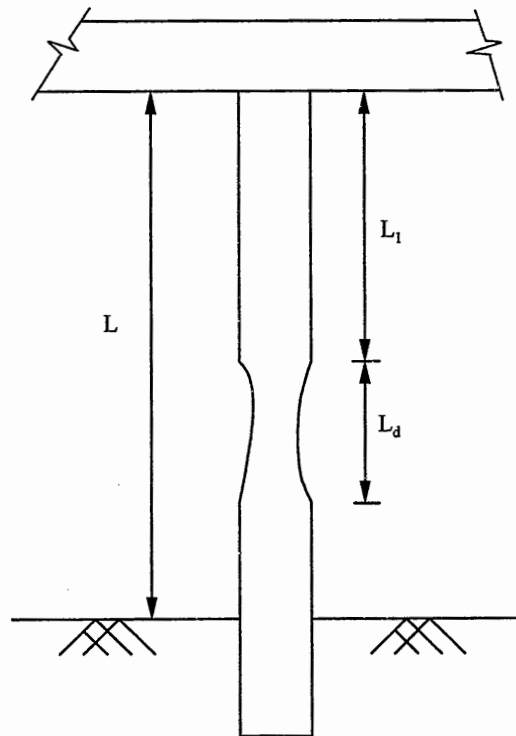
Figure D.1 Illustrates a typical deteriorated timber pile. Damage and deterioration to timber piles in bridges may occur because of termite attack or due to fungal decay. Piles may also deteriorate due to abrasive action of suspended particulate matter, damage from floating craft, drifting objects and ice. Pile deterioration may occur anywhere along the length of the pile.

Figure D.1 Deteriorated Timber Pile

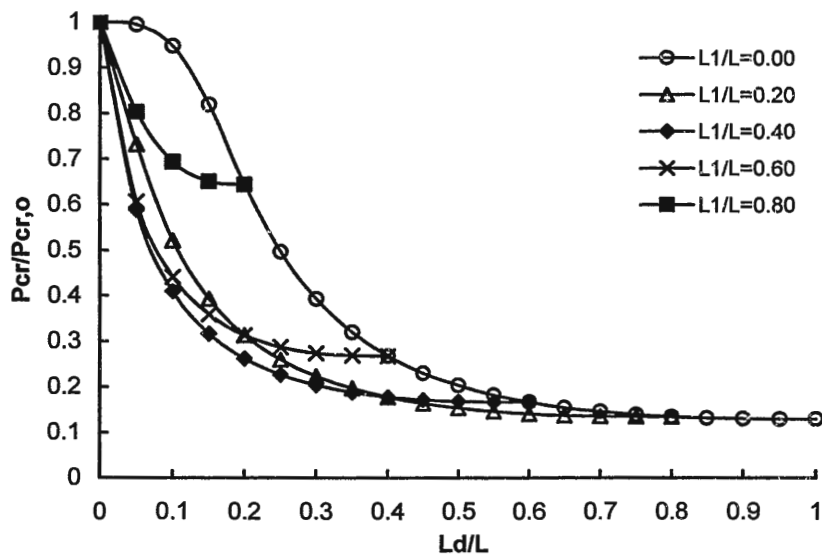
**Figure D.2 Buckling Load for Deteriorated Piles with
Pinned - Pinned Support Conditions: $R = 0.6$**

The support conditions that apply to a particular pile have to be judged by an engineer based on parameters that include depth of embedment of the pile into soil, relative stiffness of the pile and the pile cap and soil characteristics. An example to illustrate how to utilize the developed graphs to calculate the capacity of a deteriorated pile is provided at the end of this Appendix.

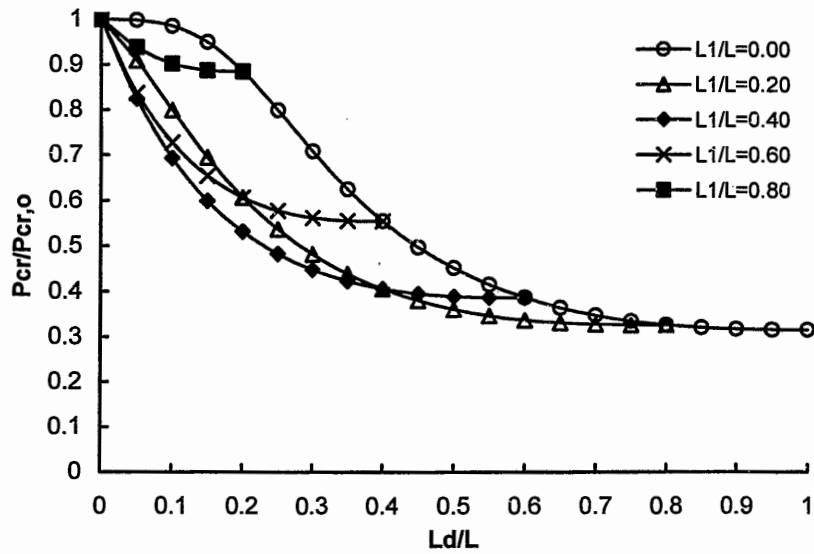
**Figure D.3 Buckling Load for Deteriorated Piles with
Pinned - Pinned Support Conditions: $R = 0.75$**

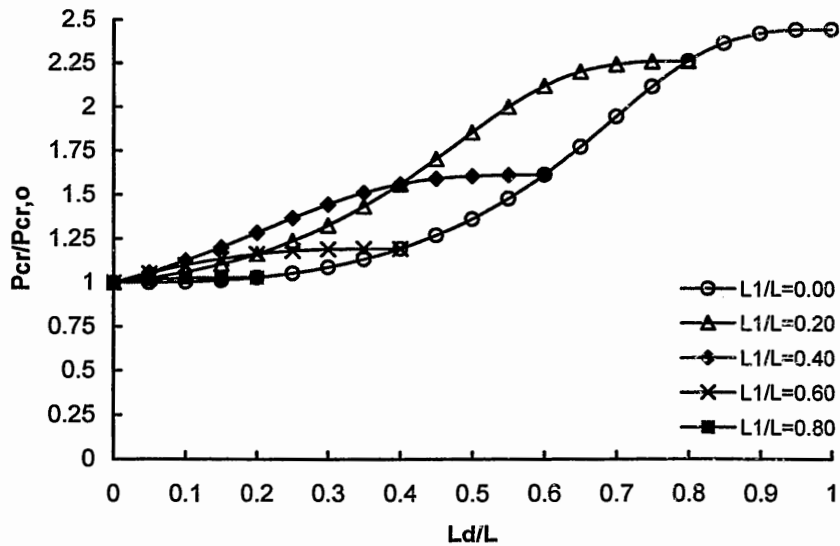
**Figure D.4 Buckling Load for Retrofitted Piles with
Pinned - Pinned Support Conditions: $R = 1.25$**

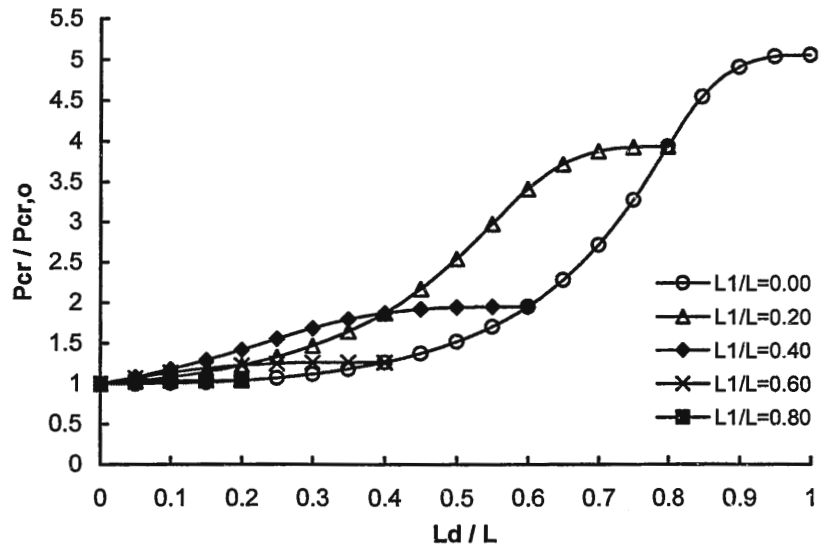
**Figure D.5 Buckling Load for Retrofitted Piles with
Pinned - Pinned Support Conditions: $R = 1.5$**

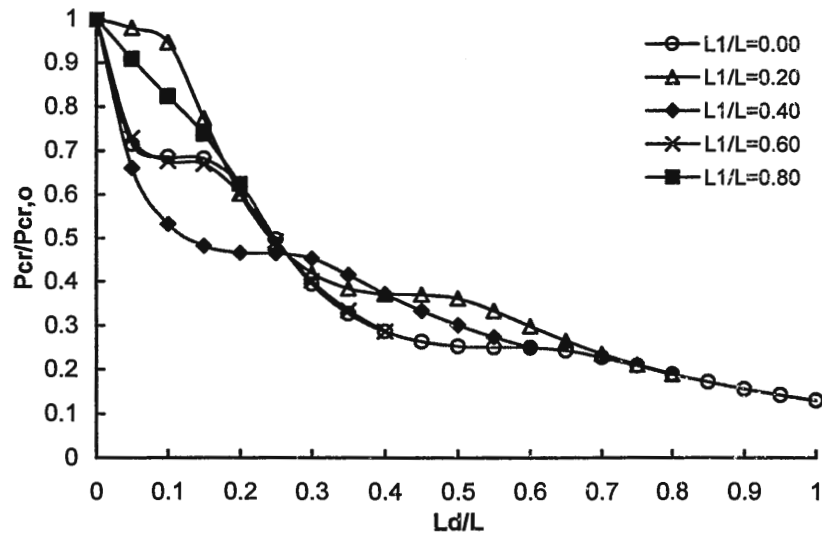
**Figure D.6 Buckling Load for Deteriorated Piles with
Fixed - Fixed Support Conditions: $R = 0.6$**

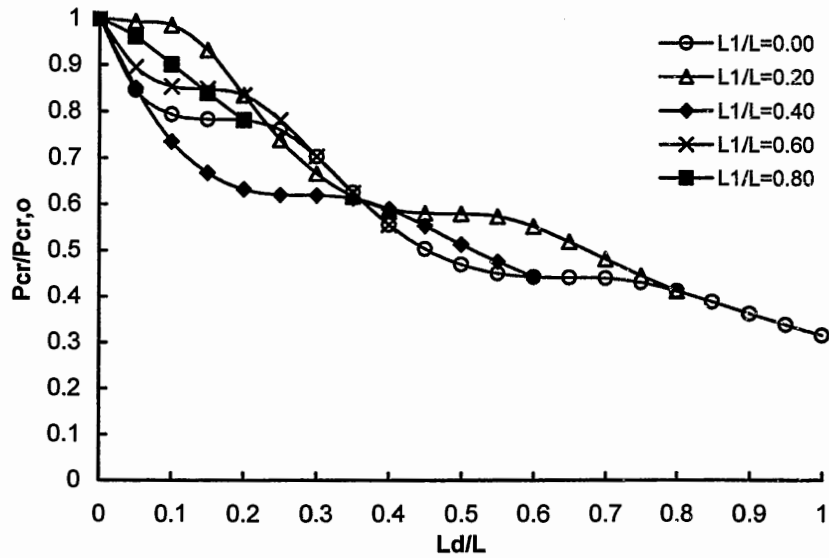
**Figure D.7 Buckling Load for Deteriorated Piles with
Fixed - Fixed Support Conditions: $R = 0.75$**

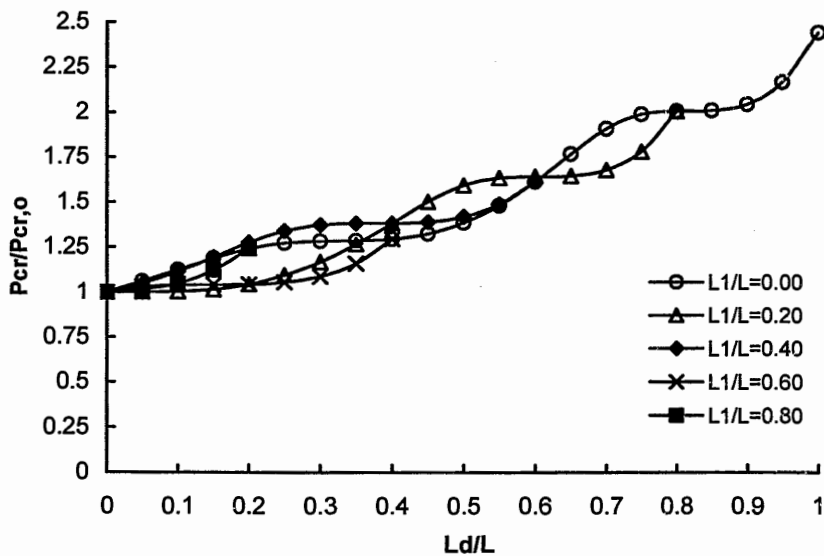
**Figure D.8 Buckling Load for Retrofitted Piles with
Fixed - Fixed Support Conditions: $R = 1.25$**

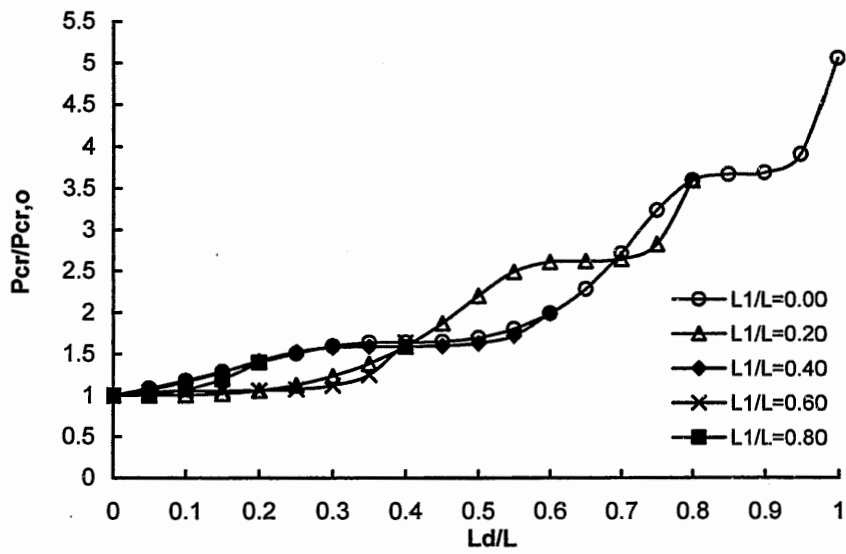
**Figure D.9 Buckling Load for Retrofitted Piles with
Fixed - Fixed Support Conditions: $R = 1.5$**

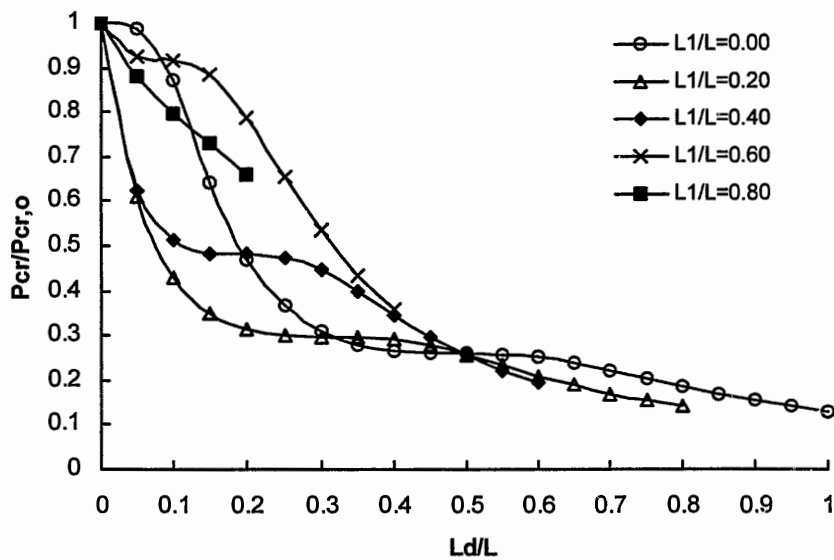
**Figure D.10 Buckling Load for Deteriorated Piles with
Pinned - Fixed Support Conditions: $R = 0.6$**

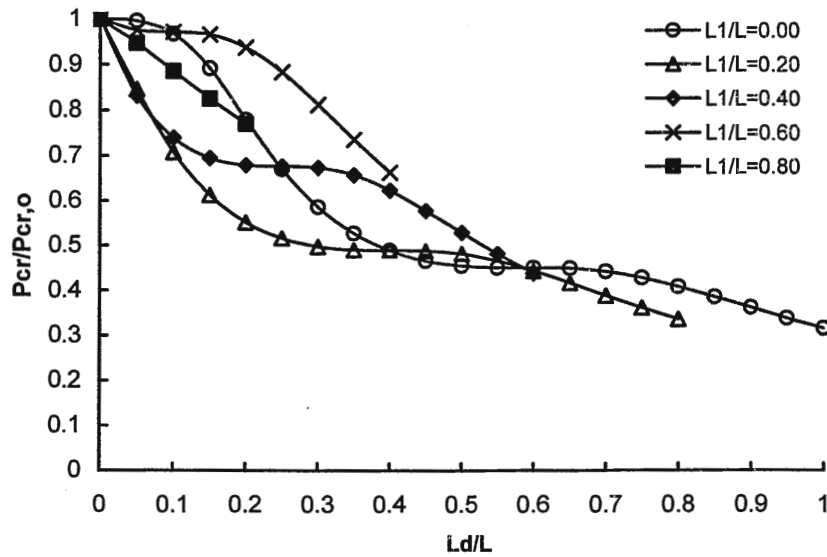
**Figure D.11 Buckling Load for Deteriorated Piles with
Pinned - Fixed Support Conditions: $R = 0.75$**

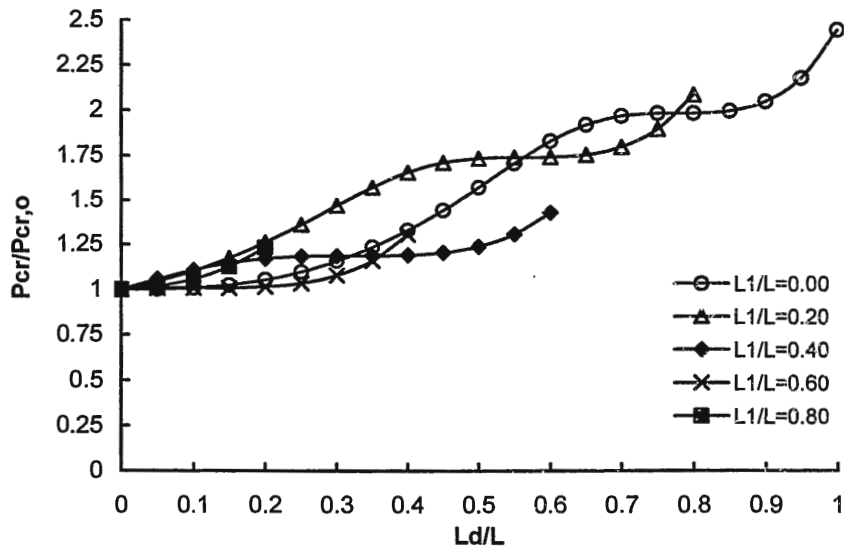
**Figure D.12 Buckling Load for Retrofitted Piles with
Pinned - Fixed Support Conditions: $R = 1.25$**

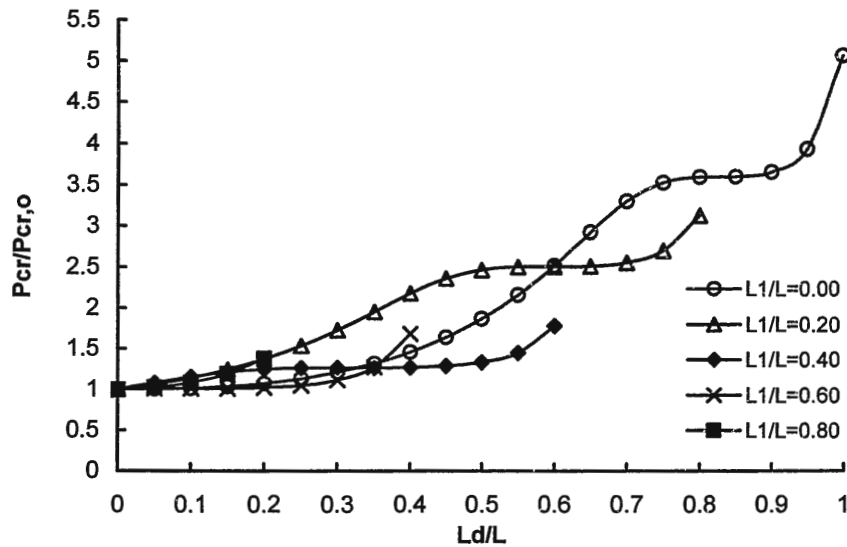
**Figure D.13 Buckling Load for Retrofitted Piles with
Pinned - Fixed Support Conditions: $R = 1.5$**

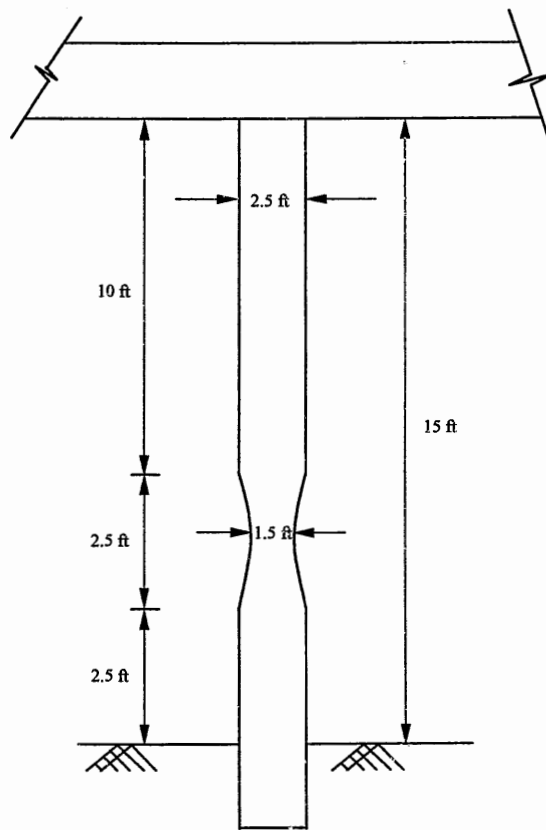
The example below illustrates a 15 feet long timber pile in a bridge structure. In the example, it was assumed that deterioration took place over a length, L_d , of 2.5 feet as shown in the figure. The original diameter, D_1 , of the pile was assumed to be 2.5 ft. and the diameter, D_2 , of the deteriorated section was assumed to be 1.5 ft. Other information required to calculate the pile capacity is listed on figure D.14.

Figure D.14 Example of a Deteriorated Pile
